CHAPTER 21
PROJECT EVALUATION

CHAPTER 21 IMPLEMENTATION PLAN

In this Chapter, the implementation plan of the road disaster prevention spots is addressed taking account of the key aspects which affect implementation. These include; executing agency, construction period, construction packages, preparatory works, implementation schedule and investment.

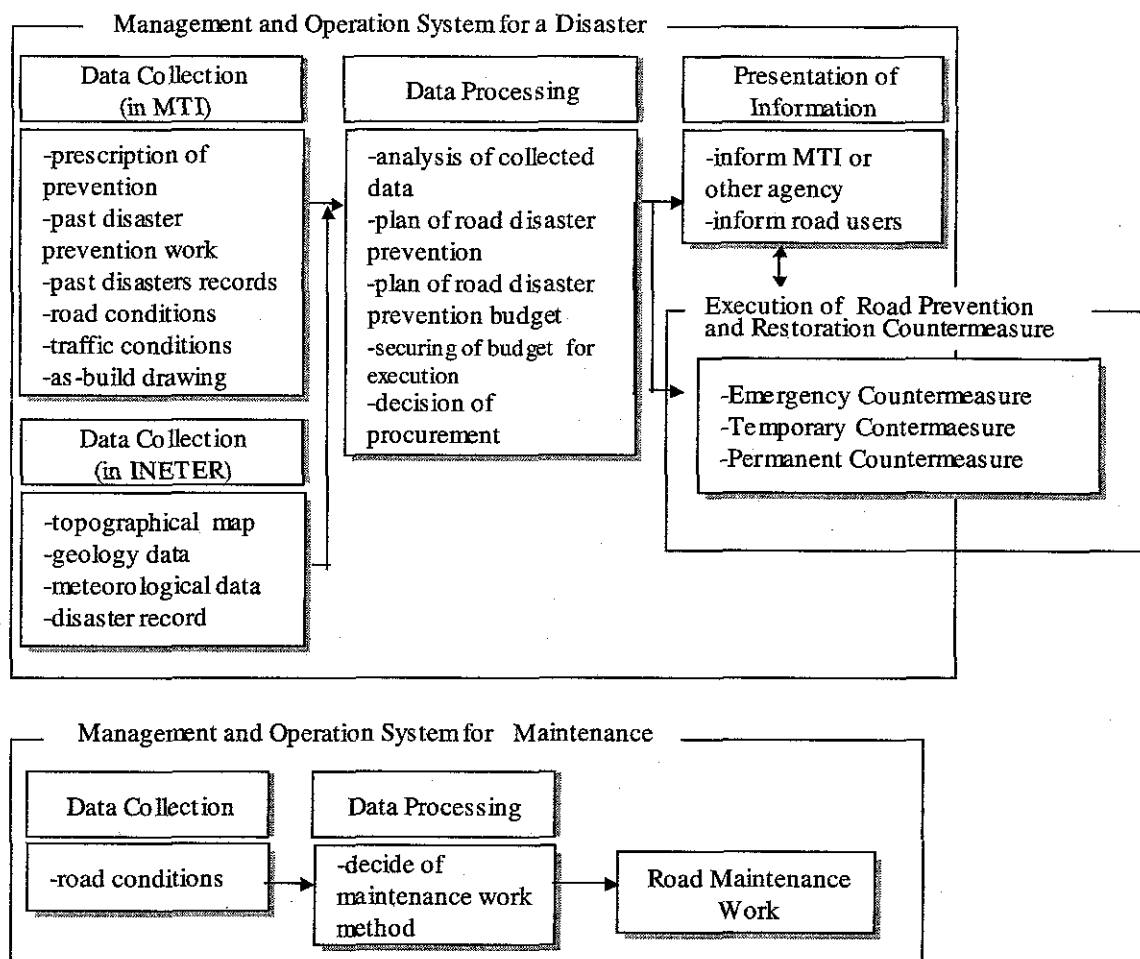
Figure 22.2.1 Concept of Maintenance and Operations System

Taking into consideration the present status of road maintenance in MTI, an overall concept for a system of road maintenance and operations is proposed as shown in Figure 22.1.1.

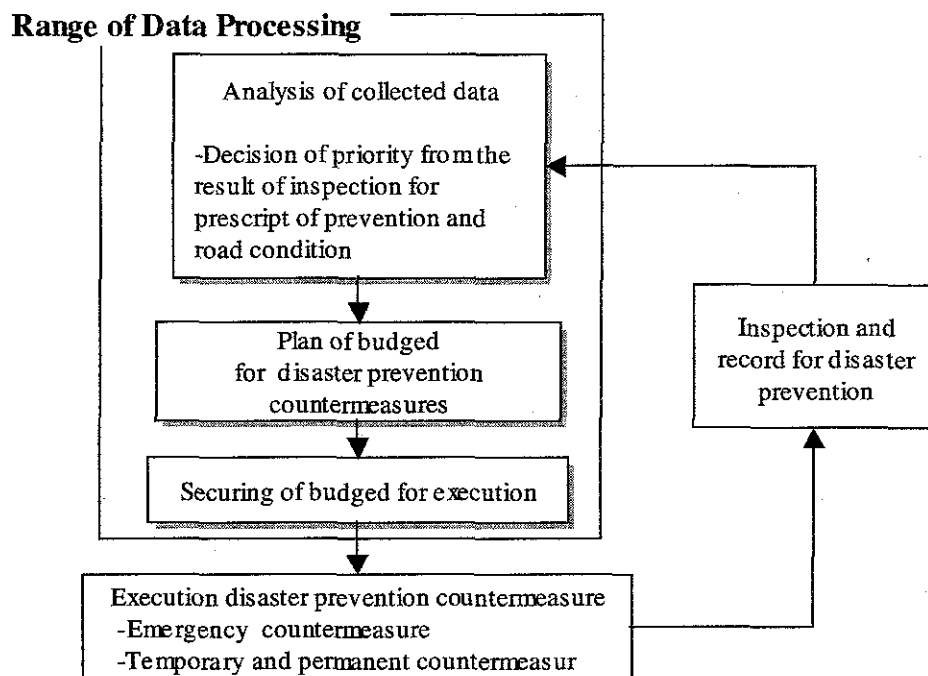
Figure 22.2.2 Method of Data Processing

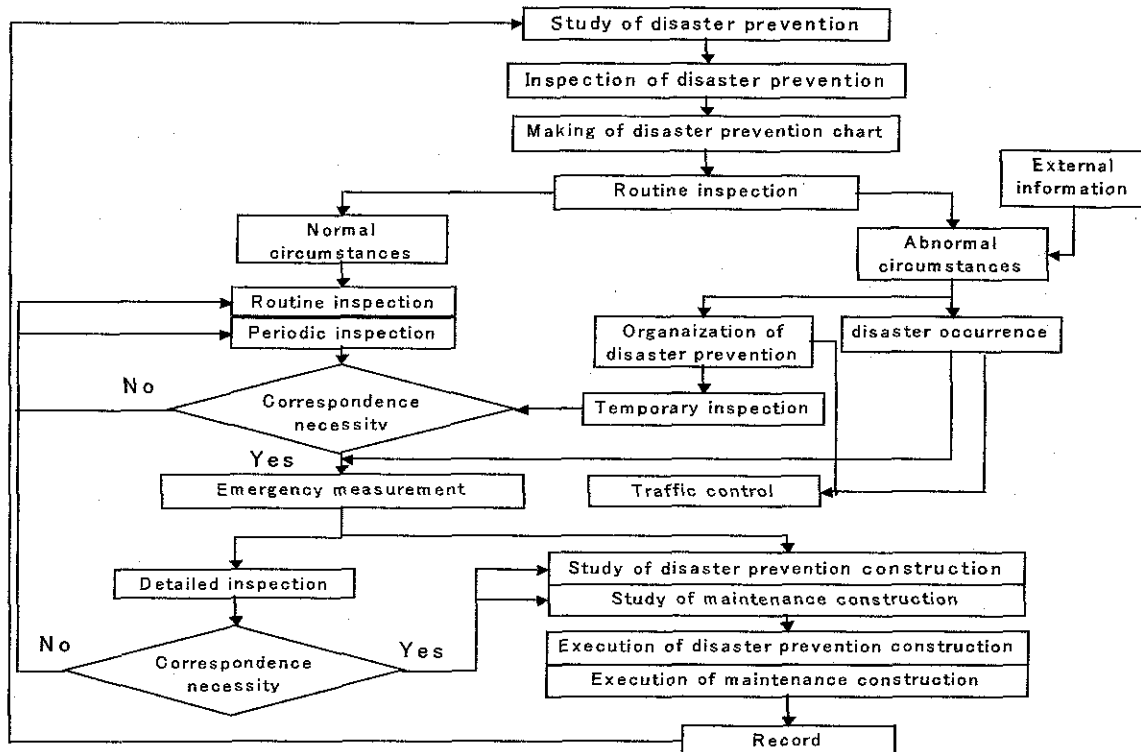
Figure 22.2.1 Flow Chart for Maintenance Management

The workflow for maintenance management is as shown in Figure 22.2.1.

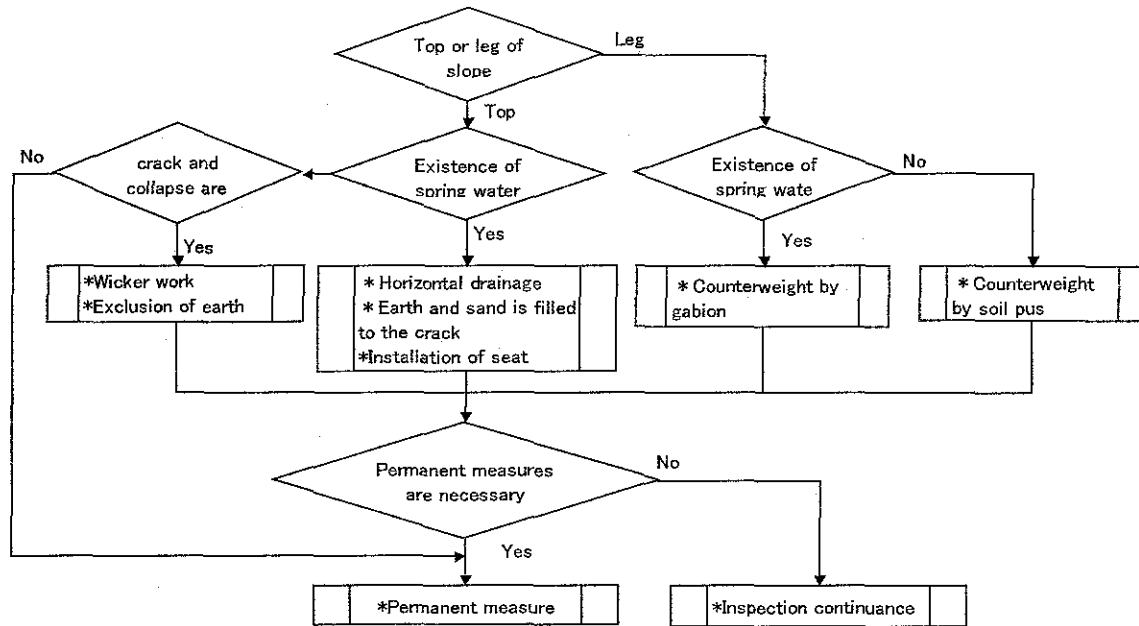
Figure 22.4.2 Method of Repair/ Rehabilitation of Crack and Damage on Slope

The selection of the method of repair and rehabilitation is as shown in Figure 22.4.2.

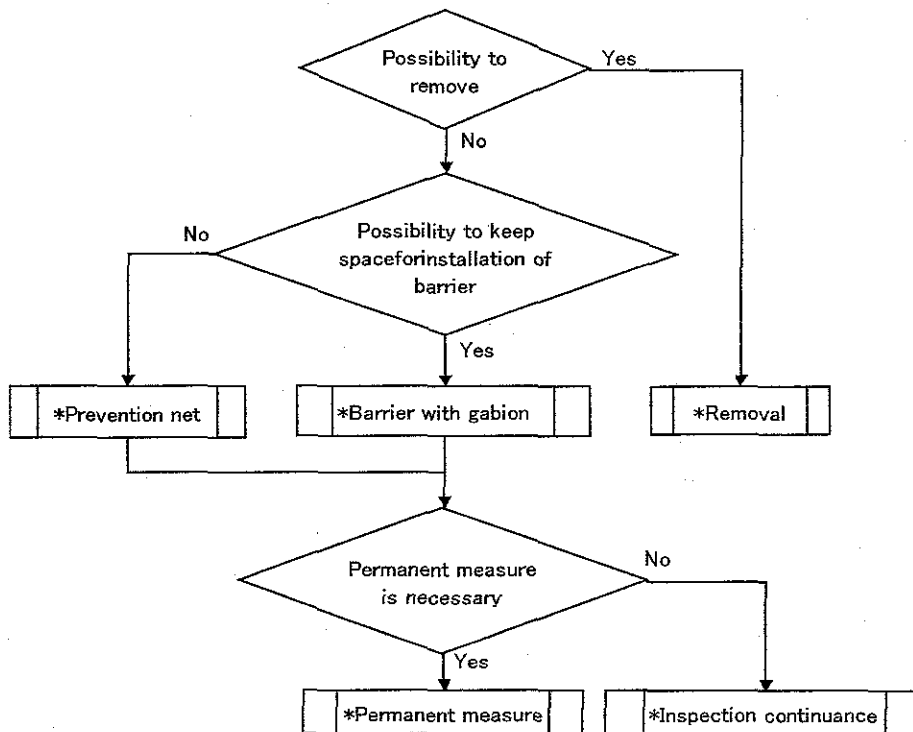
Figure 22.4.3 Method of Repair/ Rehabilitation of Boulder Stone and Unfixed Stone on Slope

The selection of the method of repair and rehabilitation is shown in Figure 22.4.3.

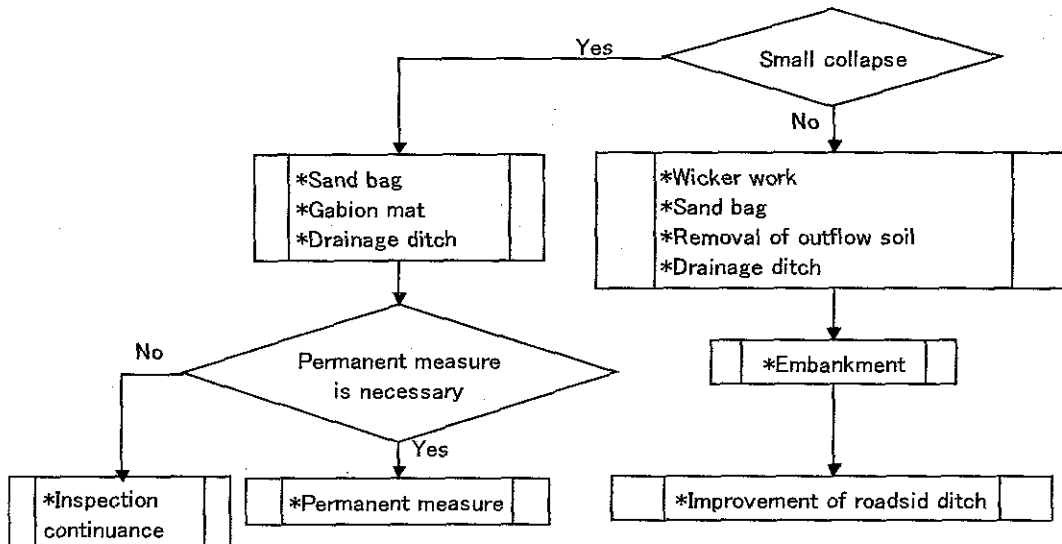
Figure 22.4.5 Method of Repair/ Rehabilitation of Slope Damage from Road Surface Water Inflows

The selection of the method of repair and rehabilitation is shown in Figure 22.4.5.

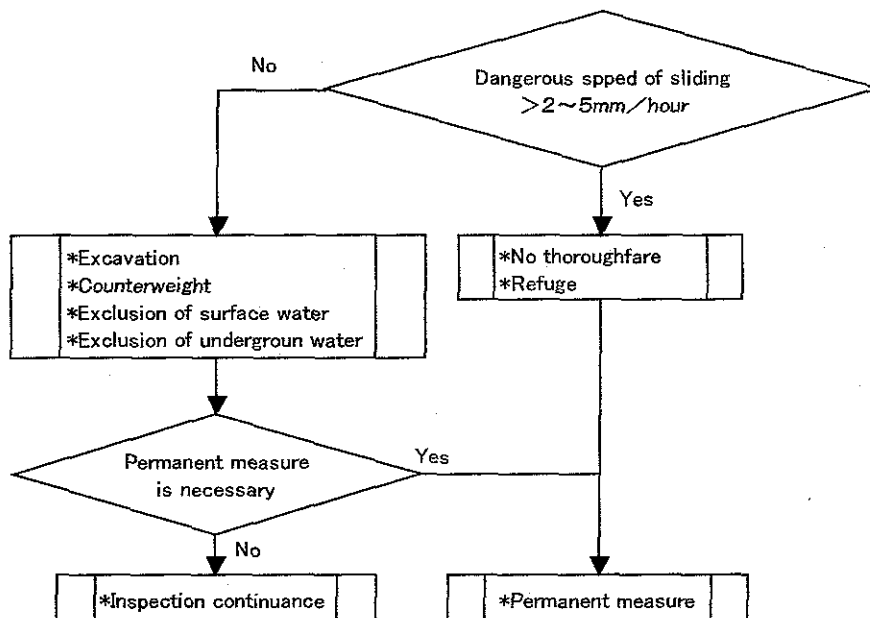
Figure 22.4.6 Method of Repair/ Rehabilitation of Damage from Landslides

The selection of the method of repair and rehabilitation is shown in Figure 22.4.6.

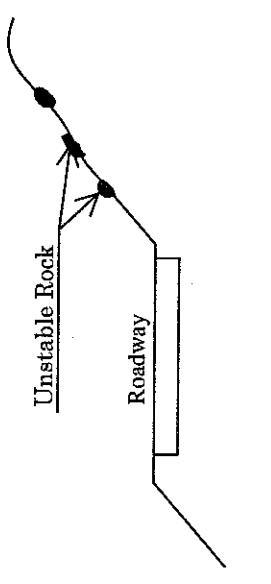
| Classification | Type of Work | Functional Characteristics | Application | Illustration |
|---|---|---|---|---|
| (1) Earth Work | Removal | <ul style="list-style-type: none"> - To stabilize a slope by removing unstable portions - To remove unstable rocks before they falling down | <ul style="list-style-type: none"> - Cut slope - Generally applied to huge and medium-size rocks. Rock-fall/collapsing Rock collapsing Slope damage Debris flow | |

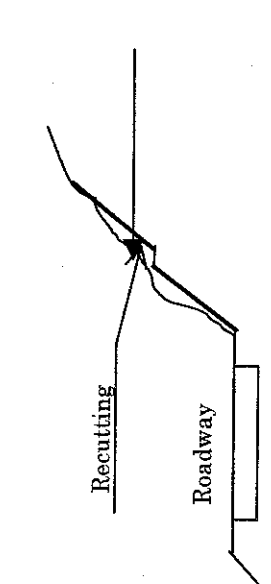
| Classification | Type of Work | Functional Characteristics | Application | Illustration |
|---|---|---|---|---|
| | Recutting | <ul style="list-style-type: none"> - To stabilize a slope by cutting it to its optimum gradient. | <ul style="list-style-type: none"> - Cut slope(soil & rock) Rock-fall/collapsing Rock collapsing Slope damage Debris flow | |

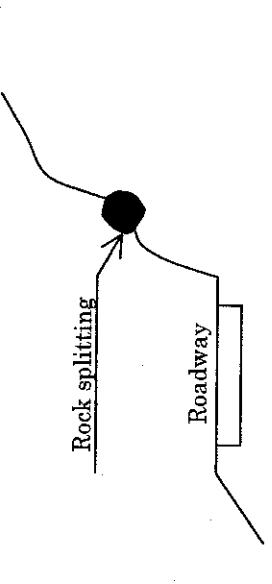
| Classification | Type of Work | Functional Characteristics | Application | Illustration |
|---|---|---|---|---|
| | Rock splitting | <ul style="list-style-type: none"> - To stabilize a slope by split it. | <ul style="list-style-type: none"> - Applied to huge rocks. Rock-fall/collapsing Rock collapsing Debris flow | |

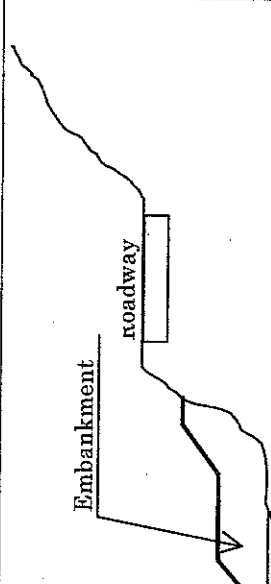
| Classification | Type of Work | Functional Characteristics | Application | Illustration |
|---|---|---|---|---|
| | Embankment | <ul style="list-style-type: none"> - To refill a cavity created by erosion, scouring, etc. | <ul style="list-style-type: none"> Rock-fall/collapsing Slope damage Debris flow | |

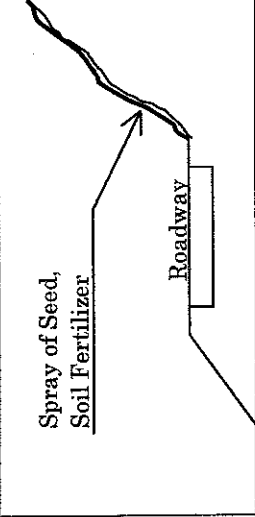
| Classification | Type of Work | Functional Characteristics | Application | Illustration |
|---|---|---|---|---|
| (2) Vegetation | Hydroseeding | - To prevent the erosion, scouring and weathering of a slope by covering it with vegetation. | - Mainly applied to the weathered rock, soft rock and soil surface of a cut and fill slope. Rock-fall/collapsing Rock collapsing Slope damage Debris flow | |

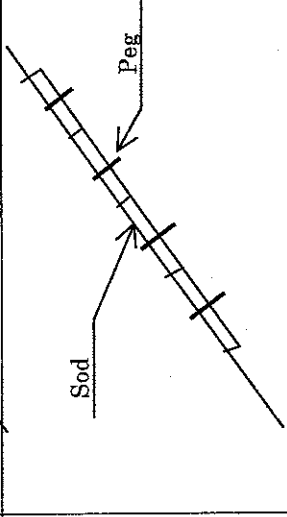
| Classification | Type of Work | Functional Characteristics | Application | Illustration |
|---|---|---|---|---|
| | Vegetation | - To prevent the erosion, scouring and weathering of slope by covering it with vegetation. | - Fill slope - Cut slope(soil) | |

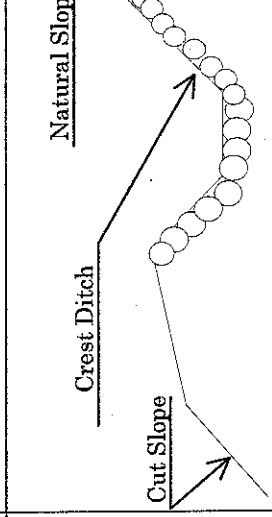
| Classification | Type of Work | Functional Characteristics | Application | Illustration |
|---|---|---|---|---|
| (3) Surface Drainage | Crest ditch | - To prevent the erosion and scouring of a slope surface by collecting runoff water along the top of a cut slope | Rock-fall/collapsing Slope damage Debris flow - Cut slope - Weathered rock, soil | |

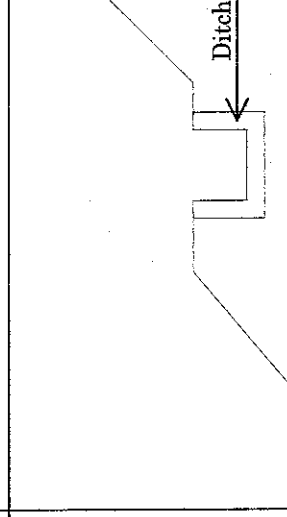
| Classification | Type of Work | Functional Characteristics | Application | Illustration |
|---|---|---|---|---|
| | Berm ditch | - To prevent the erosion and scouring of a slope surface by collecting surface water in berm. | - Cut slope and fill slope. - Weathered rocks and soil | |

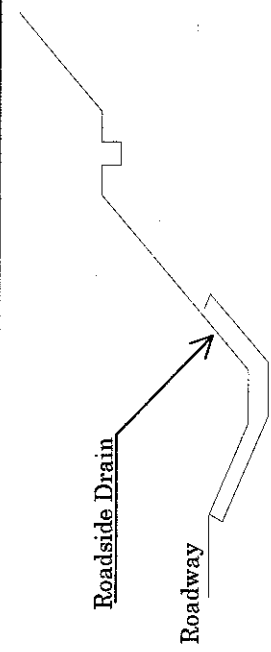
| Classification | Type of Work | Functional Characteristics | Application | Illustration |
|---|---|---|---|---|
| (3) Surface Drainage | Roadside drain | - To prevent runoff water from reaching a road's surface. | - Cut slope, fill slope. Rock-fall/collapsing Rock collapsing Slope damage | |

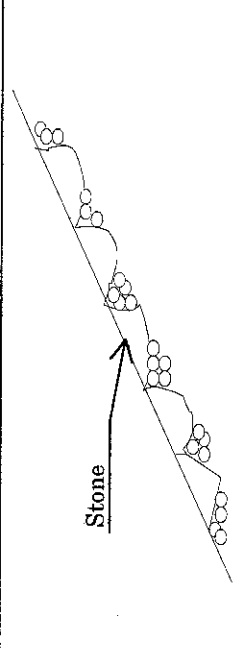
| Classification | Type of Work | Functional Characteristics | Application | Illustration |
|---|---|---|---|---|
| (4) Structure | Stone pitching | - To protect a slope by covering it with stone pitching. | - Usually applied to a slope surface gentler than 1.5:1 Rock-fall/collapsing Slope damage | |

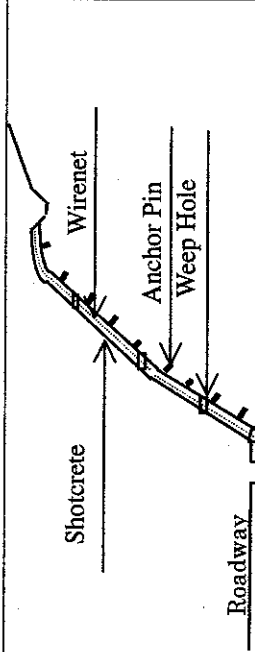
| Classification | Type of Work | Functional Characteristics | Application | Illustration |
|---|---|---|---|---|
| | Shotcrete | - To protect a slope by covering it with sprayed concrete(or mortar) | - Cut slope(rock) - Not applicable to a slope surface with much seepage water. Rock-fall/collapsing Rock collapsing Slope damage Debris flow | |

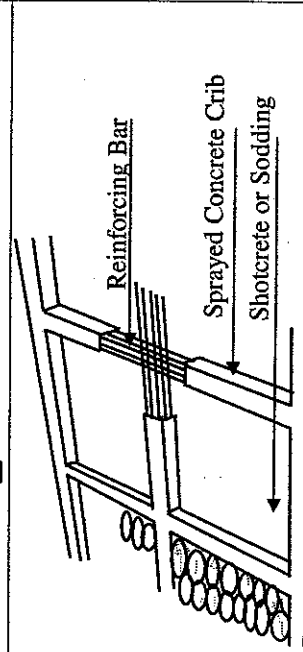
| Classification | Type of Work | Functional Characteristics | Application | Illustration |
|---|---|---|---|---|
| | Sprayed concrete crib | - To protect a slope by covering it with crib made with a gun. | - Applicable to a slope surface steeper than 1.0:1. - Applicable to an undulated surface. Rock-fall/collapsing Rock collapsing Slope damage Debris flow | |

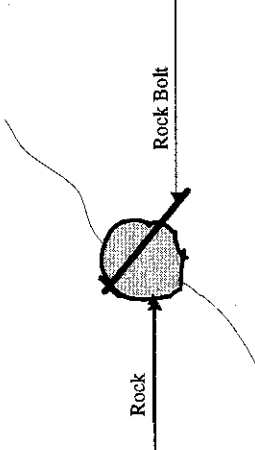
| Classification | Type of Work | Functional Characteristics | Application | Illustration |
|---|---|---|---|---|
| (5) Protection | Rock bolt | - To prevent unstable rocks from falling down by anchoring them to bedrock with rock bolt. | - Applicable to huge rocks. Rock-fall/collapsing Rock collapsing | <p>A diagram showing a circular rock mass with a diagonal line representing a potential failure plane. A rock bolt is shown as a line passing through the rock mass, anchored into the bedrock on the opposite side of the failure plane.</p> |

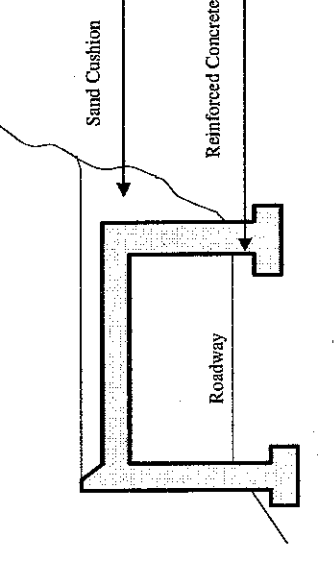
| Classification | Type of Work | Functional Characteristics | Application | Illustration |
|---|---|---|---|---|
| Rock shed | | - To prevent unstable rocks from falling down by rock shed and debris flow. | - Cut slope - Debris flow Rock-fall/collapsing Rock collapsing Debris flow | <p>A diagram of a rock shed structure. It consists of a concrete frame with a flat top surface labeled 'Sand Cushion' and a vertical wall labeled 'Reinforced Concrete'. Below the structure is a 'Roadway'.</p> |

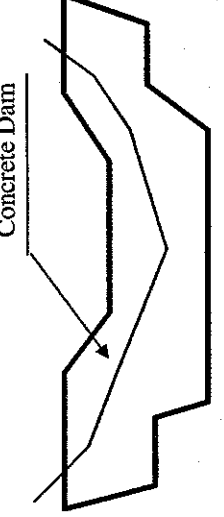
| Classification | Type of Work | Functional Characteristics | Application | Illustration |
|---|---|---|---|---|
| Concrete dam | | - To prevent a slope from debris flow by concrete dam. | - Debris flow Debris flow | <p>A diagram of a concrete dam structure, showing a cross-section of a dam with a stepped profile.</p> |

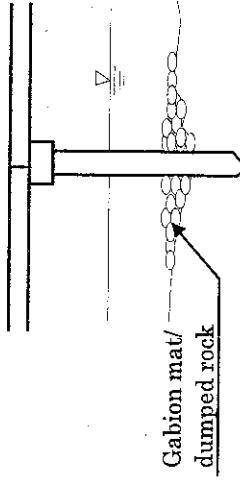
| Classification | Type of Work | Functional Characteristics | Application | Illustration |
|---|---|---|---|---|
| | Gabion mat protection | - To prevent falling rock from reaching a road by providing a catch fence. | Bridge - Applicable to a long and short bridge. | |
