3.4 Method for the Evaluation of Stability: Rock Collapsing

3.4.1 General

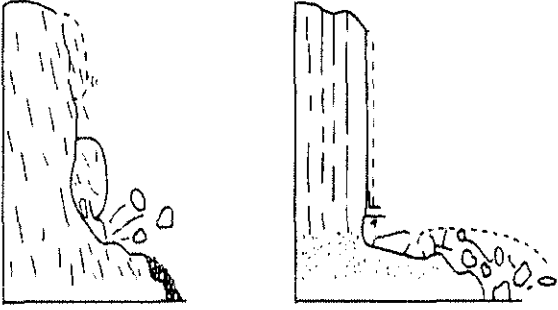
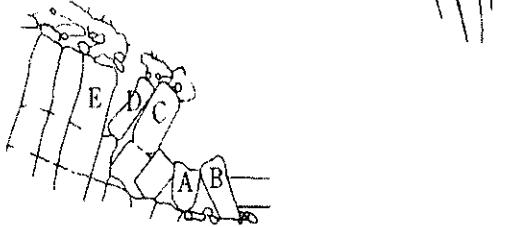
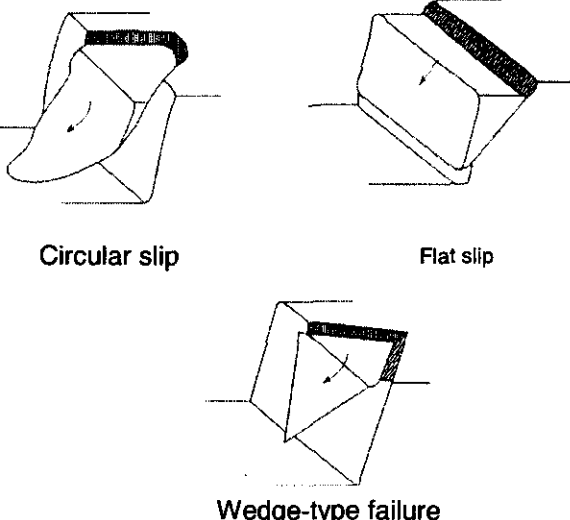
Figure 3.4.2 Type of Rock Collapsing

Types of Rock Collapsing	Description
<p><i>Fall of earth</i></p> <p>This is the phenomenon that mass rock fall from the rock base at the discontinuities part such as joint of steep slope or cliff. It is the kinetic movements due to the rockfalls, as free fall, bound and jumps</p>

<p><i>Overtuning(toppling failure)</i></p> <p>It is the kinetic movement due to overturning moment. Overturning is made by gravity, the pressure from contiguous blocks, and water pressure along cracks.</p>

<p><i>Rock slides</i></p> <p>It is the kinetic of shear slide such as the movement along circular slip surface or flat slip. Wedge-type failures are also a type of rockslide, which appear upper position above the surface along discontinuities part, and it are typical phenomena on pure rock slopes.</p>

<p style="text-align: center;">Circular slip Flat slip</p> <p style="text-align: center;">Wedge-type failure</p>

The types of rock collapse are nominated as rock falling, overturning and sliding of rocks and so forth (Figure 3.4.2). The factors for these phenomena depend on condition of cracks, the quality of rocks, topography and ground waters and so forth. The evaluation should be carried out with a focus on these factors and the degree of efficiency of existing countermeasure works. For the point of evaluation and inspection, a symptom of rock collapsing should be an important factor. However, it is not limited for the evaluation of stabilities at the spots. Because it is the insufficiency of data regarding rock collapsing, and it are not limited as low stability at the spots where the disaster such as rock collapsing have occurred before and so forth.
