Part-D

***Geological Investigation
of Proposed Schemes***

Part-D: GEOLOGICAL INVESTIGATION OF PROPOSED SCHEMES**Table of Contents**

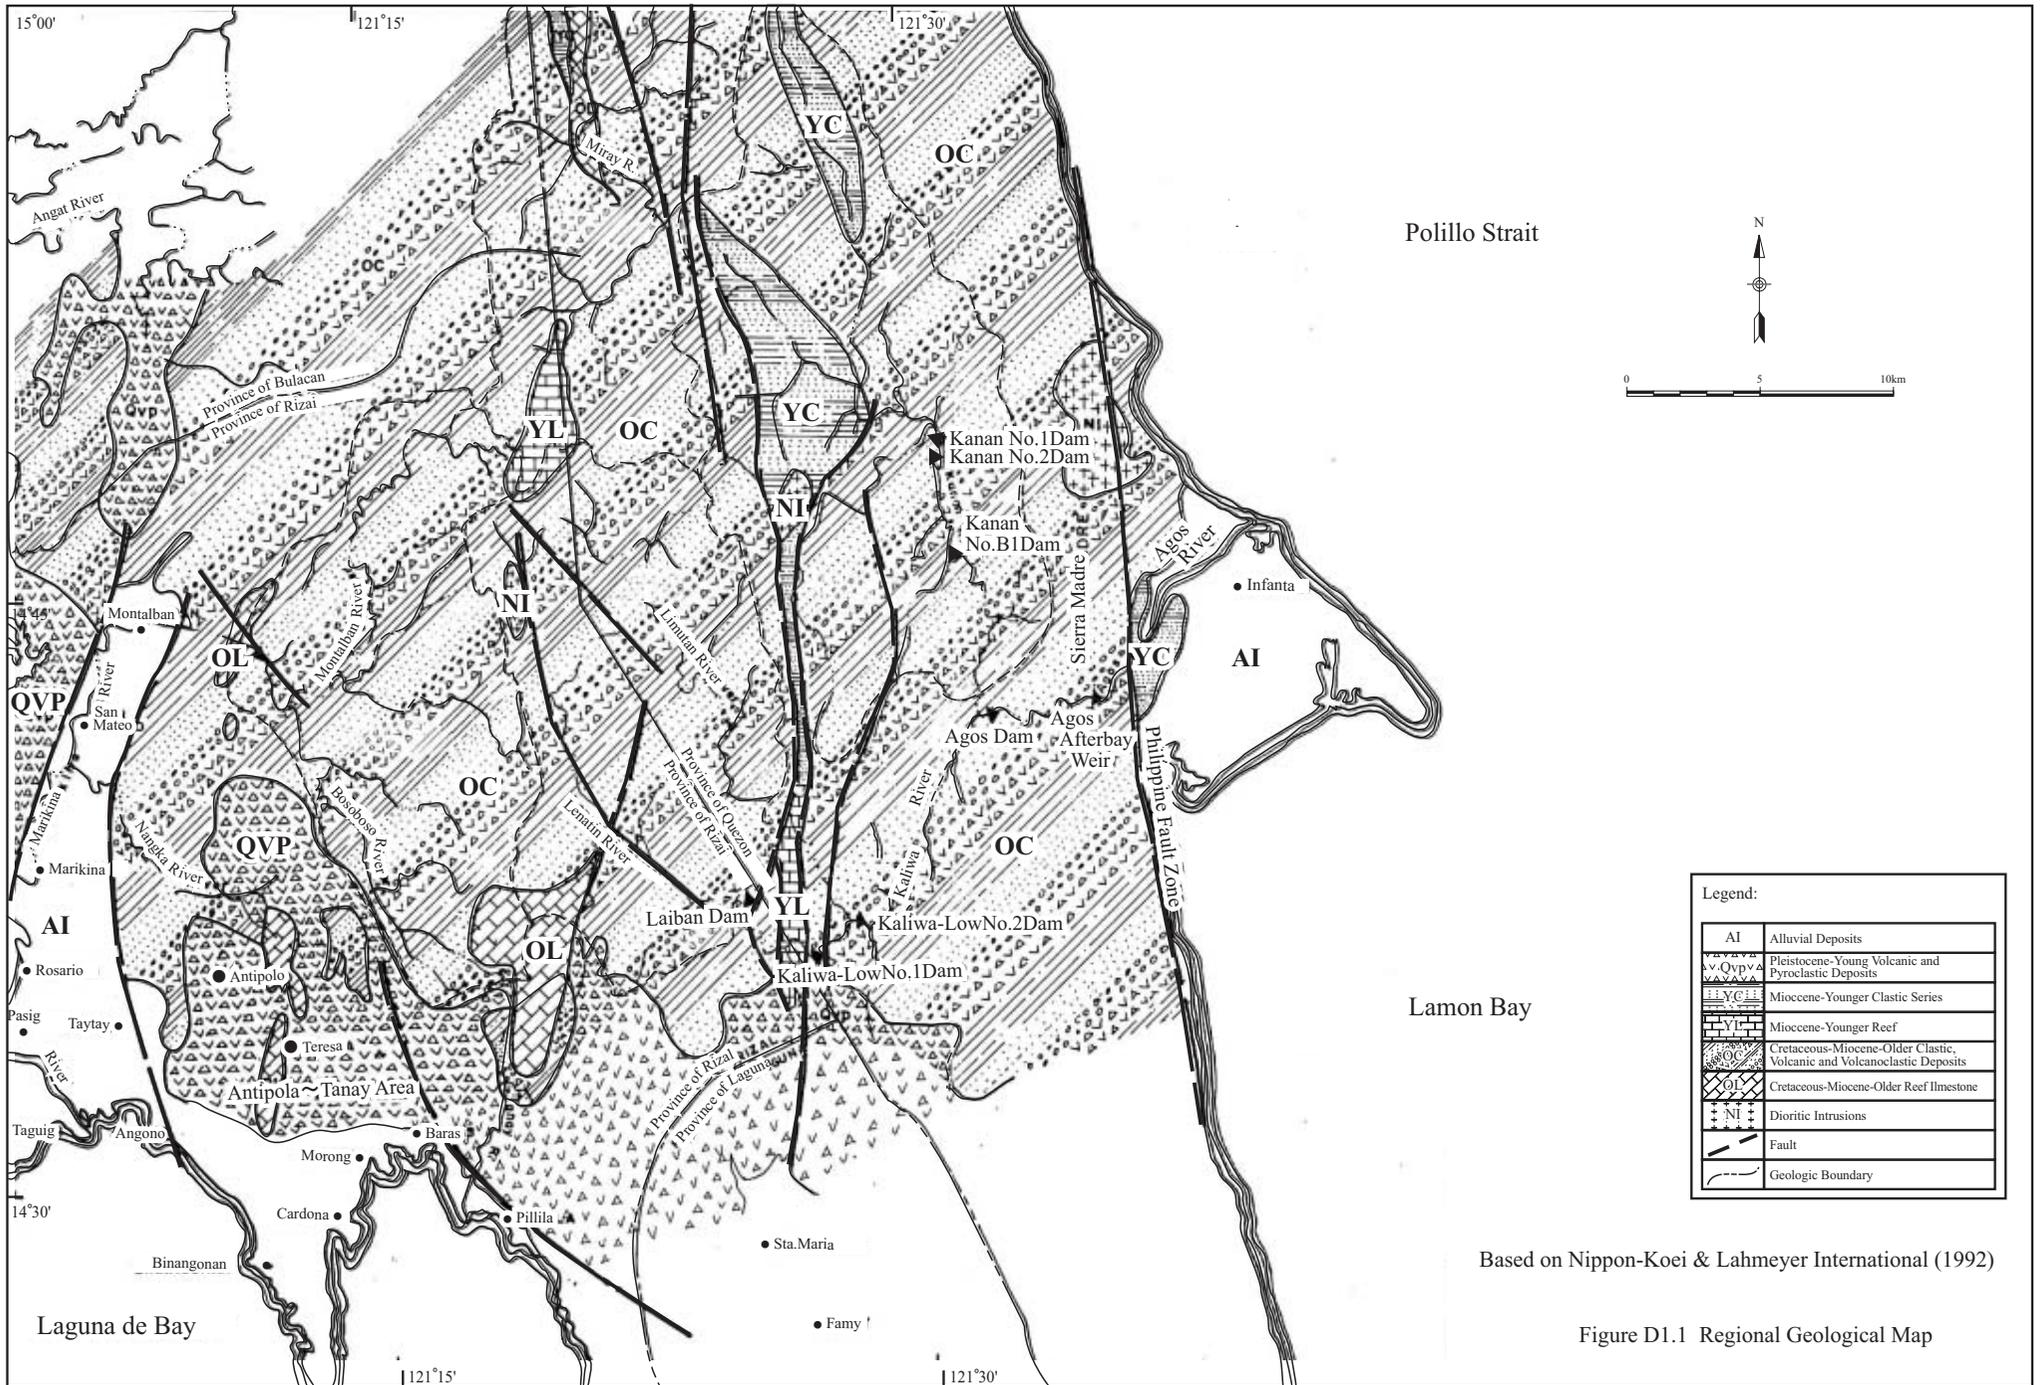
Figure D1.1 Regional Geological Map

Based on Nippon-Koei & Lahmeyer International (1992)

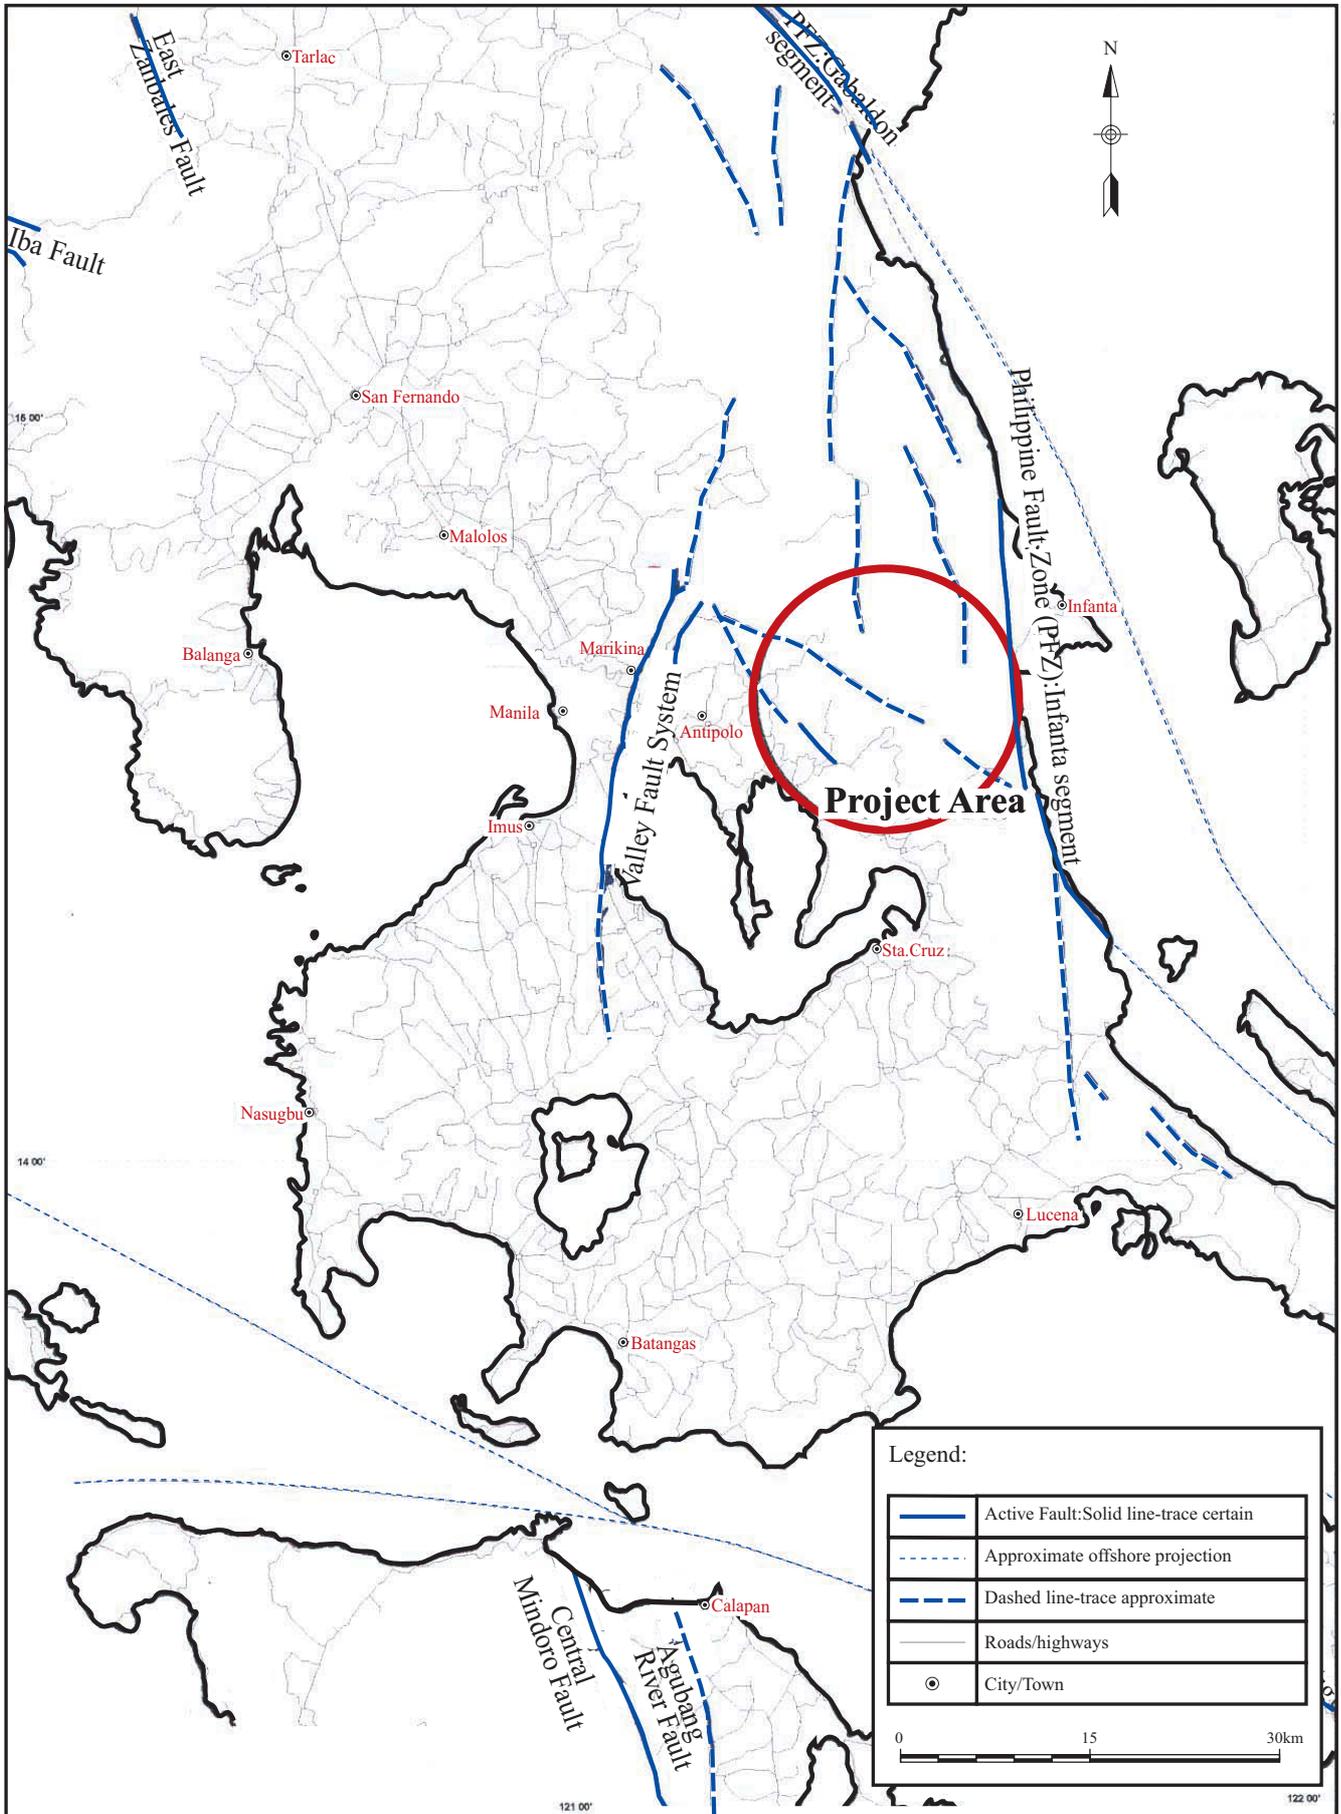
Figure D2.2
Distribution of Active Faults in Southern Luzon

By PHILVOLCS (2000)

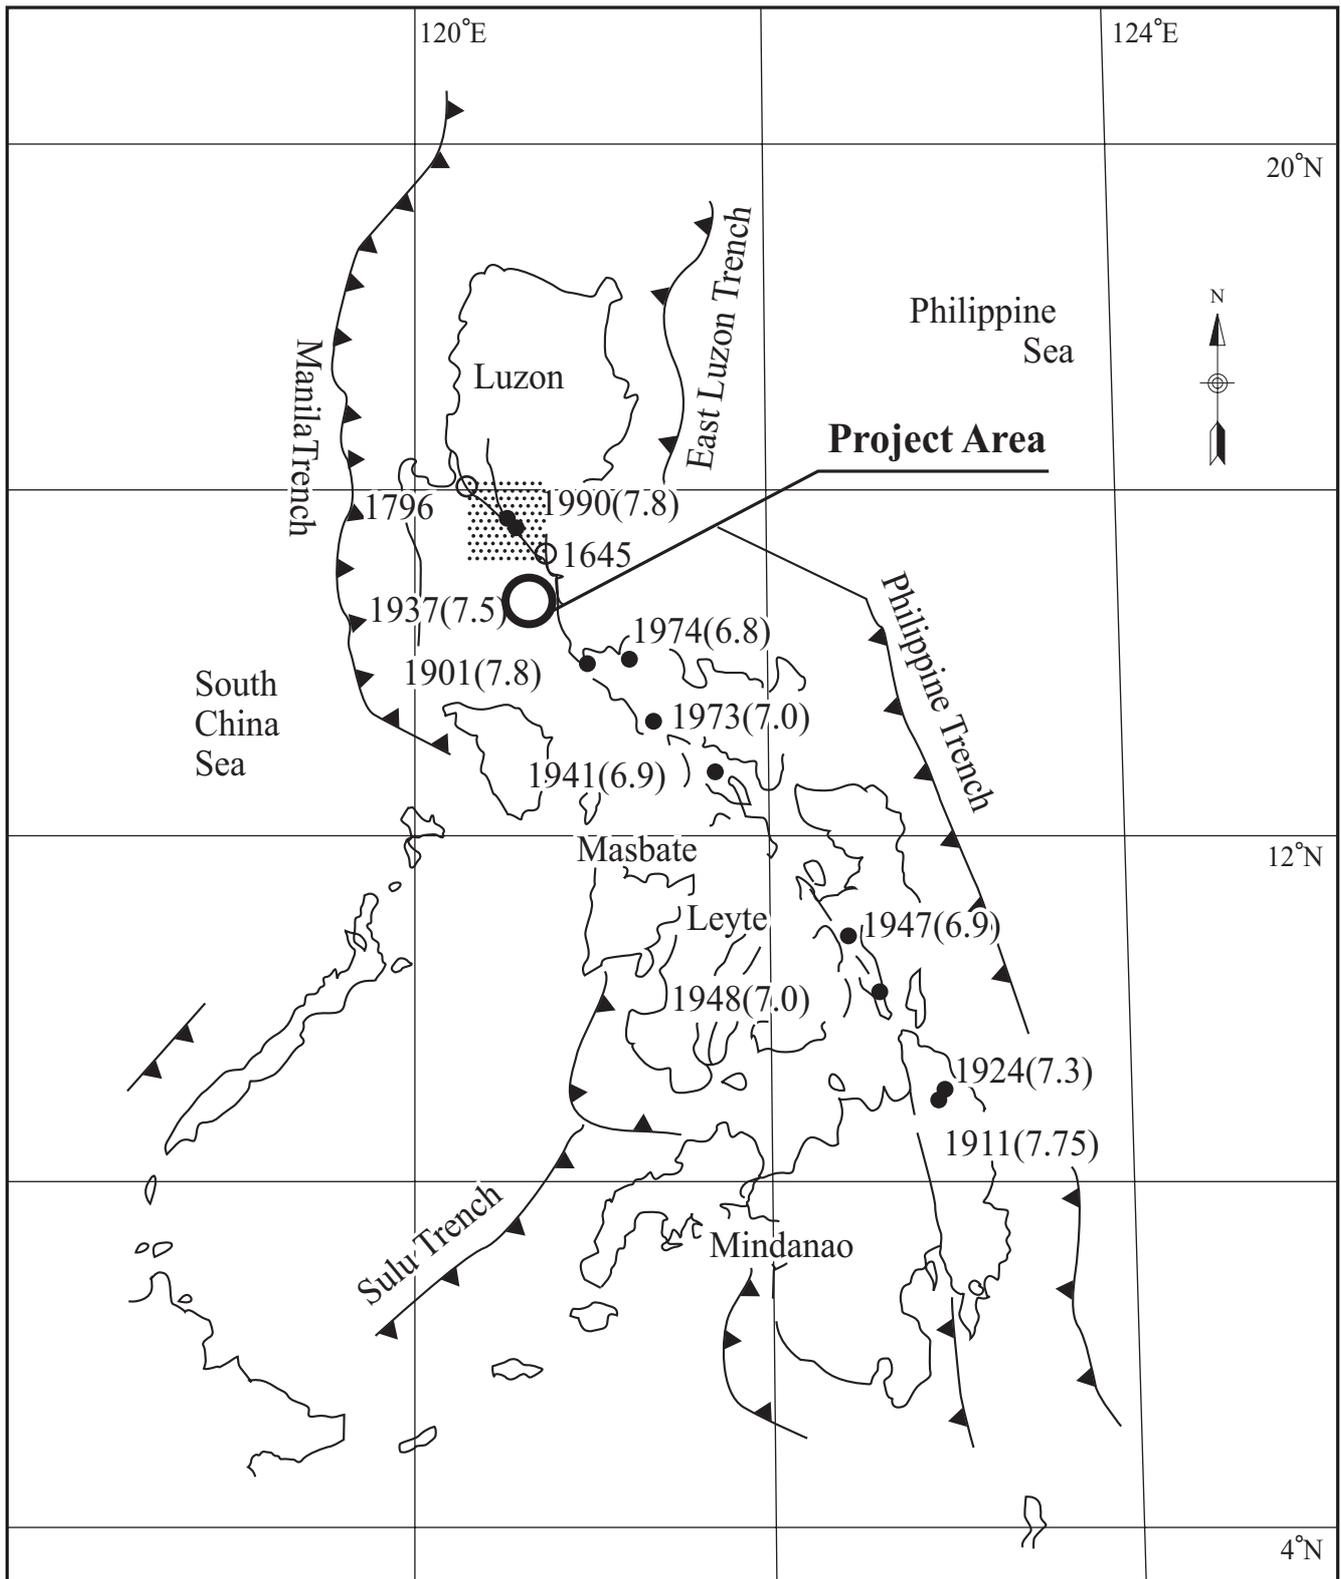
Figure D2.3

Epicenters of the 1990 Luzon Earthquake and locations of the large earthquakes along the Philippine Fault in this
