*Annex B*

*Geological Investigation*

## Annex B GEOLOGICAL INVESTIGATION

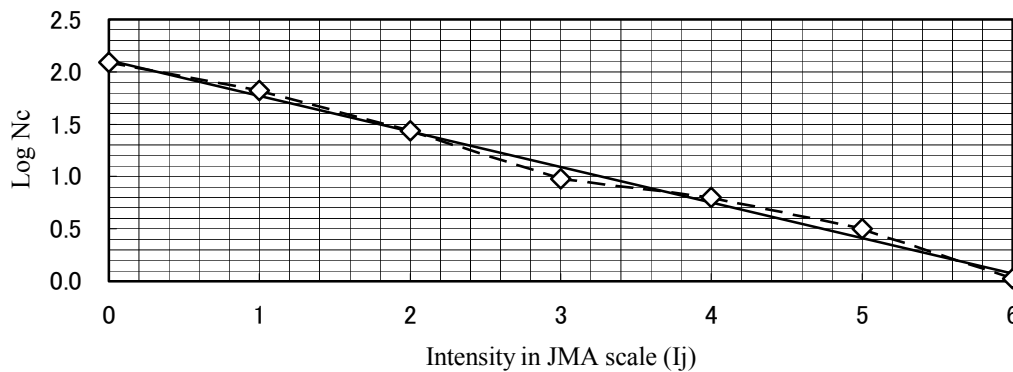
**Relation between Intensity ( $I_j$ ) and Frequency ( $N_c$ )**

In case the minimum square method is applied, the relation between  $I_j$  and  $N_c$  is derived as shown below:

Intensity ( $I_j$ )	Frequency in 95 years	Frequency in 100 years	Cumulative number for 100 years ( $N_c$ )
0 (less than 0.6)	54	56.84	123.16
1 (0.6-1.5)	37	38.95	66.32
2 (1.6-2.5)	17	17.89	27.37
3 (2.6-3.5)	3	3.16	9.47
4 (3.6-4.5)	3	3.16	6.32
5 (4.6-5.5)	2	2.11	3.16
6 (5.6-6.5)	1	1.05	1.05
Total	117	123.16
