Figure B4.3 Geological Condition around the Agos Dam Site

Figure B4.4 Geological Profile of the Agos Damsite (1)

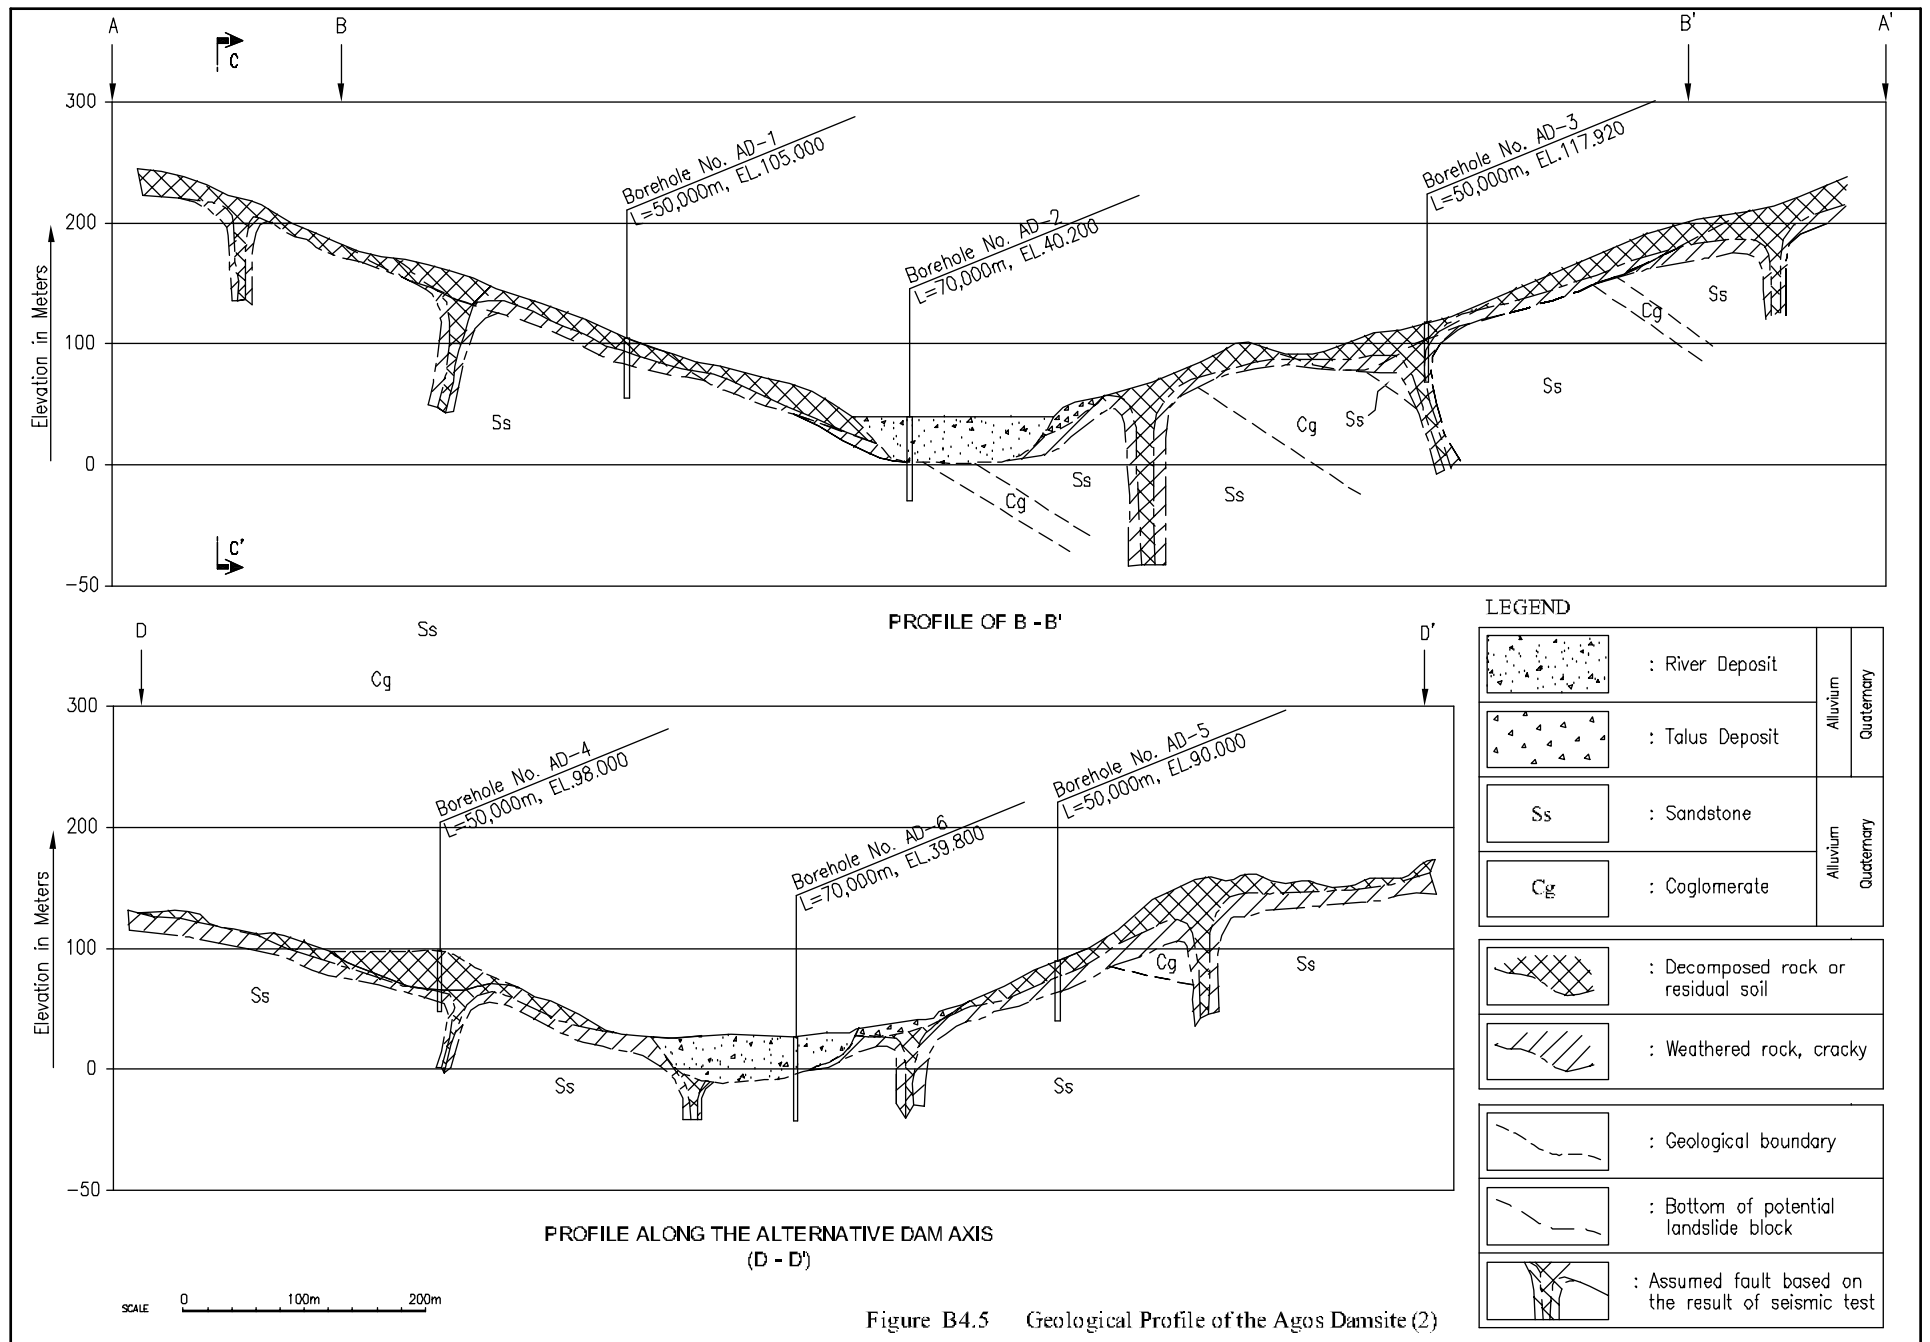
Figure B4.5 Geological Profile of the Agos Damsite (2)

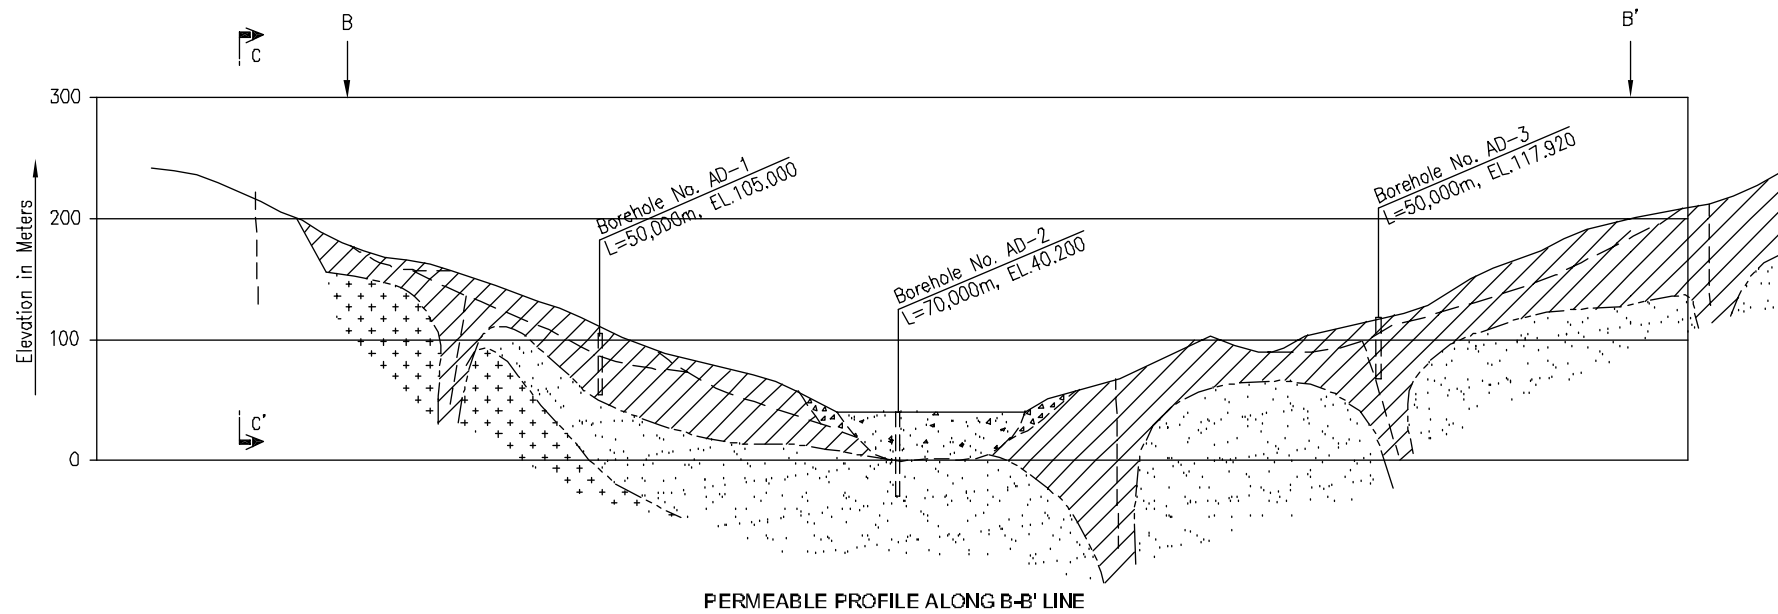
Lugeon-value

: $5 \leq Lu$
	: $1 \leq Lu < 5$
	: $Lu < 1$

Figure B4.6 Permeable Profile of the Agos Damsite

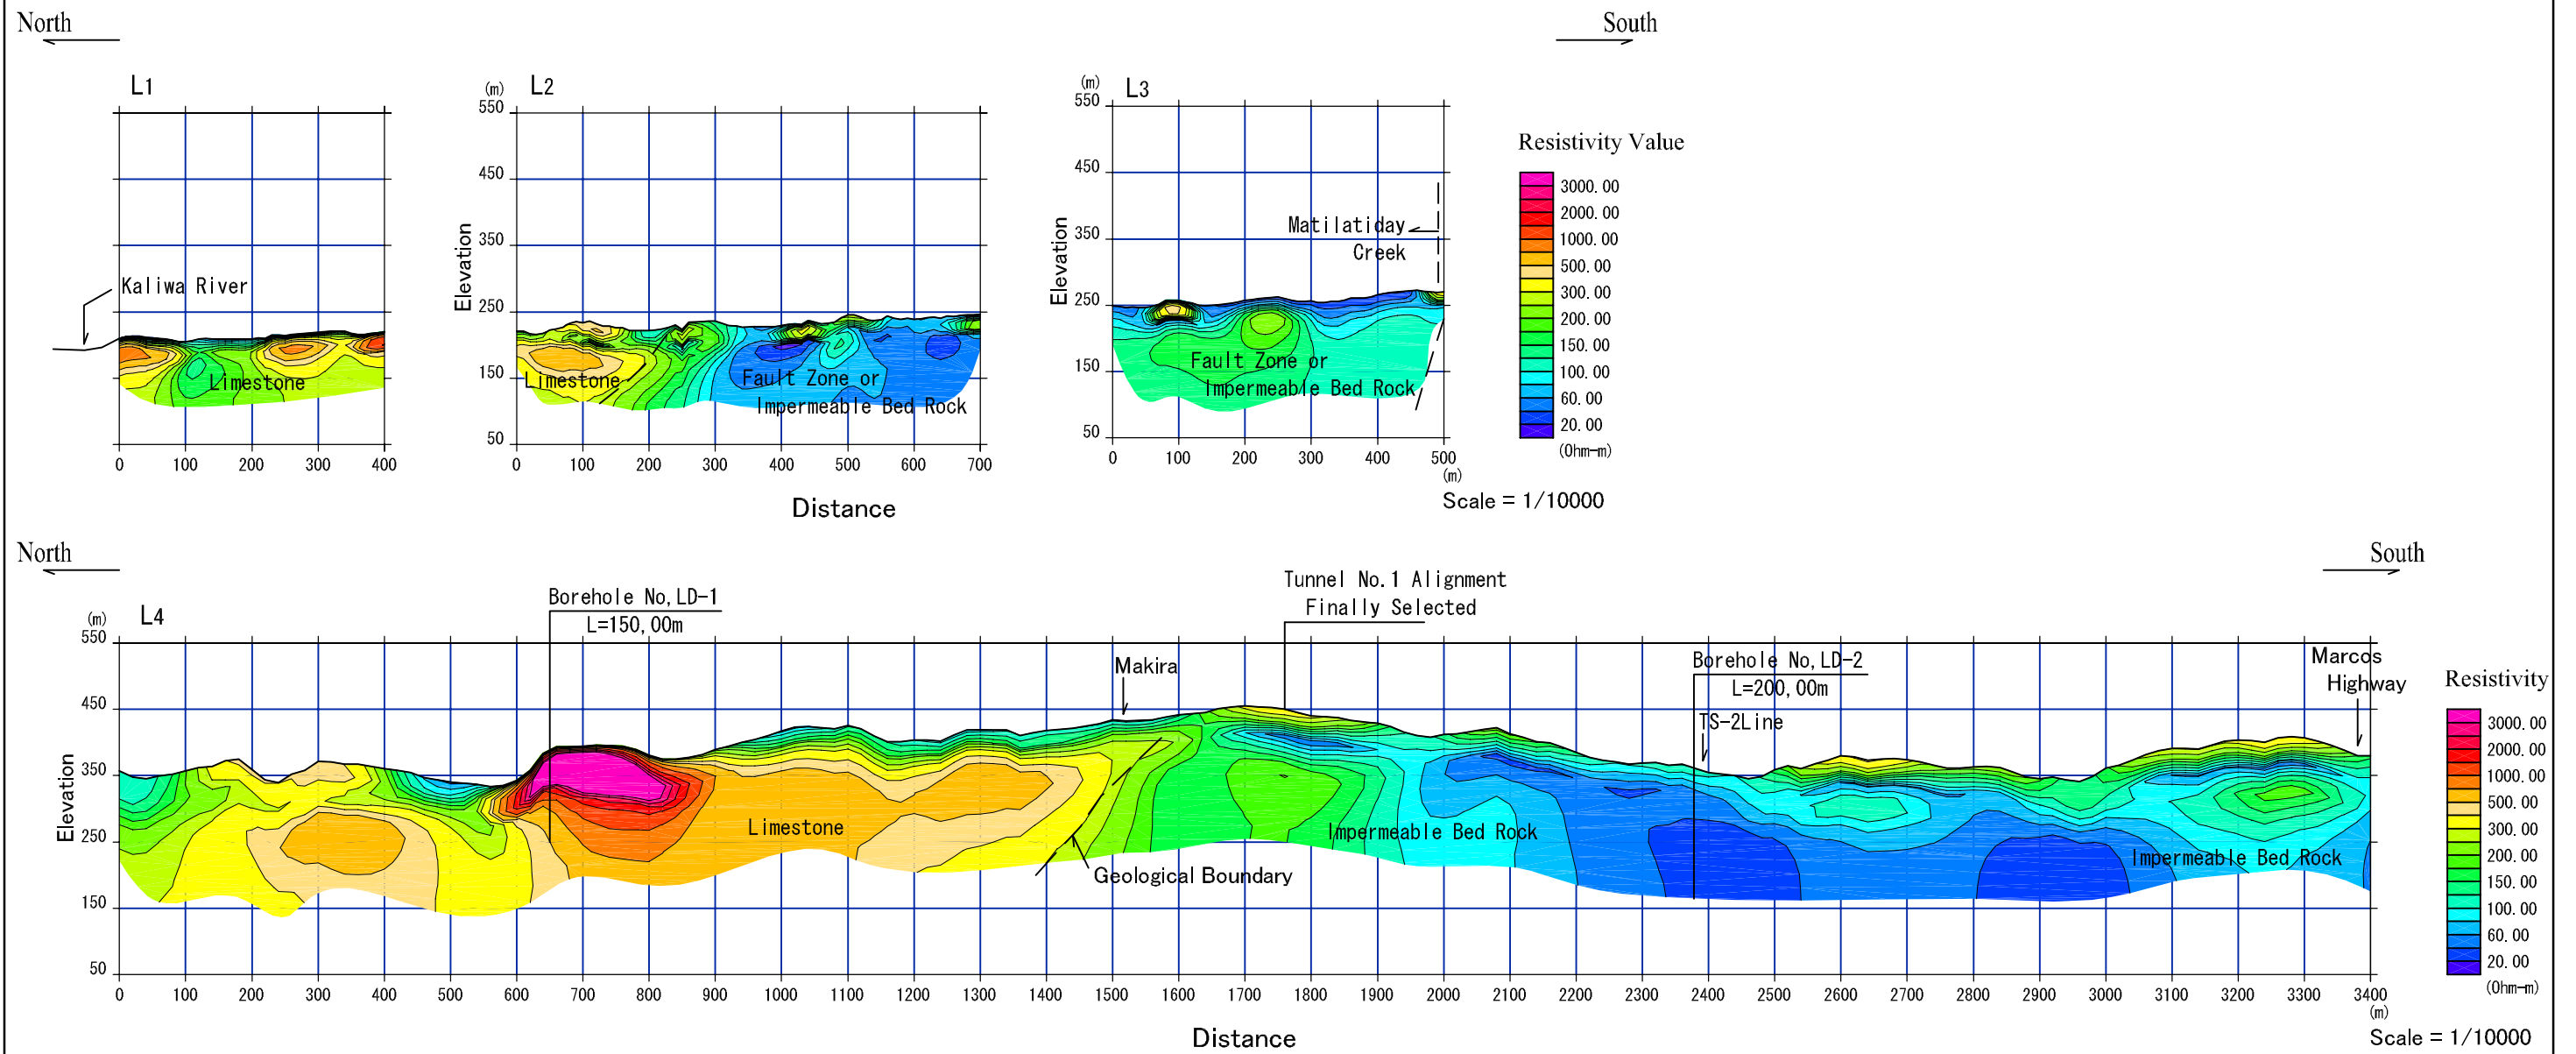
Figure B4.8 Result of Electric Prospecting
(Two-dimensional resistivity profiling)
