BASIC DESIGN STUDY REPORT
ON
THE PROJECT FOR THE CONSTRUCTION OF
MULTIPURPOSE CYCLONE SHELTERS (V)
IN
THE PEOPLE'S REPUBLIC OF BANGLADESH

AUGUST 2003

JAPAN INTERNATIONAL COOPERATION AGENCY
JAPAN ENGINEERING CONSULTANTS CO., LTD.

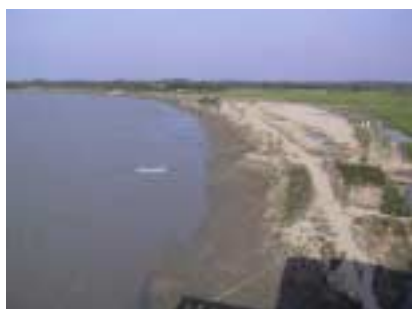
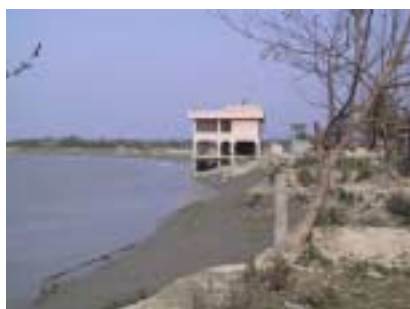
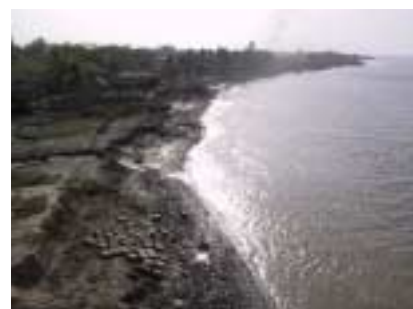
**Situation of Shelter Constructed with Japanese Assistance along the Left Bank of
the Lower Reach of Sangu River (Phase II-2: Rata Khordo GPS)**

The current shore line on the left bank around this site shows that the shelter site is slightly protruding towards the centre of the river, greatly exposing the site to water flow at the time of flooding. This situation appears to encourage erosion, posing a danger to the shelter. While work has been conducted in the past to avoid the loss of this shelter, no such work is currently taking place. There are signs of the implementation of reinforcement work to resist bank erosion in both the upstream and downstream but the current shape of the embankment immediately upstream of the shelter is like a razor, i.e. an extremely narrow crown width of the embankment, suggesting that it is highly vulnerable to erosion. Depending on the scale of flooding this year, the bank erosion will further progress, possibly causing the circle of river water around the embankment to invade the embankment, leaving the shelter in the river. The shelter is currently being used as a school building with little protection.

View of the upstream from the rooftop

View of the shelter from the downstream

View of the downstream from the rooftop

According a JICA expert (assigned to the LGED), the situation of the shelter (Phase II Project Site No.2: Rata Khordo GPS) constructed with Japanese assistance at Banshkhali in mid-March, 2003 little differed from that in November, 2002 although it was facing imminent loss.

- ④ According to the survey on damage by bank erosion to existing shelters, even though no shelter has been lost in Banshkhali Upazila, one shelter (Phase II-2) in the downstream of the candidate site is facing imminent loss due to the scouring of its foundations. In addition, a shelter constructed by Saudi Arabia is facing a risk of its foundations being scoured in the upstream of the nearest bank to the candidate site.

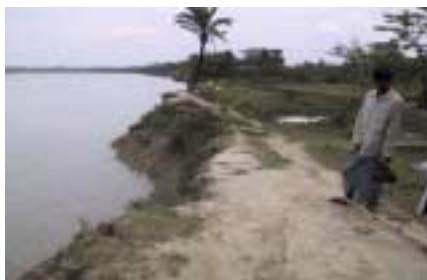
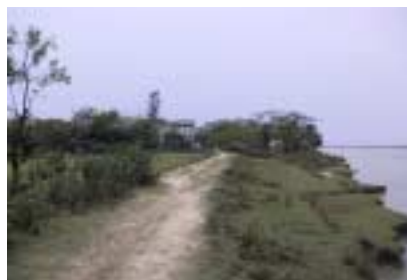
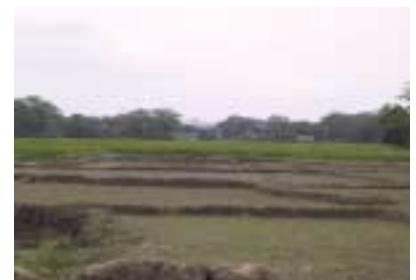
Shelter on Left Bank in Lower Reach of Sangu River likely to be Affected by Bank Erosion in the Future

There is another shelter constructed with Saudi Arabian assistance on the left bank of the upper reach of Sangu River some 5.7 km north of the shelter referred to in (1) above. This shelter is situated some 15 m of the river bank of Sangu River at a section which is currently suffering from ongoing erosion. According to the interview survey results, a mosque located some 100 m upstream of this shelter was washed away last year. Because of the absence of a new embankment, etc. to prevent further bank erosion, there appears to be a strong likelihood of the erosion or even loss of the shelter's foundations depending on the scale of flooding this year and thereafter.

View of the left bank upstream seen from the shelter

View of the shelter seen from the upstream

View of Site No. 30 to the south seen from the river bank

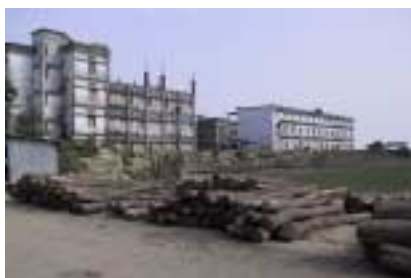
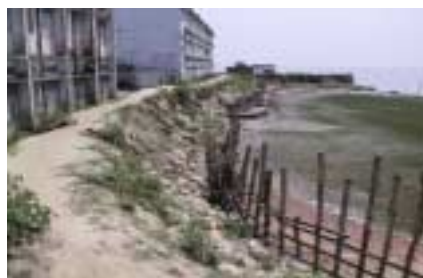
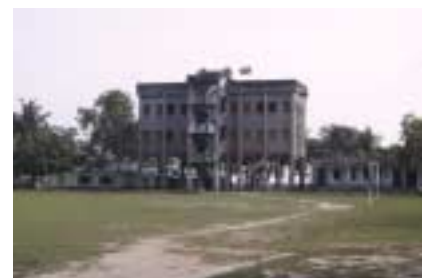
College Campus along West Bank of Sandwip Island

The west bank of Sandwip Island has been eroded by some 2.2 km in the last some 30 years and the shoreline is now approaching the back of the college campus. As shown on the photographs, the bank is being reinforced but there is concern in regard to the further progress of erosion in the coming years.

View of the college building seen from the west bank side

State of slope protection at the west bank

Shelter on the college campus

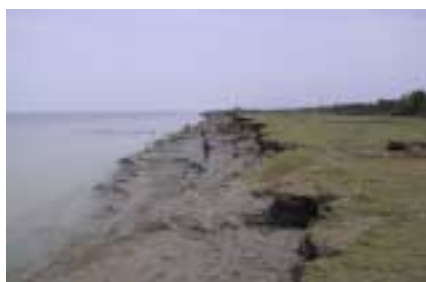
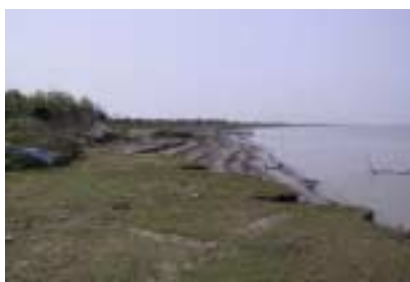
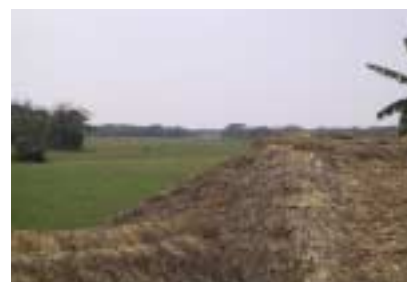
Situation of West Bank on Hatiya Island

The west bank of Hatiya Island has been eroded by approximately 1.5 km over a period of some 30 years and bank erosion is still in progress. According to the interview survey results, the last 12 months have seen the receding of the bank by some 600 m due to erosion. Along the bank near Site No. 39, the embankment is situated some 200 m inland from the bank and a shelter constructed by Caritas is located inside this embankment. Although this embankment extends along the bank, it ends some 300 m to the south where its distance from the bank is approximately 20 m.

View of the west bank seen
from the south to the north

View of the west bank seen
from the north to the south

View of Site No. 39 seen
from the top of the embankment

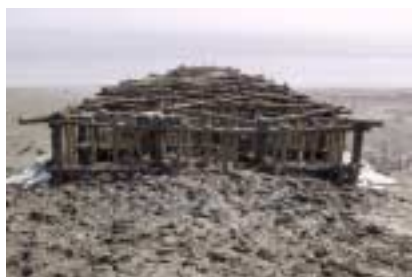
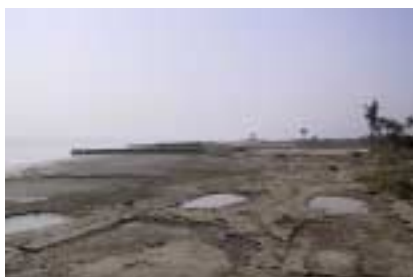
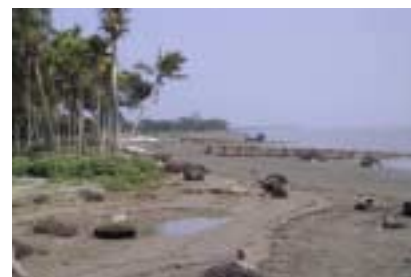
Situation of Bank Erosion Control Work Being Implemented by the Ministry of Water Sources

One shelter constructed with Japanese assistance (Phase III-9: Char Gazi GPS) has already been lost along the left bank in the lower reach of Meghna River at Ramgati. At another shelter located upstream of this lost shelter along the trunk road, there is a shelter constructed by the EU. According to the interview survey results, a request was made two years ago for the implementation of bank erosion control work and work to protect the bank commenced by the Ministry of Water Resources in February this year. The current situation of the work is shown on the photographs below.

Bank protection work

View of the left bank
in the upstream of Meghna River

View of the left bank
in the downstream of Meghna River
