THE GOVERNMENT OF THE PHILIPPINES
THE DEPARTMENT OF PUBLIC WORKS AND HIGHWAYS

**The Study on Sabo and Flood Control for
Western River Basins of Mount Pinatubo
in the Republic of the Philippines**

JAPAN INTERNATIONAL COOPERATION AGENCY

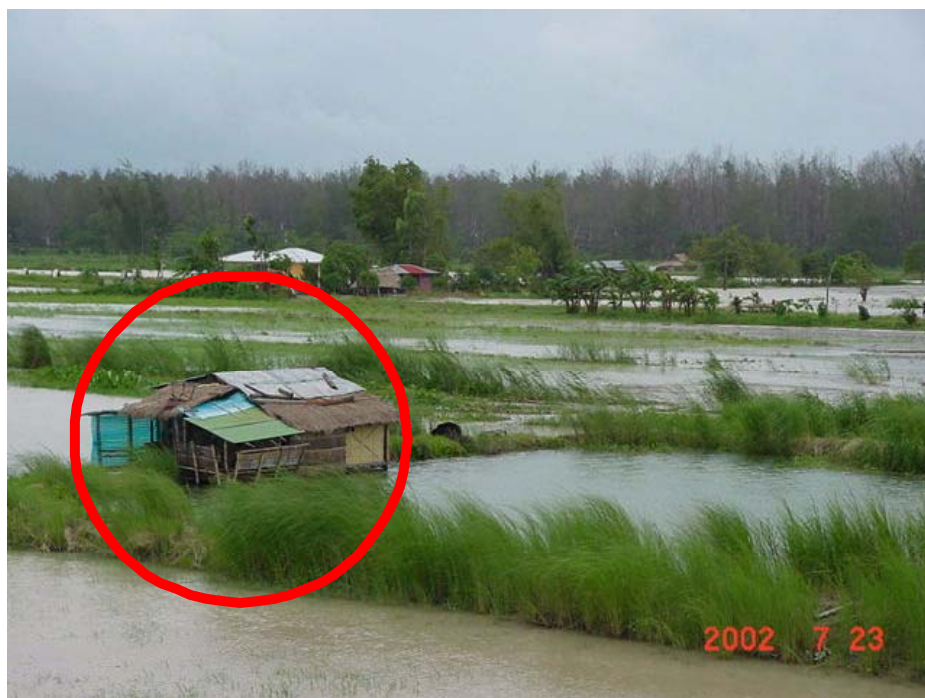
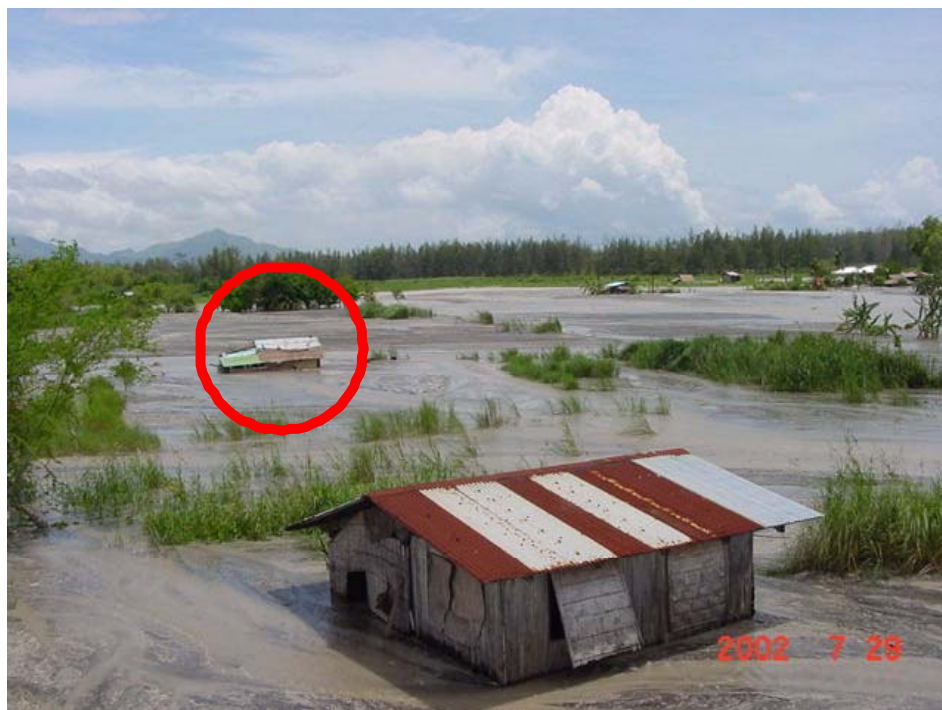
Figure 12.1.2

A. During Flood

B. After Flood

Inundated area / building were fully buried by sediment more than 1 m depth.
House and farm land are no longer available after flood

**Actual Flood Damage Condition due to Dike
Breach in July 2002 in the Sto. Tomas River**

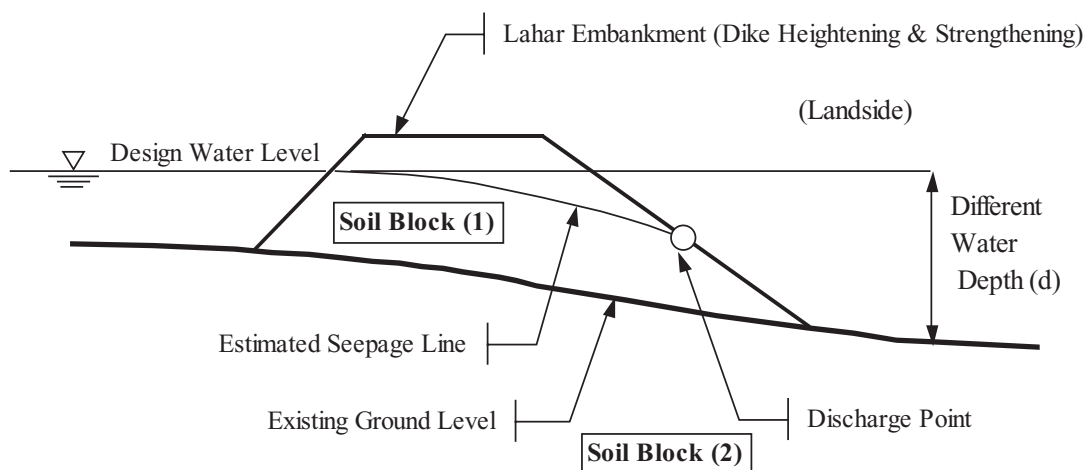
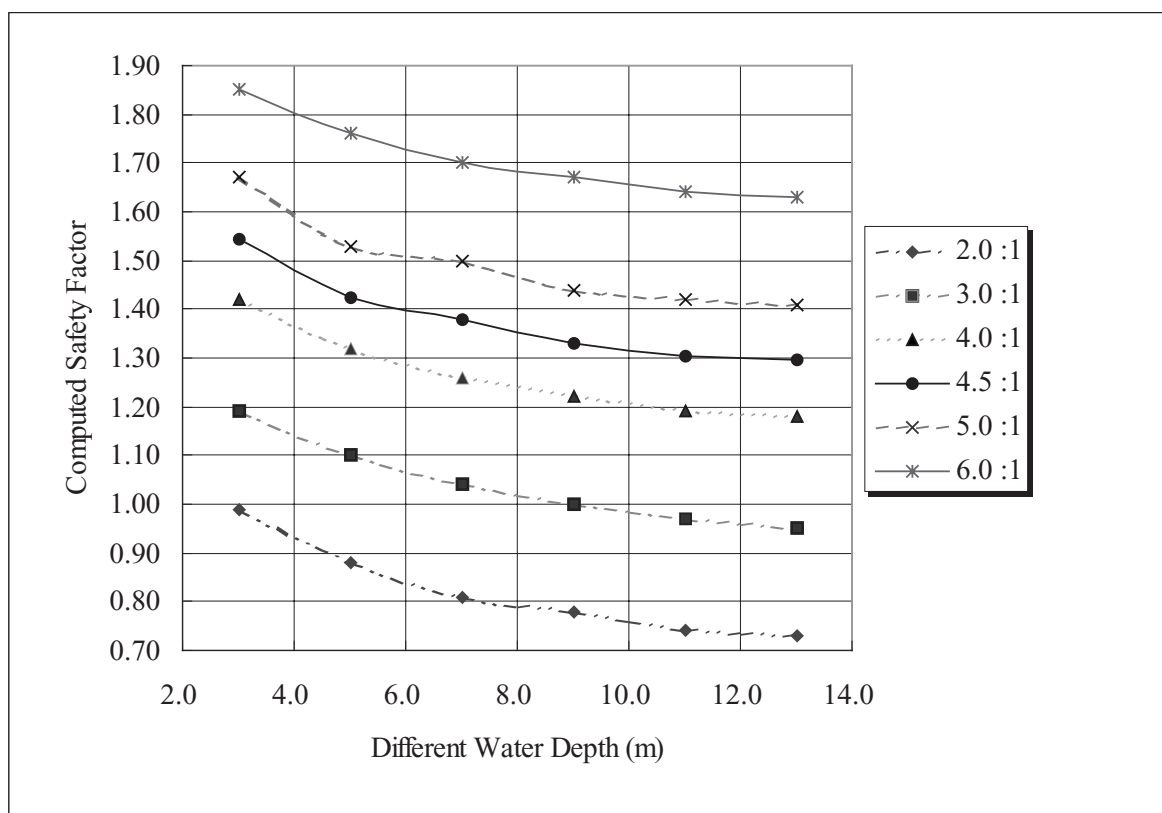
Figure 15.15

Relation Between Different Water Depth and Computed Landside Slope Failure

Estimated Soil Properties

Soil Block	Average N-Value	Unit Wet Density	Unit Saturated Density	Unit Submergible Density	Internal Friction Angle	Cohesion
Unit	N	γ_t (kN/m ³)	γ_{sat} (kN/m ³)	γ' (kN/m ³)	ϕ	C (kN/m ²)
(1)	15	17.0	19.0	7.0	30.0	0.0
(2)	9	16.0	18.0	6.0	27.0	0.0

Results of Computed Landside Slope Failure

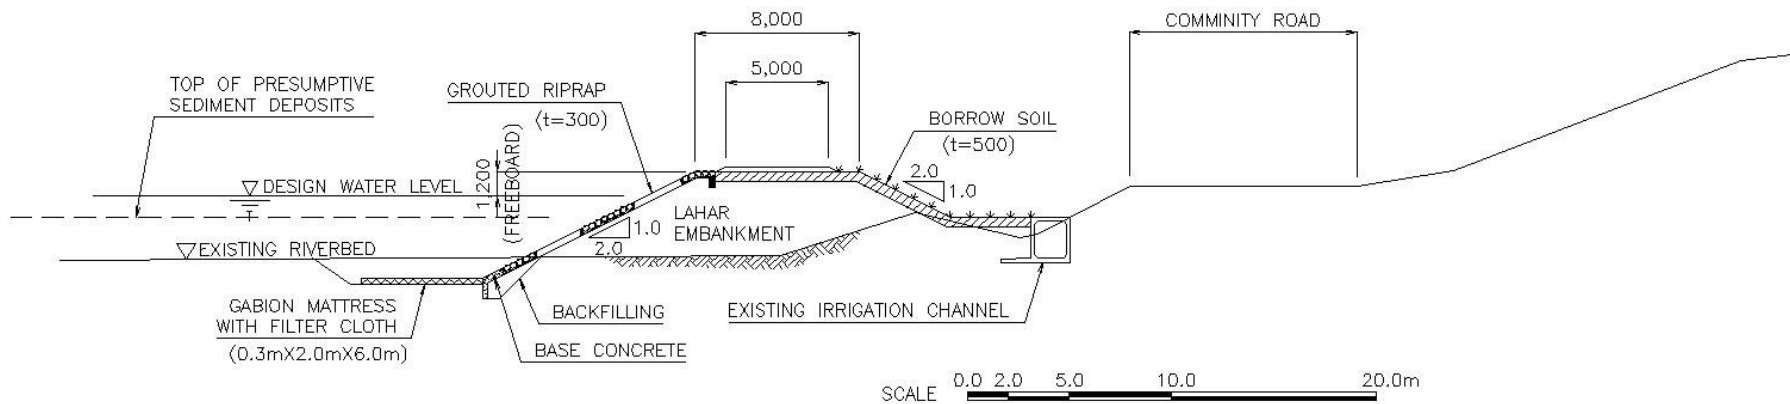
Figure 15.1.6

BUCAO BRIDGE TO STA.+4.8 KM

STA.+4.8 KM UPSTREAM

Typical Cross Sections of Proposed Dike
Heightening in the Bucao River
