THE GOVERNMENT OF THE PHILIPPINES
THE DEPARTMENT OF PUBLIC WORKS AND HIGHWAYS

**The Study on Sabo and Flood Control for
Western River Basins of Mount Pinatubo in
the Republic of the Philippines**

JAPAN INTERNATIONAL COOPERATION AGENCY

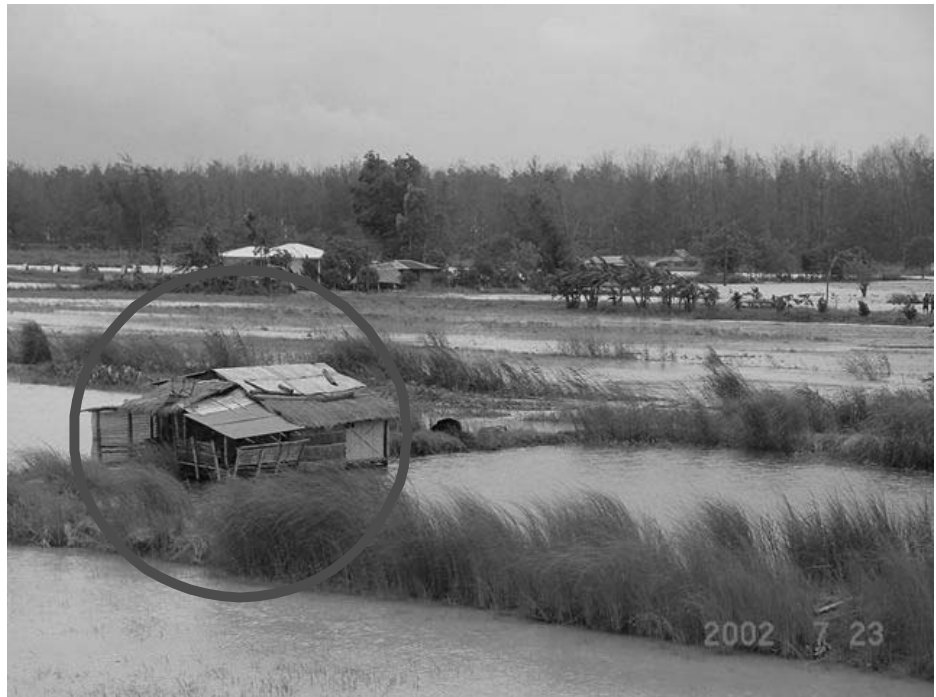
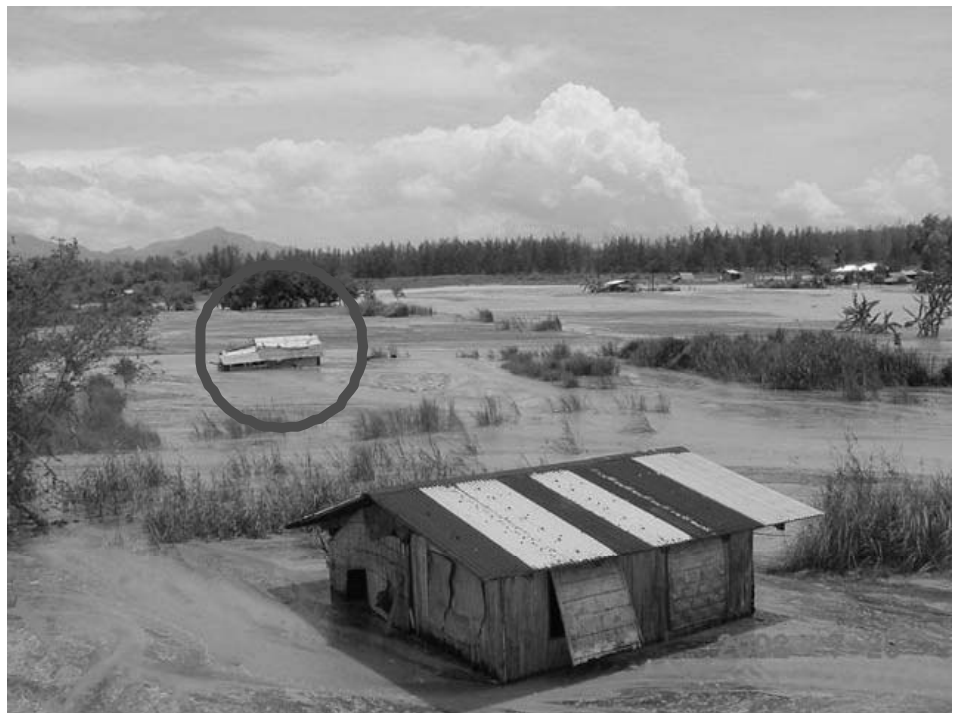
Figure 2.2.2

A. During Flood

B. After Flood

Inundated area / building were fully buried by sediment more than 1 m depth.
House and farm land are no longer available after flood

**Actual Flood Damage Condition due to Dike
Breach in July 2002**
