*The Study on Sabo and Flood Control for Western River Basins of Mount Pinatubo  
in the Republic of the Philippines  
Final Report  
Supporting Report*

**APPENDIX-VI**  
**Sabo/ Flood Control**  
**Structural Measures**

**APPENDIX VI SABO/ FLOOD CONTROL STRUCTURAL MEASURES**

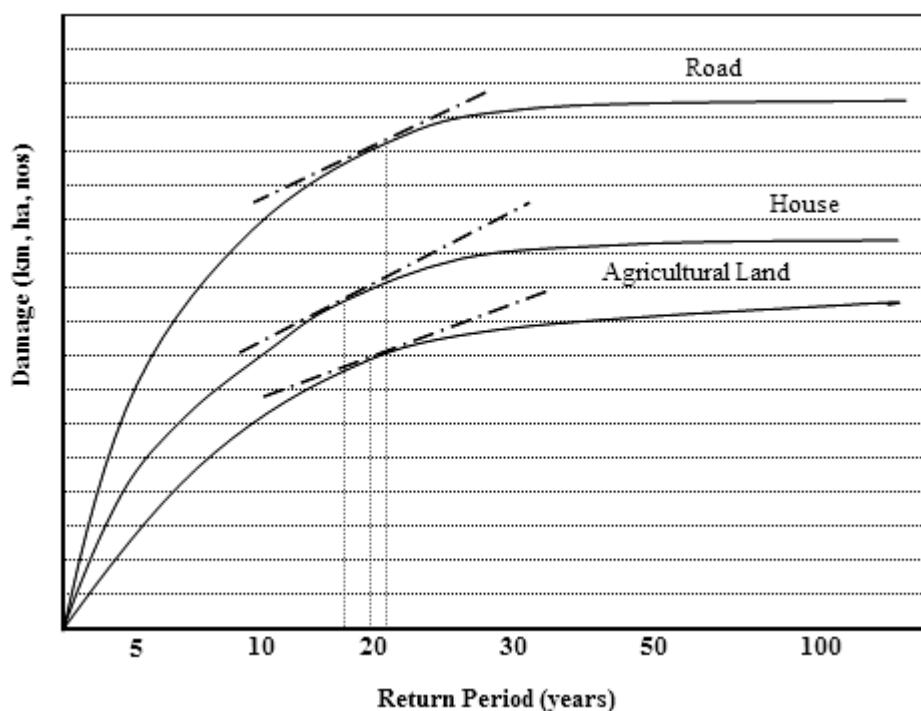
The numbers of houses, roads and paddy fields in the three river basins were computed as described in “Section 2.2 in Appendix V”, namely the Bucao River, the Maloma River and the Sto. Tomas River, respectively. The damaged assets curves based on damaged asset numbers due to the probable flood show almost same tendencies among the three river basins. The gradient of the curves in the schematic diagram below show that the incremental numbers of direct damage occurrences are not significant beyond the 20-year return period. Hence, the return period of 20 years is reasonable for the planning scale of the structures.

Schematic Diagram for the determination of Planning Scale

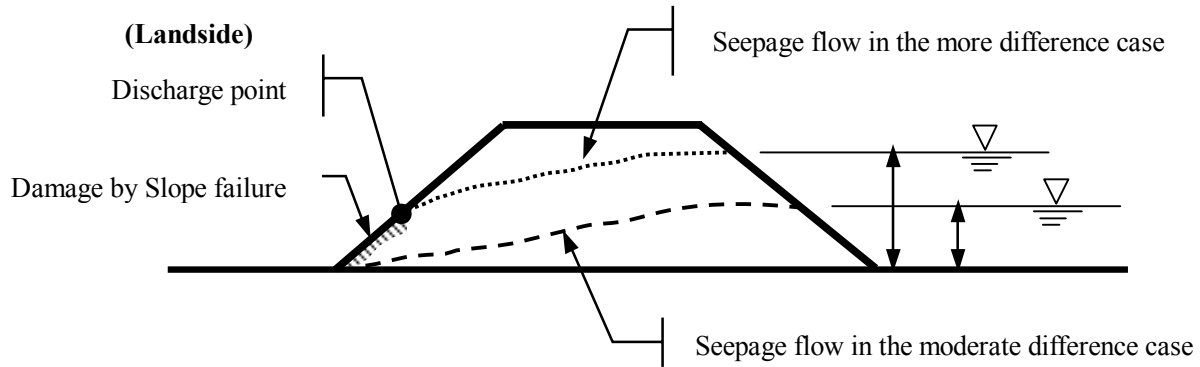
Commonly, in the flooding stage, seepage flow caused by the difference is appeared in dike body. In case of the more difference, the seepage flow encouraged in dike body may appear on vicinity of landside slope (refer to the following figure).

The cohesion having dike embankment material under the phreatic surface of seepage flow is decreased in the more difference case.

**Schematic Diagram for the Seepage Flow**

If the dike size is smaller compared with the difference between water level and existing landside ground level, potential energy of seepage flow may encourage in the dike, seepage flow sweeps away embankment material at landside toe of the dike.

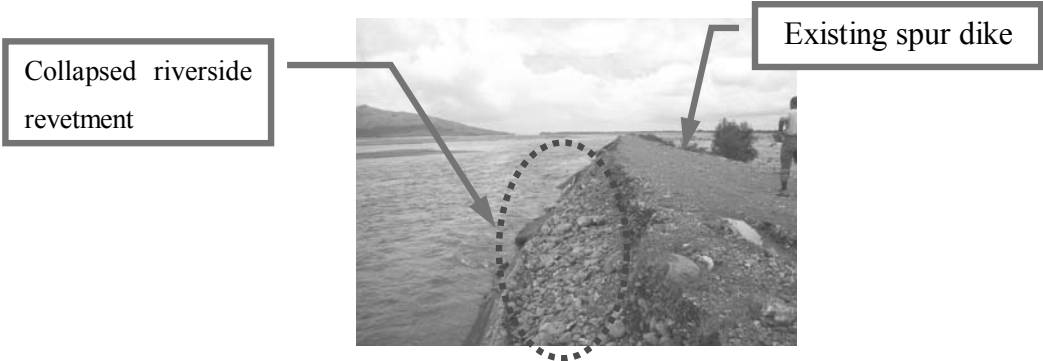
There is an existing spur dike in upper end portion of existing river dike. The existing spur dike length is about 200 m. The spur dike is accelerated to control the watercourses from the Baquilan River and upper reaches of the Bucao River. Consequently, the main watercourse in downstream from the spur dike is swerved effectively to foot of the northern mountains and a part of existing river dike is protected by effectiveness of that.

However, the existing riverside protections of spur dike are damaged due to annual flood in rainy season. Therefore, at present, the collapsed riverside revetments and dike embankment exposed to watercourse are still observed. The following photo (taken on July 29, 2002) shows present damages of the existing spur dike:

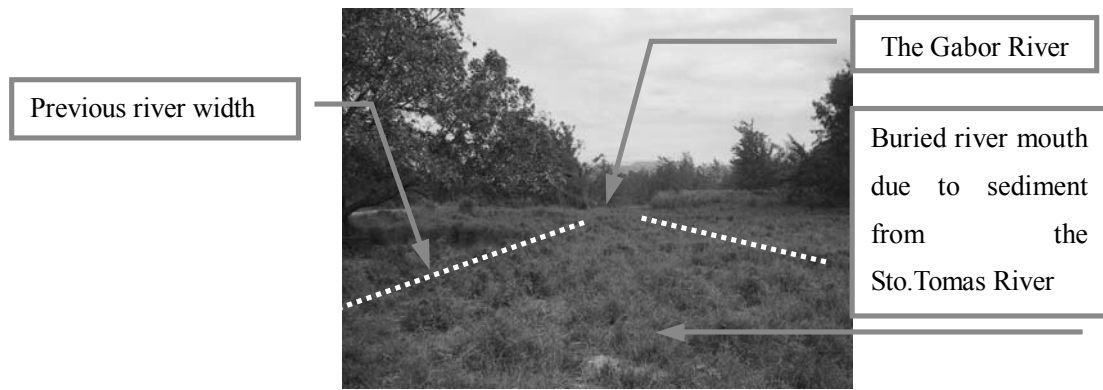
The Gabor River is one of tributaries of the Sto. Tomas River in right downstream from Maculcol Bridge. The confluence point of the Gabor River has been quite buried by sediment deposits for about 1.5 m deep because of repeated riverbed movement in the Sto. Tomas River after Mount Pinatubo eruption. The clogging at the river mouth due to sediment deposits occurs inundation in vicinity of downstream from the Gabor River due to overflowing from the river in rainy season.

The following photo (taken on February 12, 2003) shows present state of river mouth clogging in the Gabor River:
