THE GOVERNMENT OF THE PHILIPPINES
THE DEPARTMENT OF PUBLIC WORKS AND HIGHWAYS

**The Study on Sabo and Flood Control for
Western River Basins of Mount Pinatubo in the
Republic of the Philippines**

JAPAN INTERNATIONAL COOPERATION AGENCY

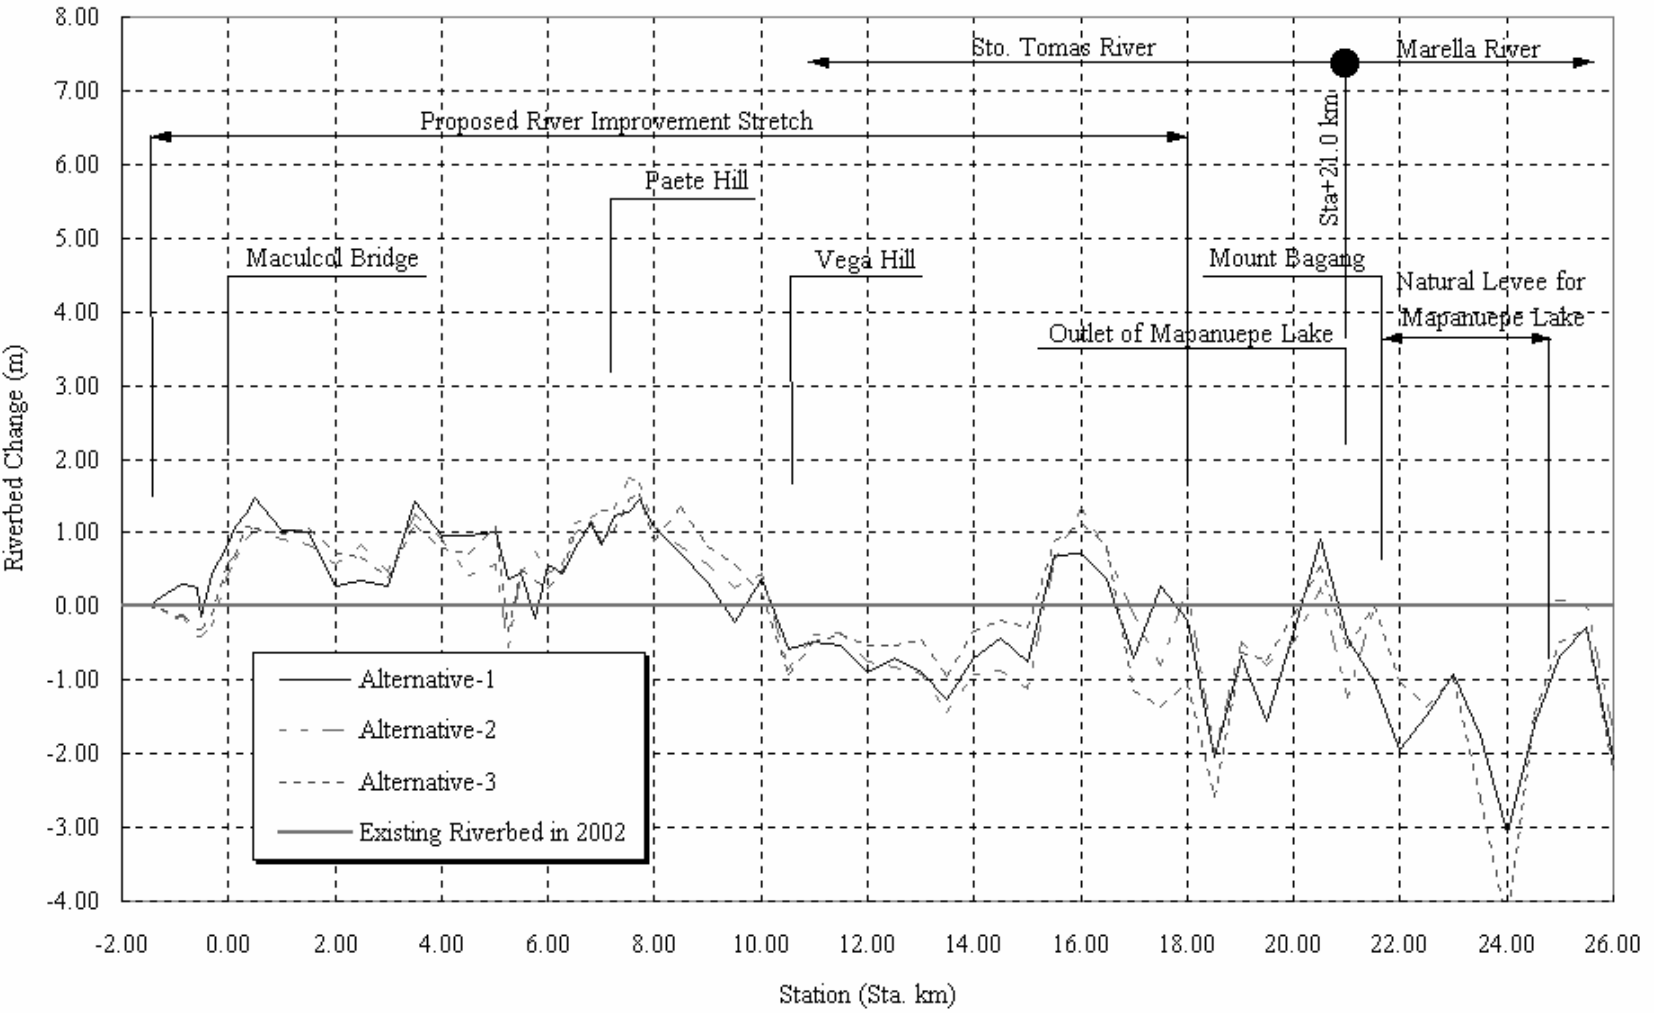
Figure 1.7.9
Presumed Riverbed Change after 20 Years
with One-Dimensional Sediment Transport
Analysis in the Sto. Tomas River

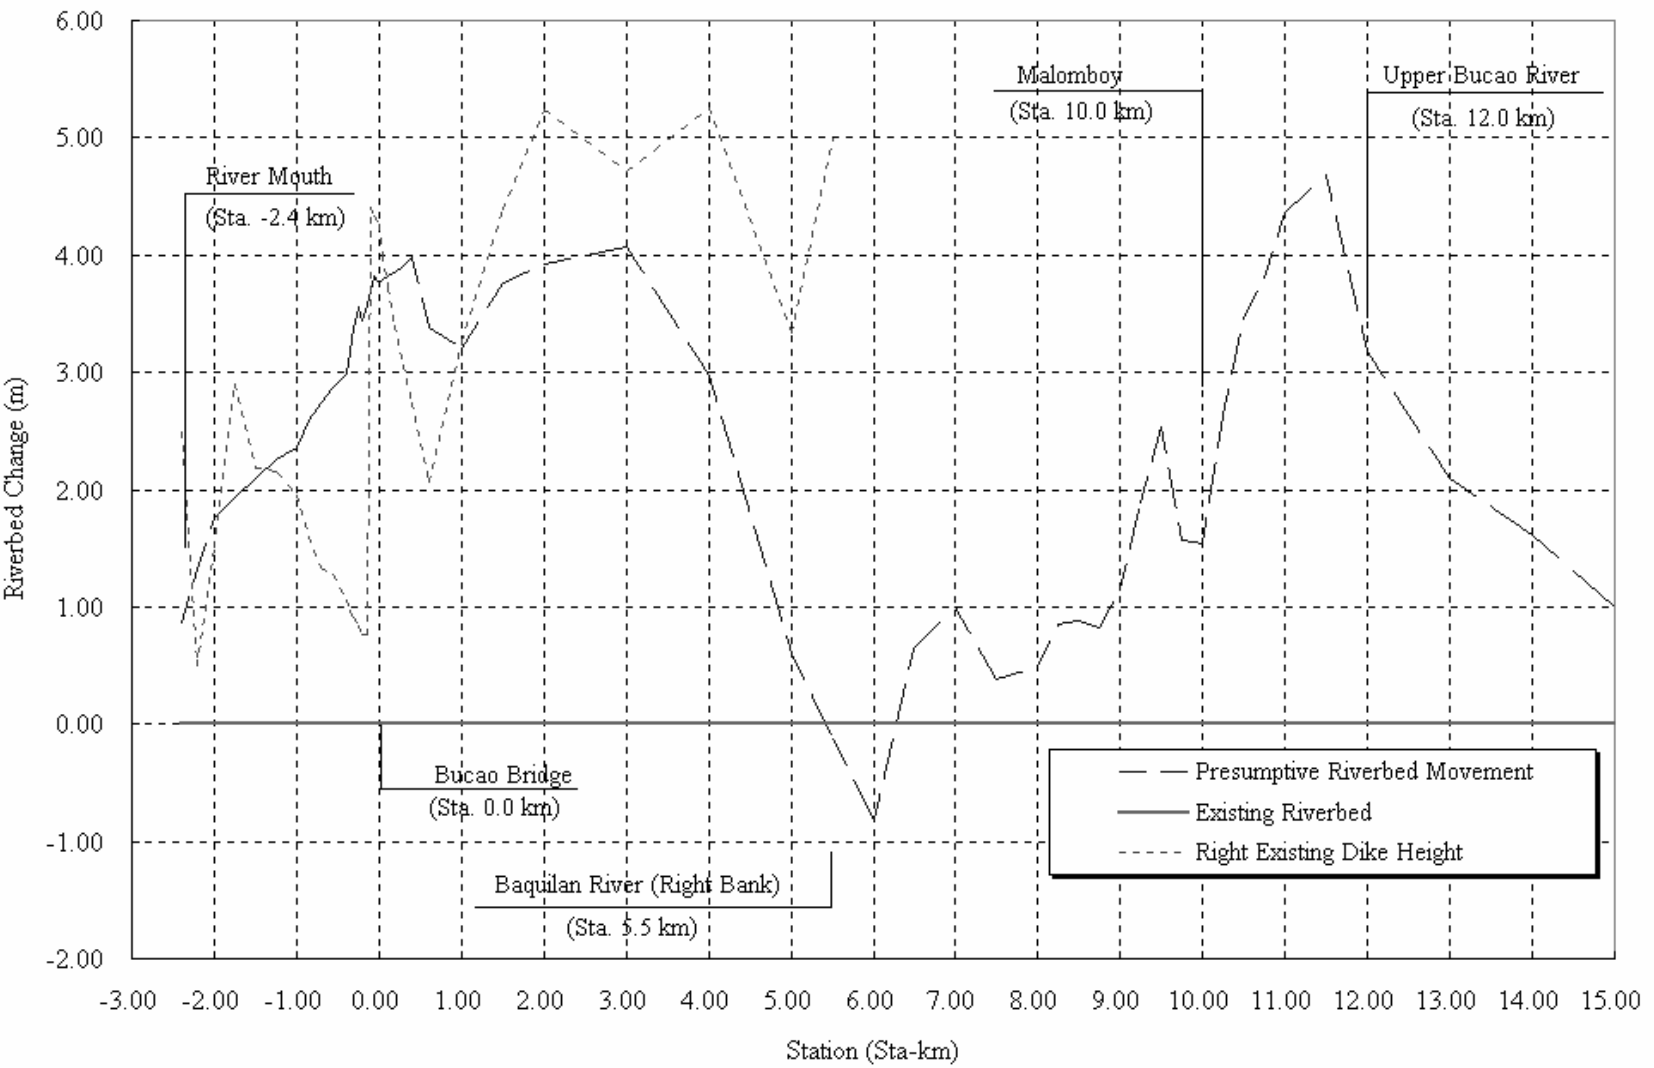
Figure 2.2.2

Presumptive Riverbed Change after 20 years
in the Bucao River

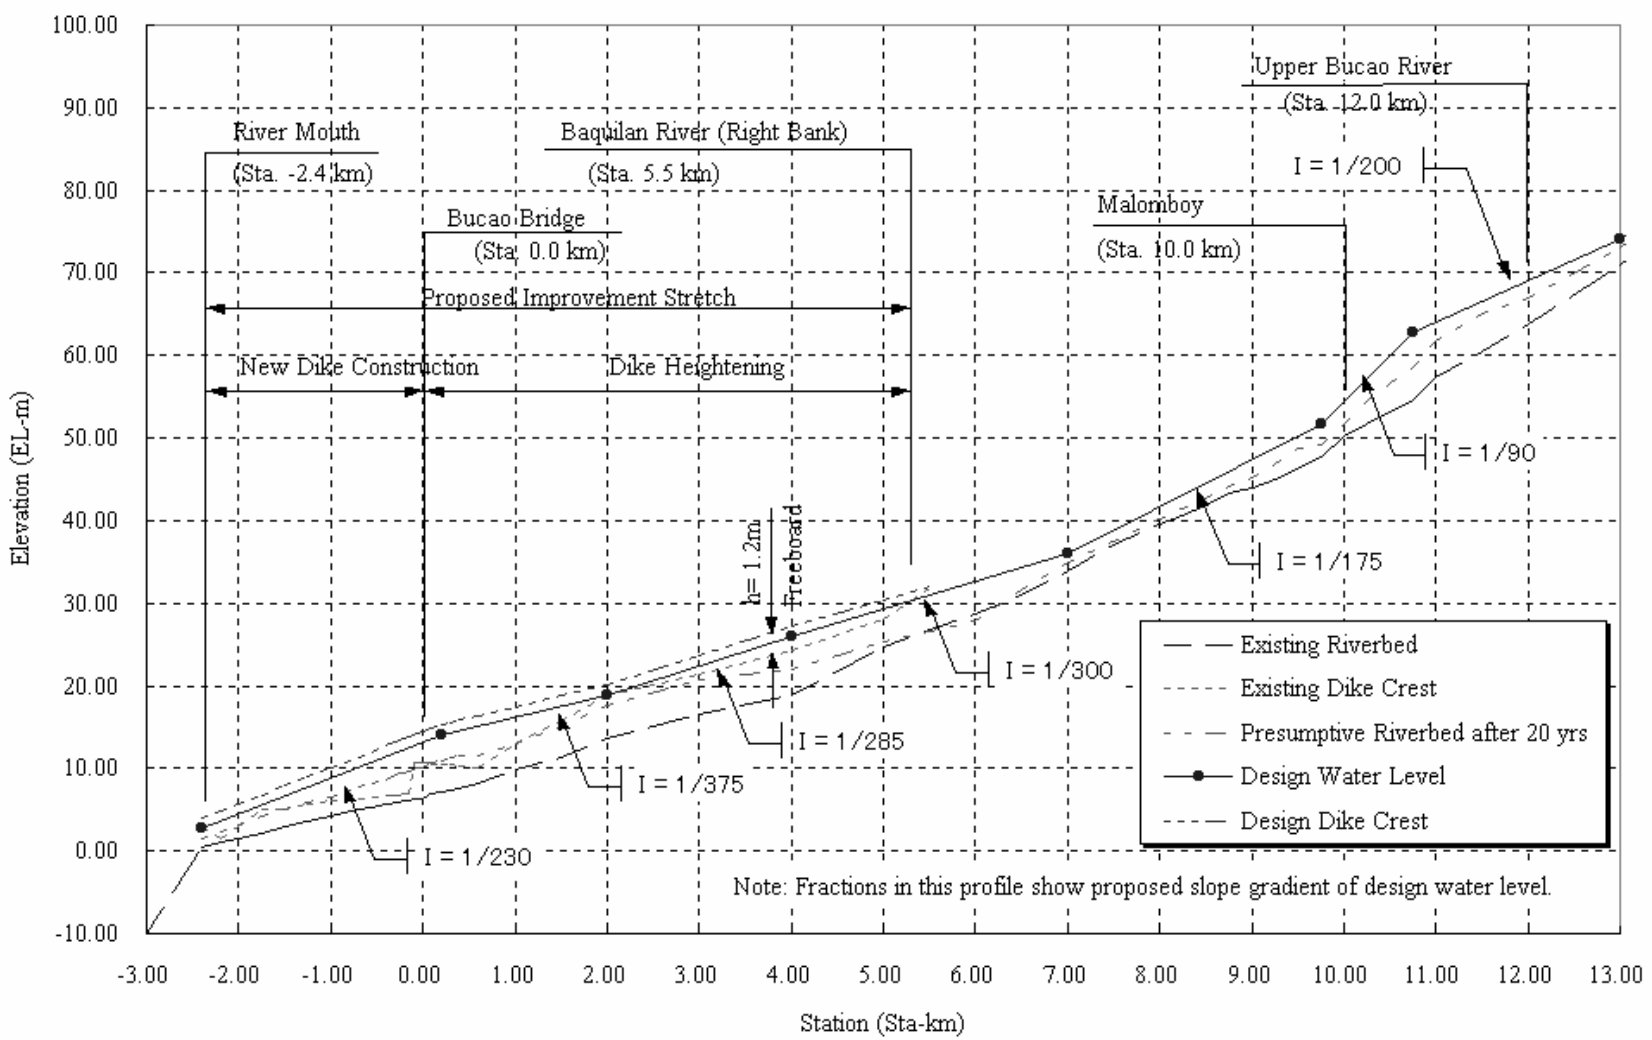
Figure 2.2.3

Longitudinal Profile of Proposed River
Improvement in the Bucao River

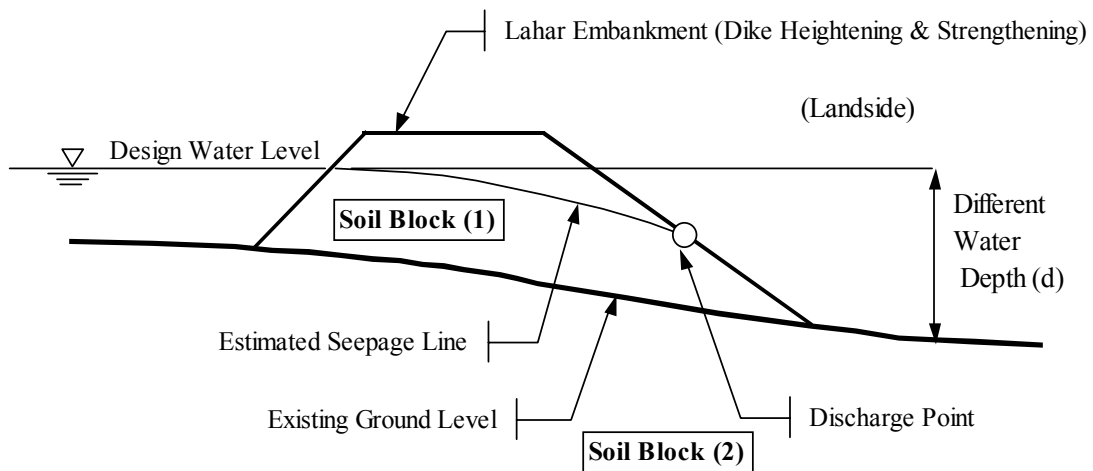
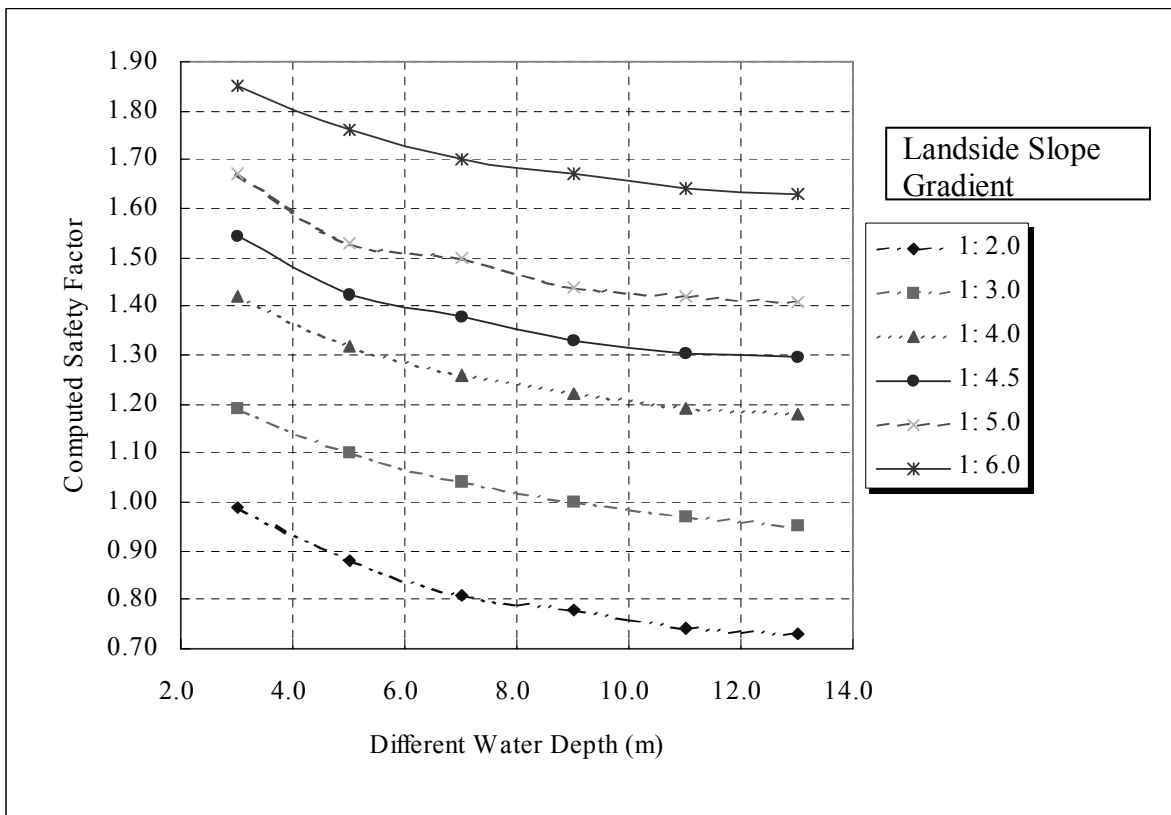
Figure 2.3.1

Relation Between Different Water Depth and Computed Landside Slope Failure

Estimated Soil Properties

Results of Computed Landside Slope Failure

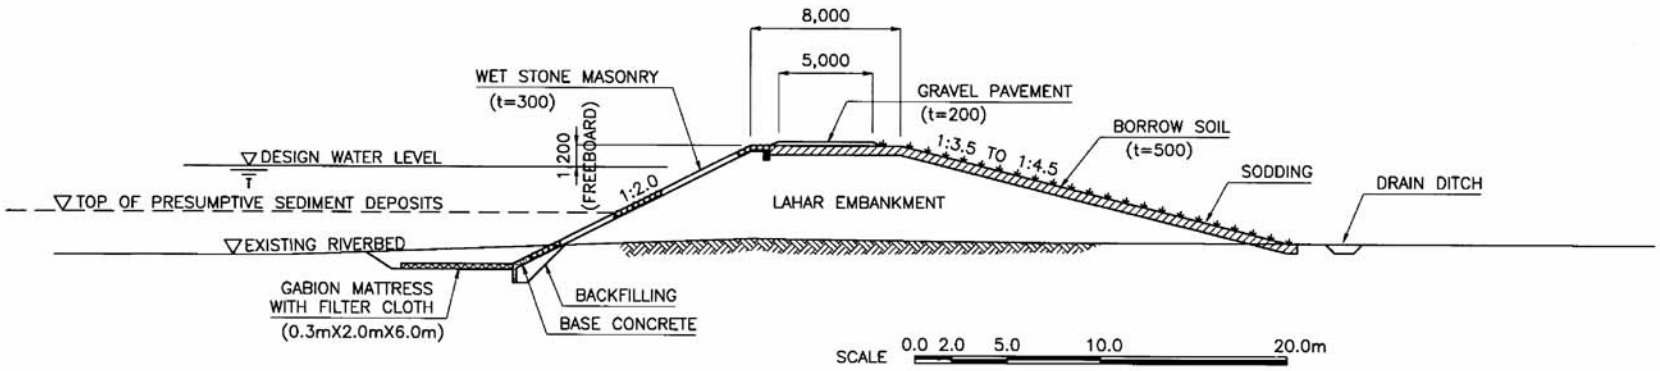
Figure 2.3.3
Typical Cross Section of Proposed New Dike
in the Bucaao River
