Appendix 5
Soil and Water Conservation

SOIL AND WATER CONSERVATION

*The Master Plan Study for Watershed Management
in Upper Magat and Cagayan River Basin
in the Republic of the Philippines*

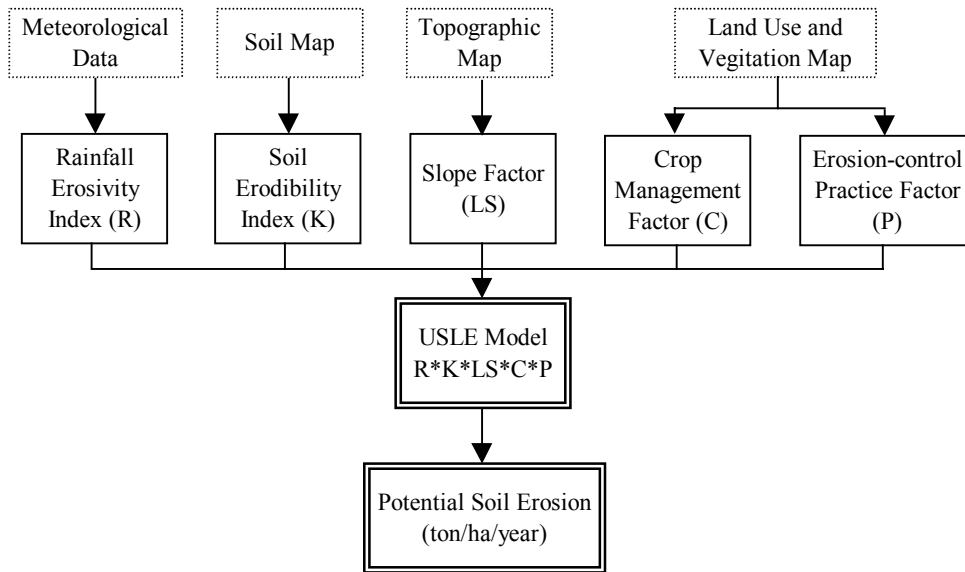
Flow of Analysis on Potential Soil Erosion

The flow of the assessment using the USLE model is illustrated below:

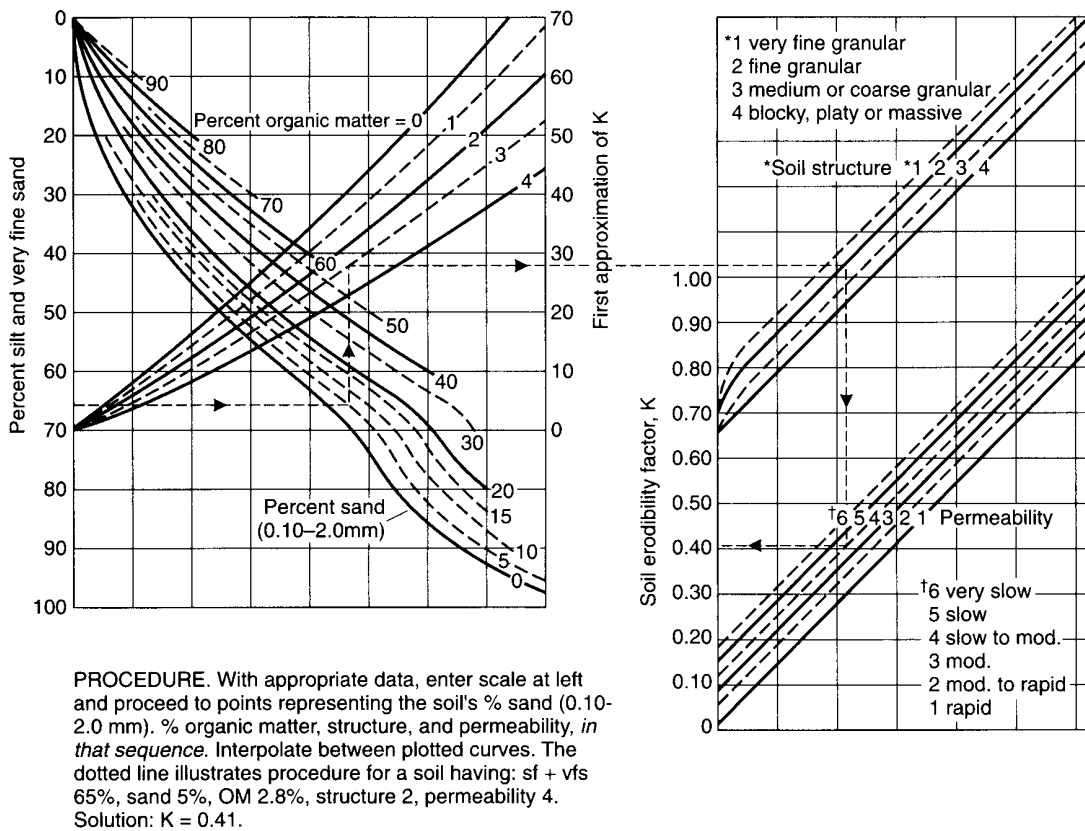
Method for Estimating Soil Erodibility Index¹

The following nomograph was used for computing K value of soil erodibility in the Study Area:

For applying this method, the physical property of soils is required as input data such as the percentage of sand, clay and silt for each soil category. Since no soil survey has been conducted in the Study, K value of each soil types was estimated in such a way that:
