7. GEOLOGY

7.1 Geological Outline of the Project Area

EL CHAPARRAL HYDROPOWER PROJECT		
LOCATION OF GEOLOGICAL INVESTIGATION AT DAM SITE		
Fig. 7.2	DATE

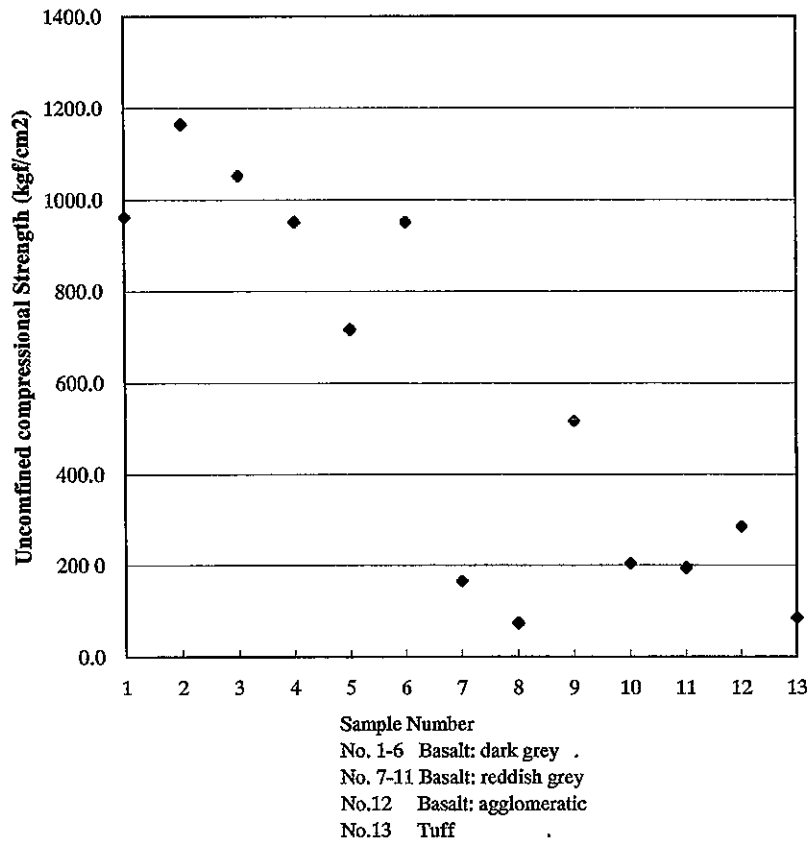
Fig.7.8 Unconfined Compression Strength

The unconfined compressional strength of these rocks is compared in Fig. 7.8. The strength of the rocks of dark gray basalt ranged from 800 to 1200 kgf/cm², while the strength of the reddish the gray basalt, the agglomeratic basalt was about 200, kgf/cm². The strength of the tuff was about 100 kgf/cm².

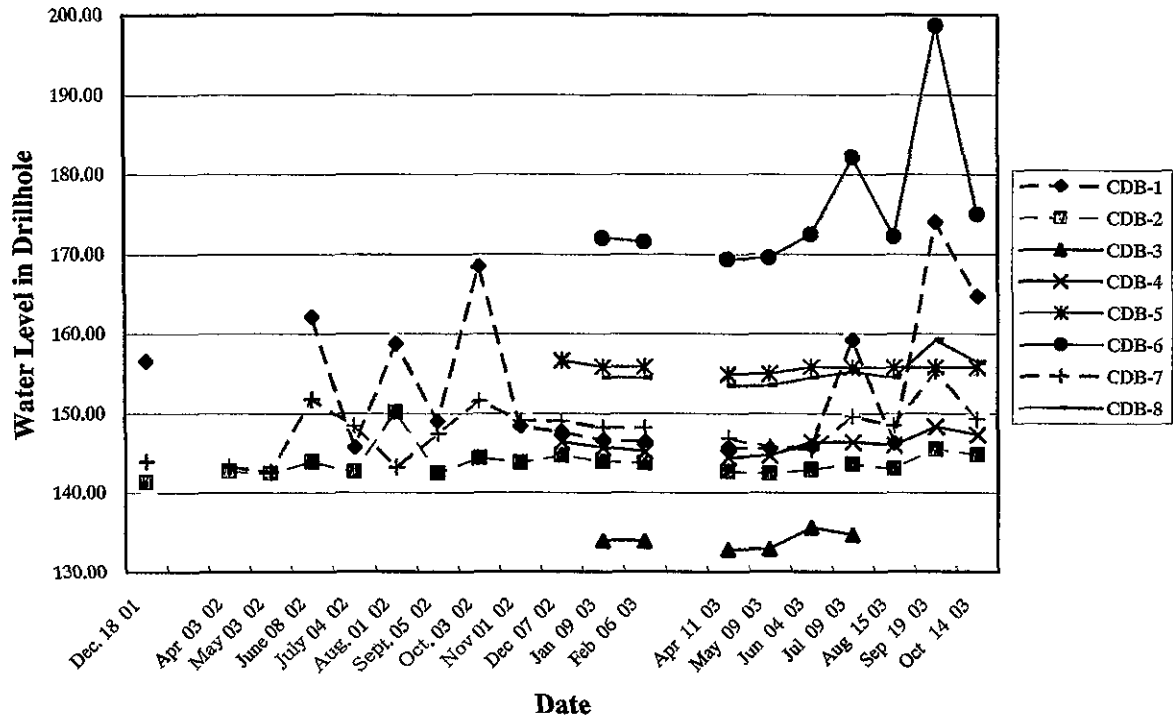
Fig. 7.9 Water Level in Drillhole

The groundwater level at the dam site was measured in drillholes. Fluctuations in the water levels as measured in drillholes were recorded for about two years on the left bank, and for about one year on the right bank (Fig.7.9). The water level in drillholes rose in the rainy season and drops in the dry season. The rise in the water level during the rainy season was small and limited to 5 m

or less for CDB-4, CDB-5 and CDB-8; whereas an increase of more than 30m was reported for CDB-1 and CDB-6.

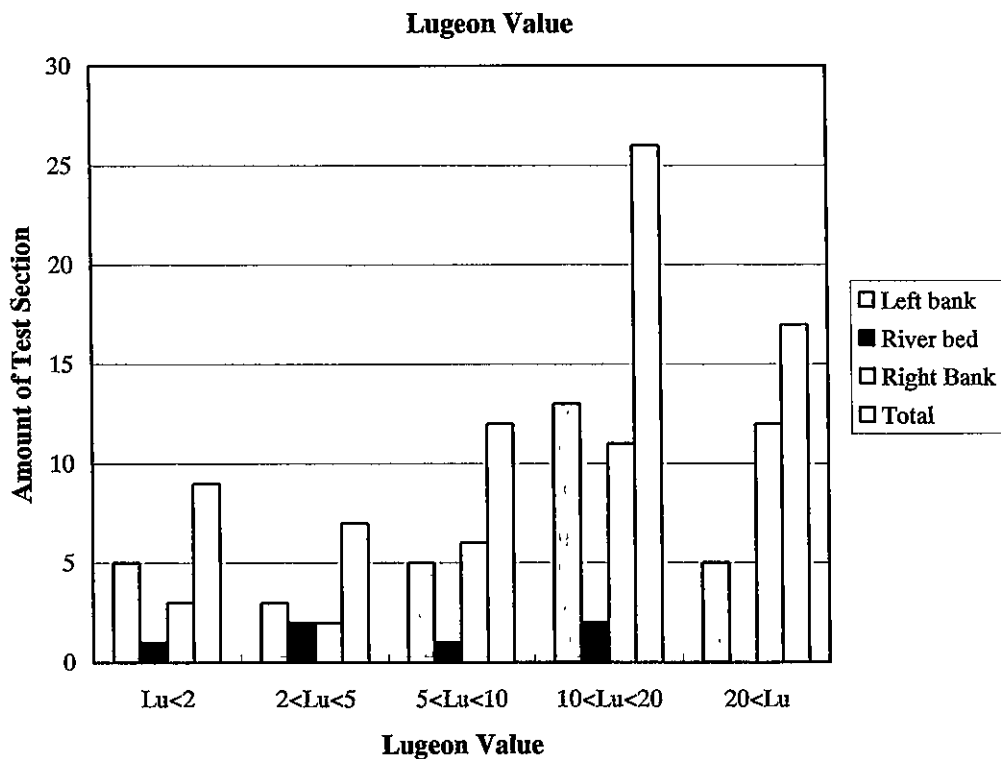
Fig.7.11 Distribution of Lugeon Values at Dam Site

Permeability tests were conducted in the drillholes at the dam site. Lugeon values for drill holes are presented in geological profiles of the dam site. (Fig.7.11). Many of the tested sections (61% of all sections) had more than 10 Lu. 35% of the sections tested on the right bank had more than 20 Lu.

Most of the tested sections in drillhole CDB-5A showed values of more than 20 Lu. This hole is the most permeable hole at the dam site. In drillhole CDB-5A, many tested sections show a critical pressure. Lugeon values obtained at the effective injection pressure of less than 6 kg/cm² or 7 kg/cm² were less than 10, whereas, in the same section, the Lugeon values increased significantly to more than 20 at a pressure level higher than these pressures. The critical pressure is between 6 kg/cm² or 7 kg/cm² and the higher pressure adopted in the next pressure stage. The Lugeon values before reaching the critical pressure were adopted in this study. The validity of the use of these values is supported by the fact that the pressure at the high water level acting to the

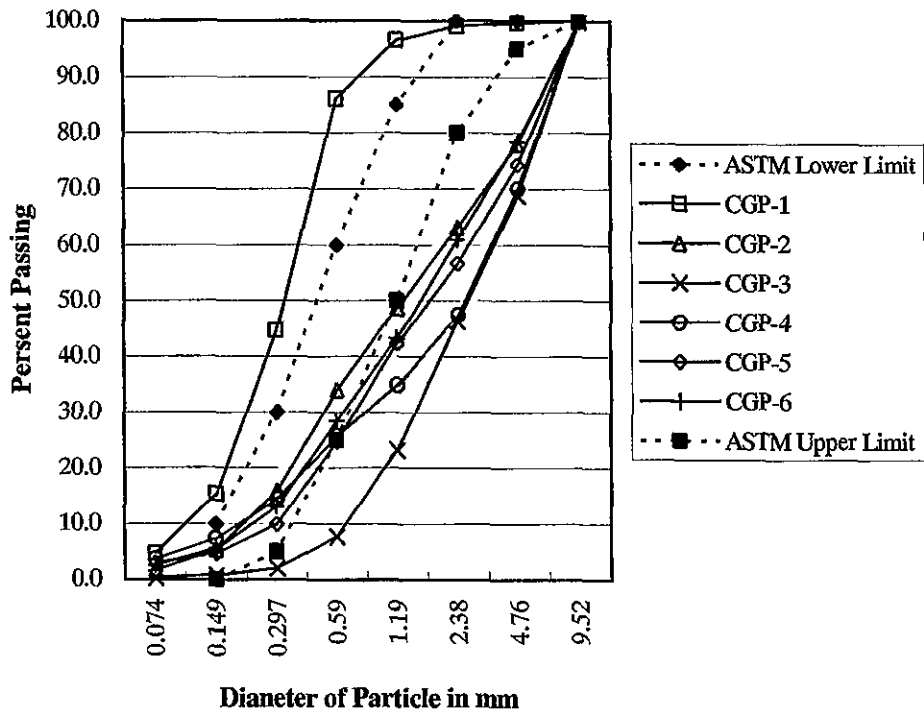
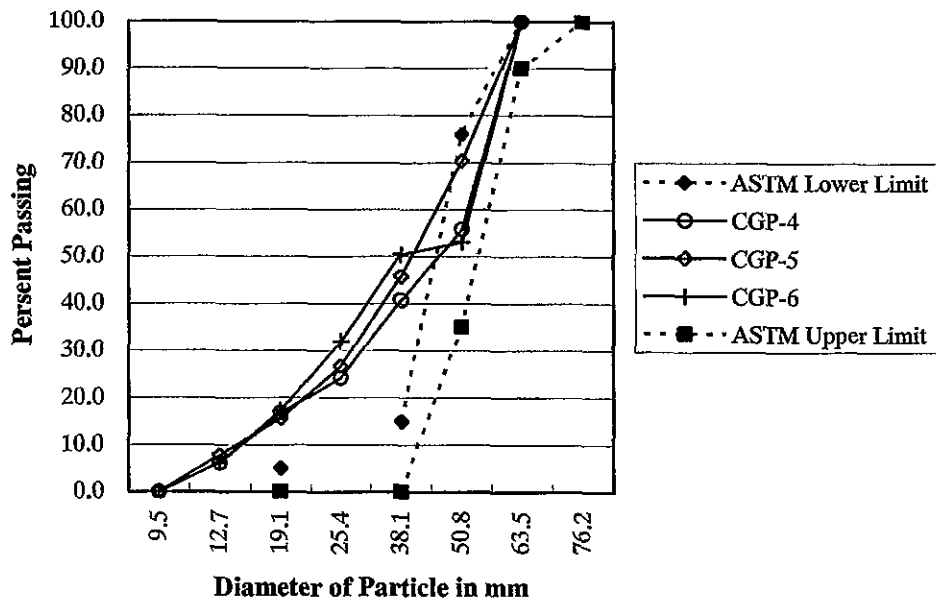
Fig.7.13 Particle Size Distribution

The graph of particle size distribution is shown in Fig.7.13. In the fine aggregate, coarse particles were less than the ASTM requirement. However, it will be possible to adjust particle size distribution to meet the requirement by crushing or blending. In the coarse aggregate, fine particles exceeded the requirement. The bar provides big gravels more than and to provide the sufficient amount of coarse aggregate with the maximum dimension of 3 inches or 2.5 inches.

Fine Particle Size Distribution

Coarse Particle Size Distribution

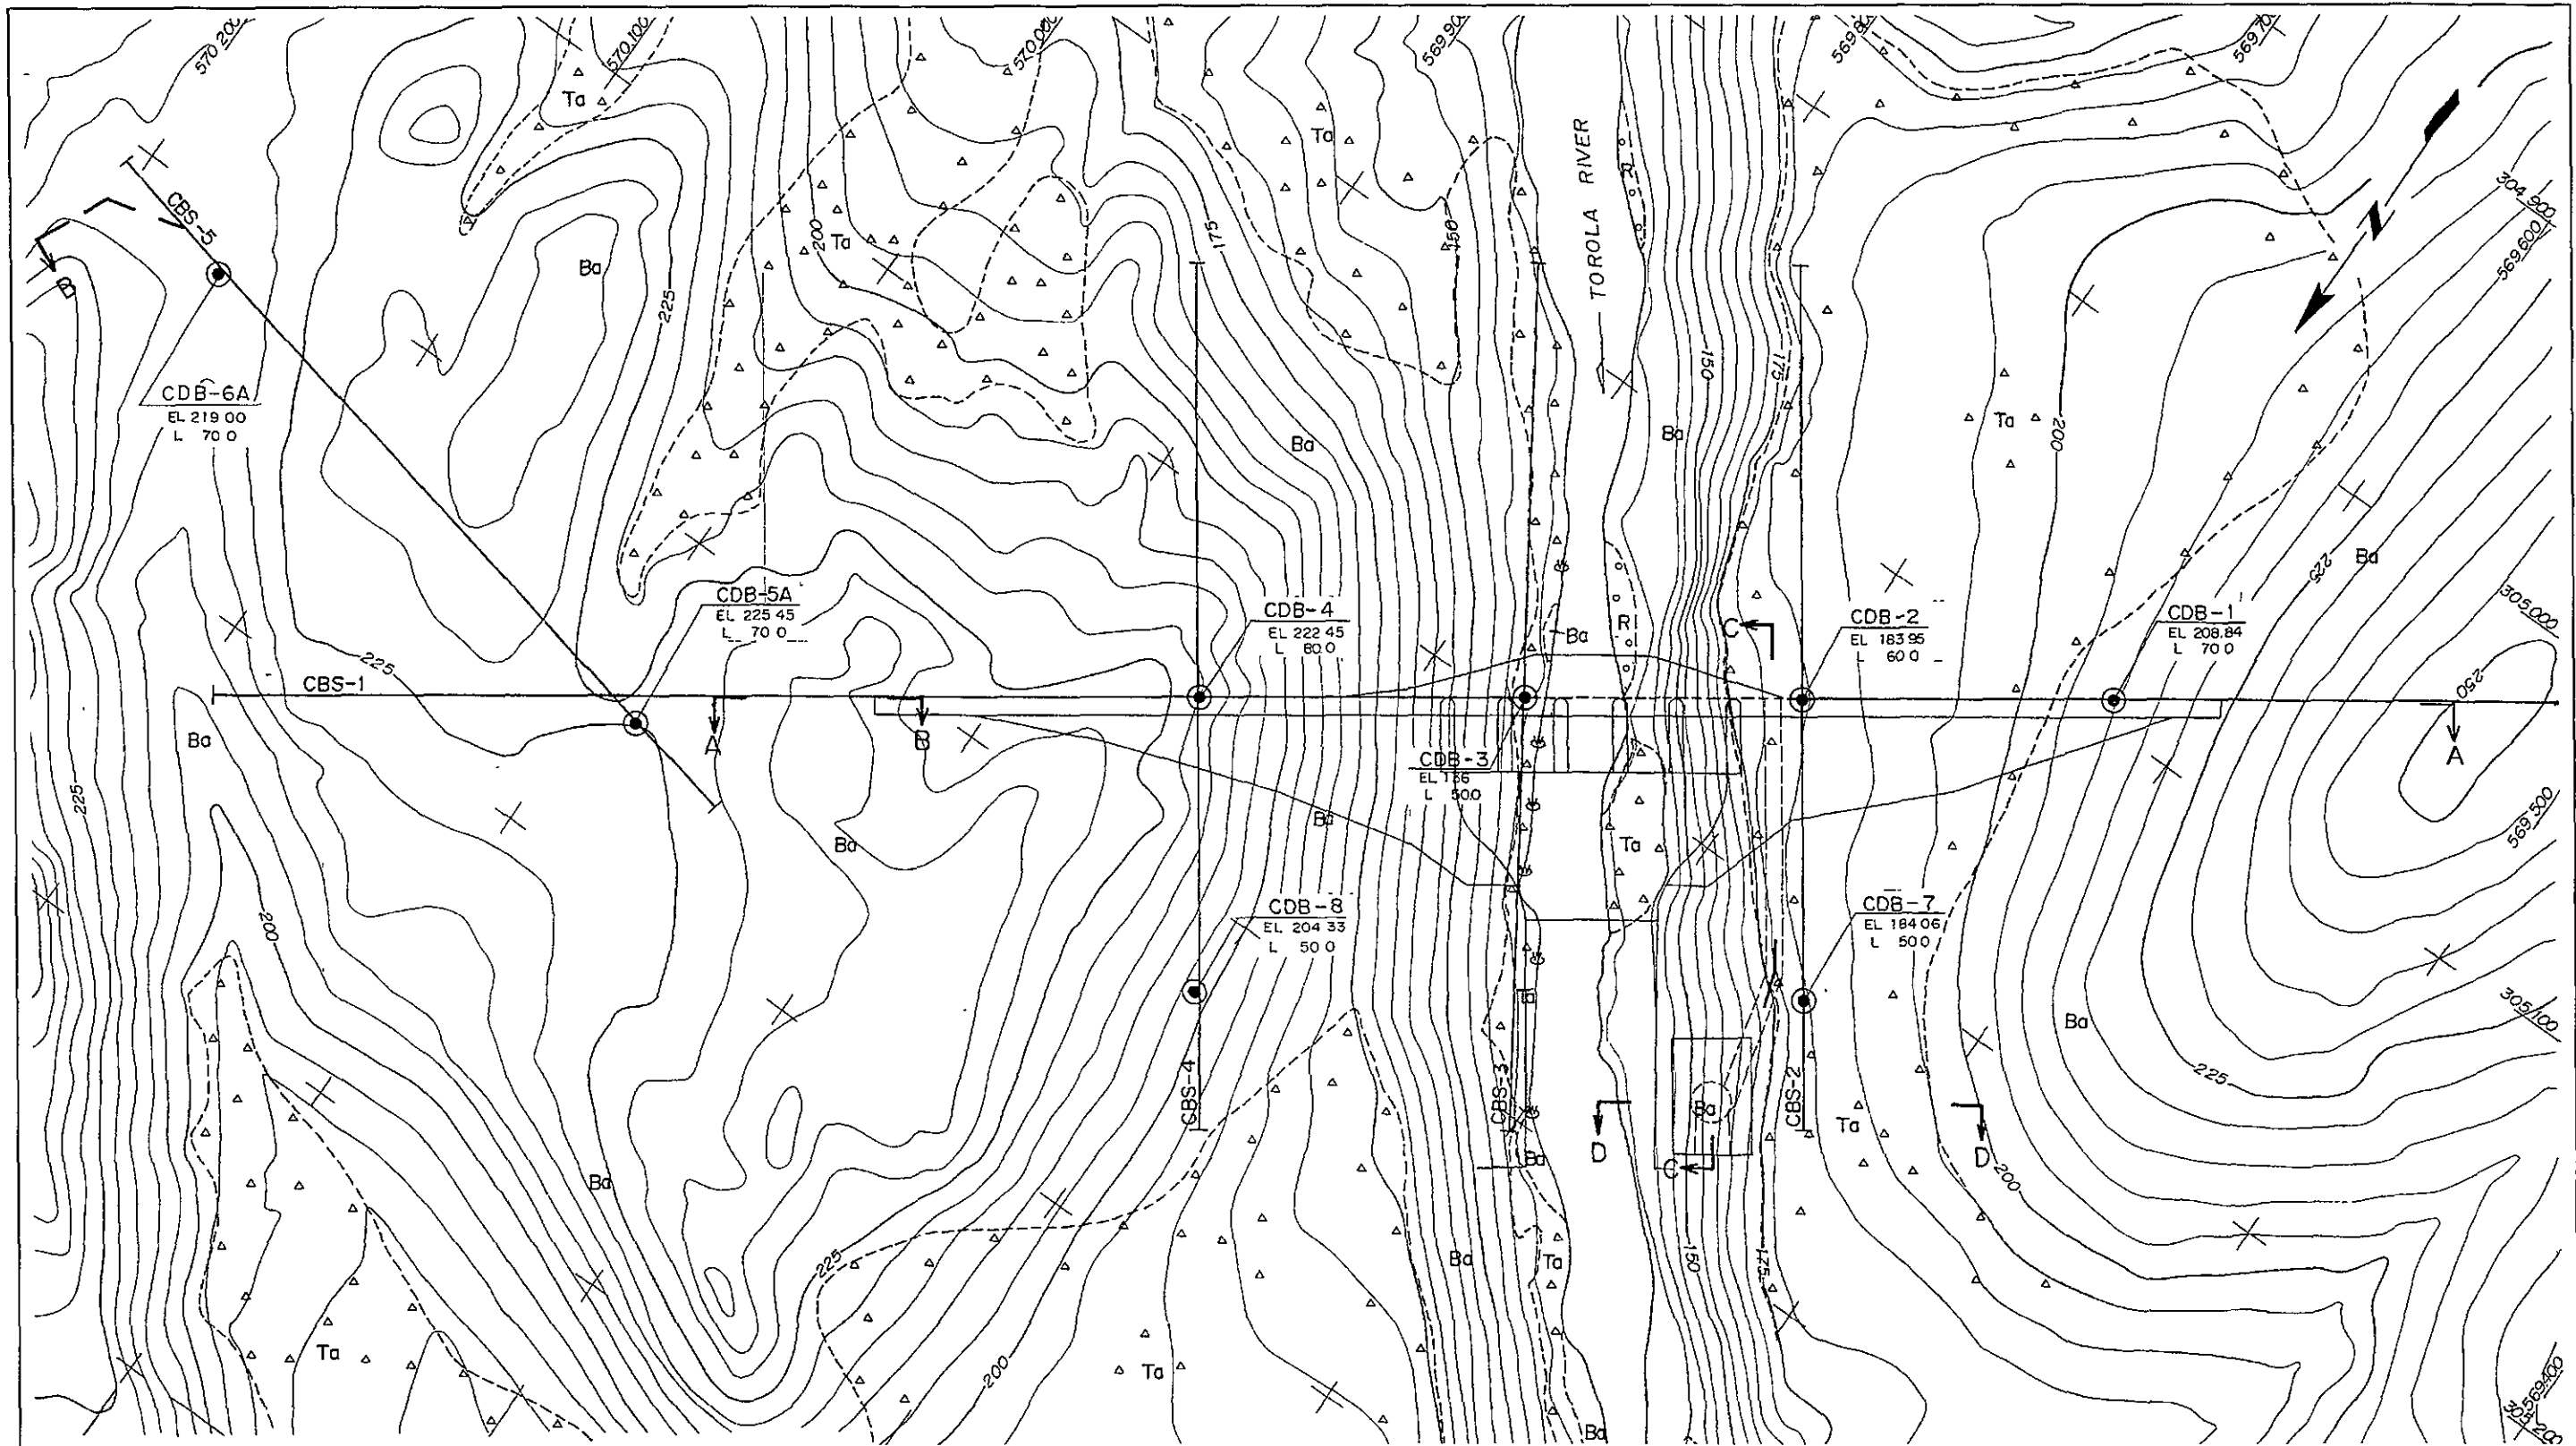
EL CHAPARRAL HYDROPOWER PROJECT	
GEOLOGICAL PLAN OF DAM SITE	
Fig. 7.5	DATE

- △ Ta △ Talus deposit and residual soil
- R ○ Recent river deposit
- Ba Basalt
- Geologic boundary
- CBS-1
- Seismic Prospecting Line
- CDB-1
- Core Boring
EL Elevation in m
L Length in m
- Spring
- Location of Profile

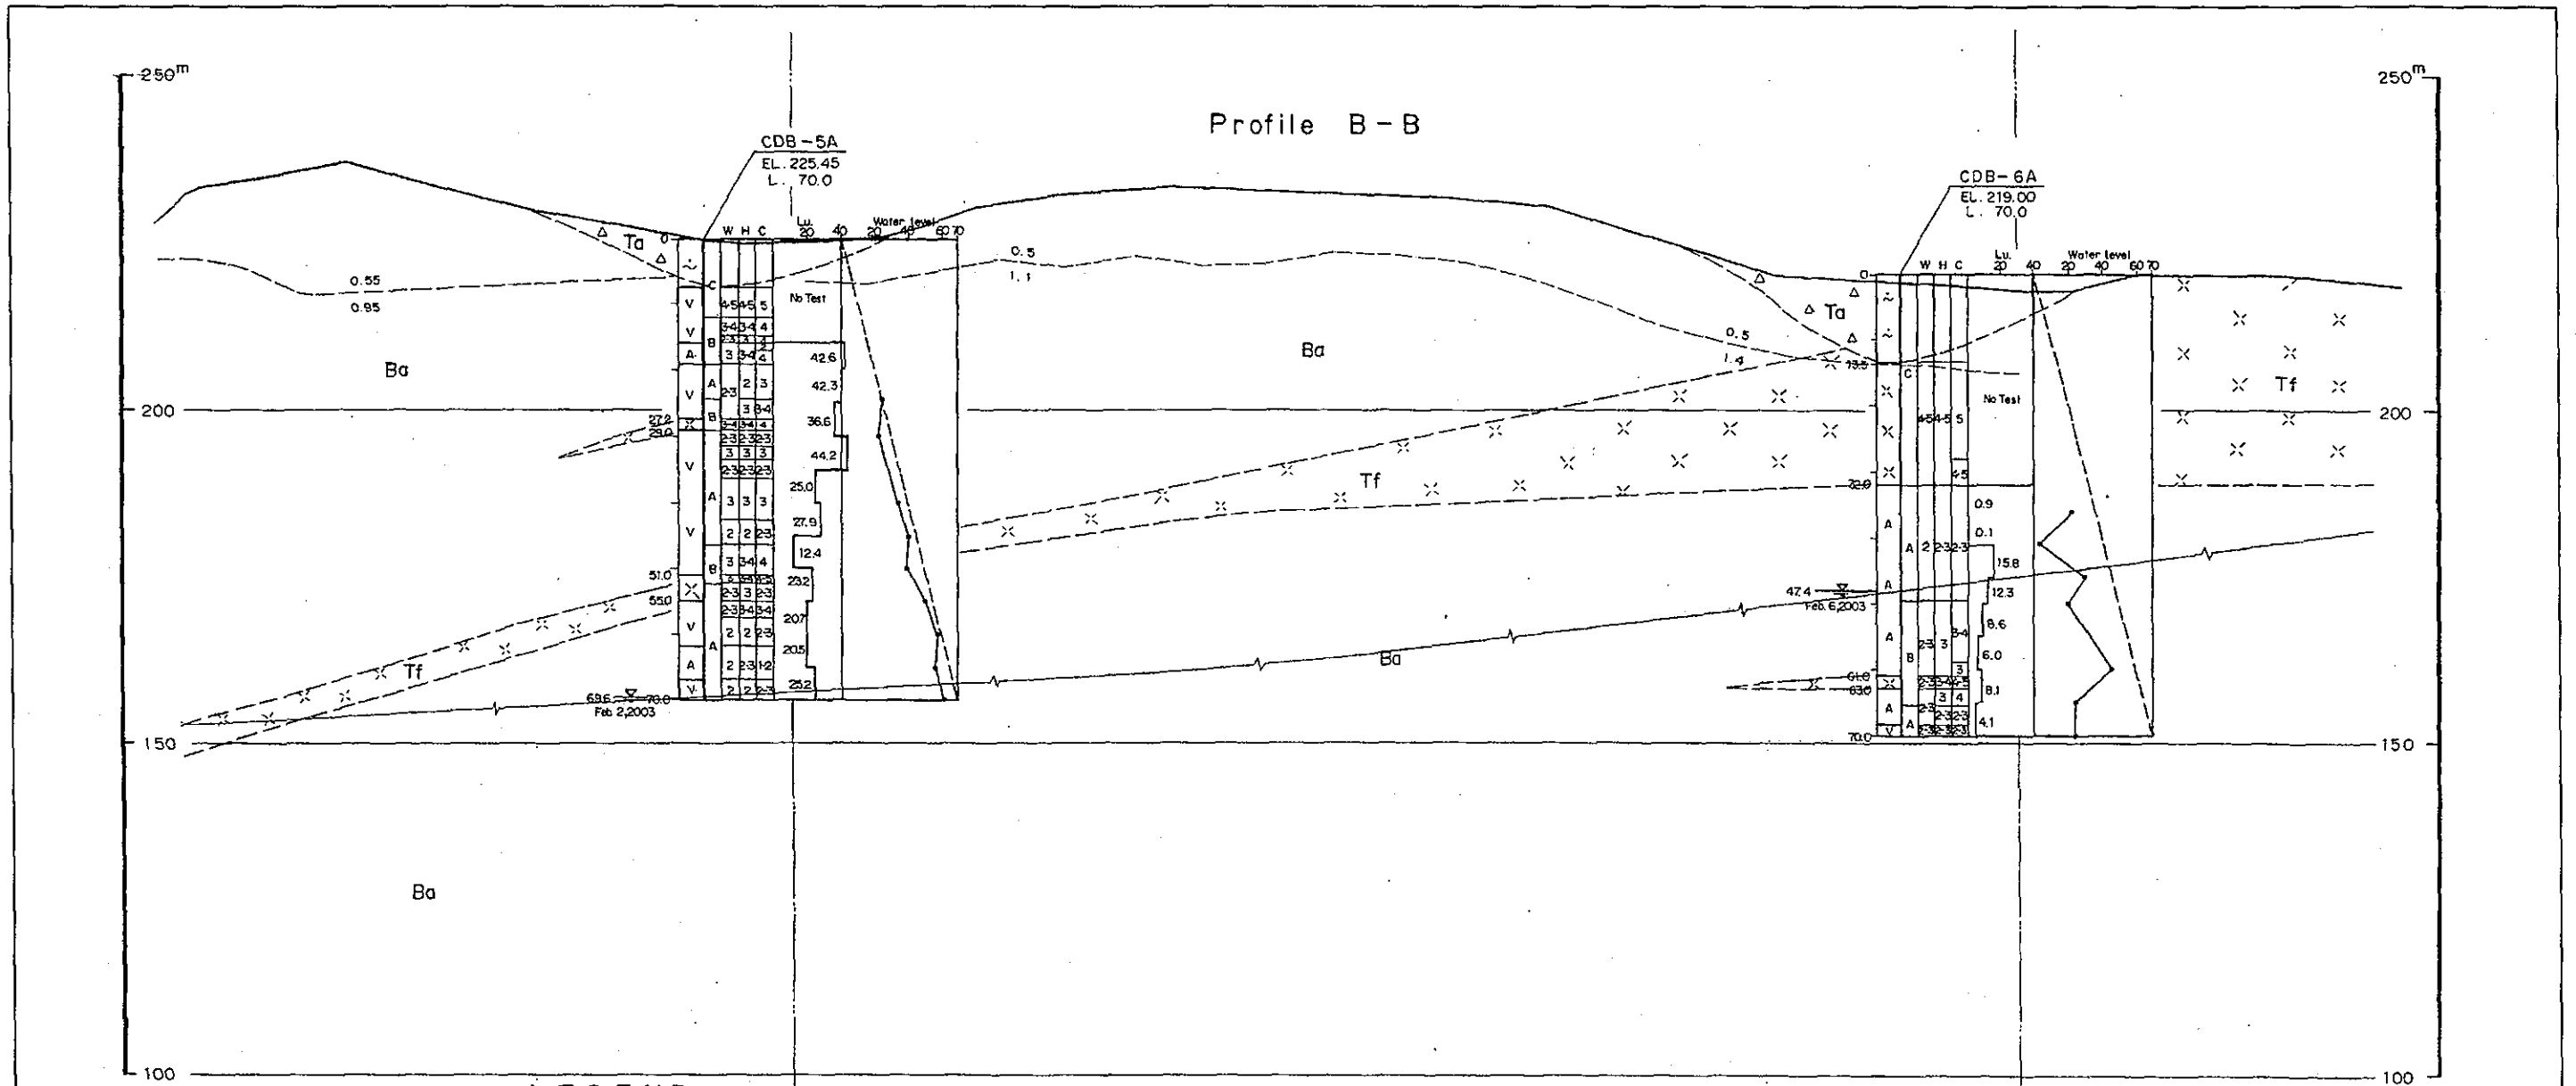
Fig. 7.7

- Talus deposit and residual soil.
- Basalt
- Tuff
- Geologic boundary
- Groundwater table
- Velocity layers and their velocity (km/sec.)

Basalt provides two kinds of rockmass. One is dark gray in color and hard, and its phenocrists are mainly composed of plagioclase and pyroxene. The other is reddish gray in color and somewhat brittle, and its phenocrists are mainly composed of plagioclase and biotite. (Table 7.6) On the cliff face at the dam site, bedded dark gray basalt intercalated with reddish portions were observed. Some contacts of the dark gray portions and reddish portions are gradual as observed at the riverbed and drilled core. Basalt is lava emplaced on the land and some portions became reddish and brittle when they were exposed to the atmosphere and cooled. Some portions of the basalt look like and are believed to be intermediate facies of basalt and agglomerate. This agglomeratic lava seems to exist underneath other lavas. (Table 7.6 and Fig. 7.7)

This evaluation is shown in log of drillholes on profiles of the dam site. (Fig.7.6 and Fig.7.7). The depth to the surface of A class rockmass is shallow on the left bank and deep on the right bank. The depth to the surface of B class rockmass is deeper on the right bank, too. (Table 7.10)

The water level on February 6, 2003 is presented in the geological profiles of the dam site (Fig 7.6 and Fig. 7.7) and the contour of groundwater table (Fig.7.10).

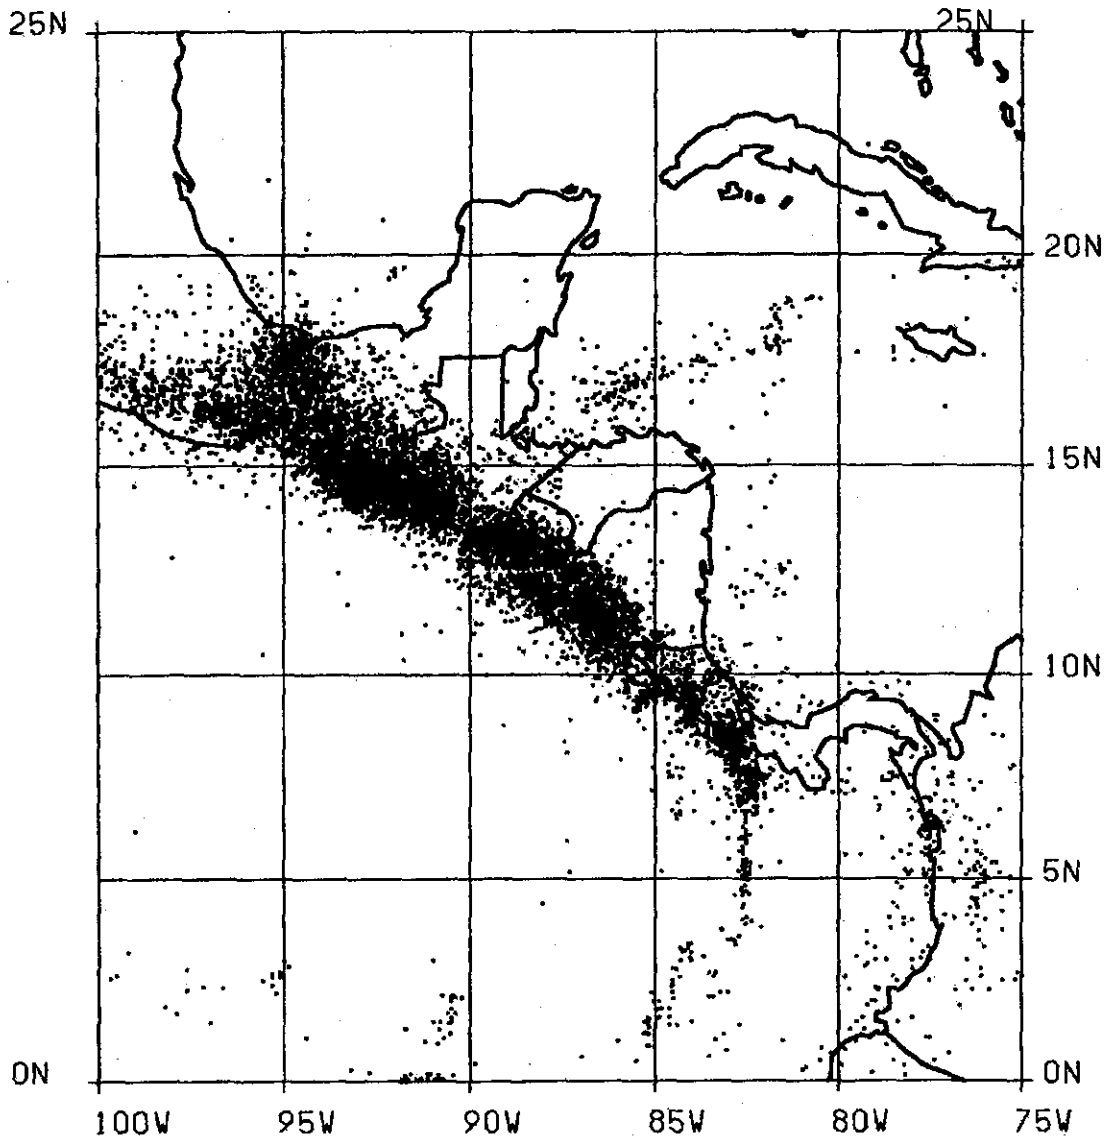
Fig.8.2 Epicenters of Historical Earthquakes around El Salvador (1902- 2002)

The epicenters of earthquakes which occurred within a radius of 1,000 km of the project site during the past 100 years were obtained from the U.S. database (U.S. Department of the Interior, U.S. Geological Survey (USGS), National Oceanic & Atmospheric Administration (NOAA)) and are shown in Fig. 8.2

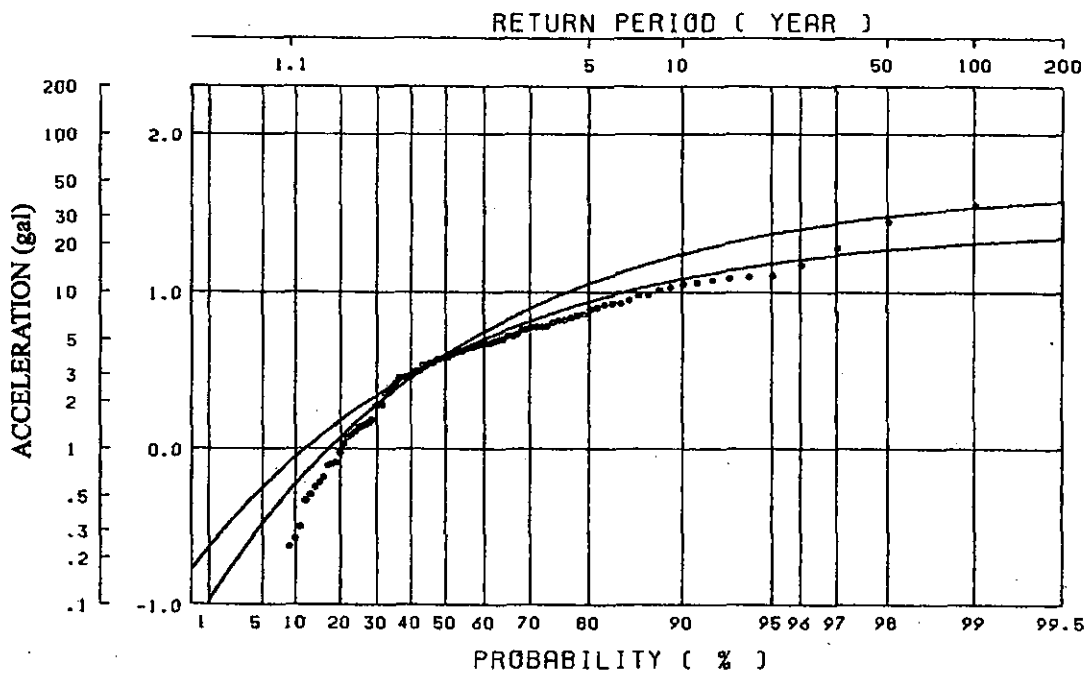
Fig.8.3 Return Period for Maximum Acceleration Calculated based on the Equation of C. Oliveira

Fig. 8.3 to 8.7 shows the stochastic function which shows the relation between the maximum acceleration and the return period calculated by each attenuation formula.

Two asymptotic lines were drawn on the same graph. The first line was drawn in an usual way, and the second line was drawn so as to exceed the maximum acceleration value in an attempt to keep the estimated acceleration value from not falling below the keyed-in historical data. Consequently, the second line was selected because it yielded greater acceleration values.

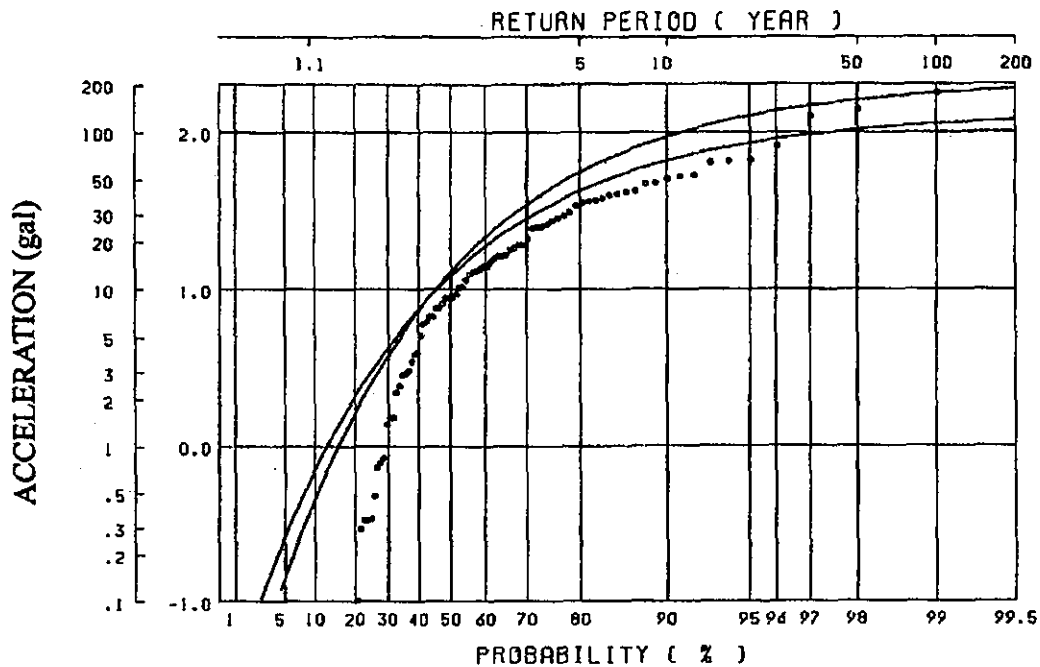
$$S: \text{LOG}(A/640) = [D+40](-7.6+1.724H-0.1036M^{**2})/100$$

(S. OKAMOTO)
