TRVERSE DIA GRAM TAUNSA BARRAGE

DAMAGE CONDITION REPORT
FOR THE BARRAGE FLOOR
(JANUARY 2004)

CROSS SECTION THROUGH UNDER-SLUICE OF TAUNSA BARRAGE

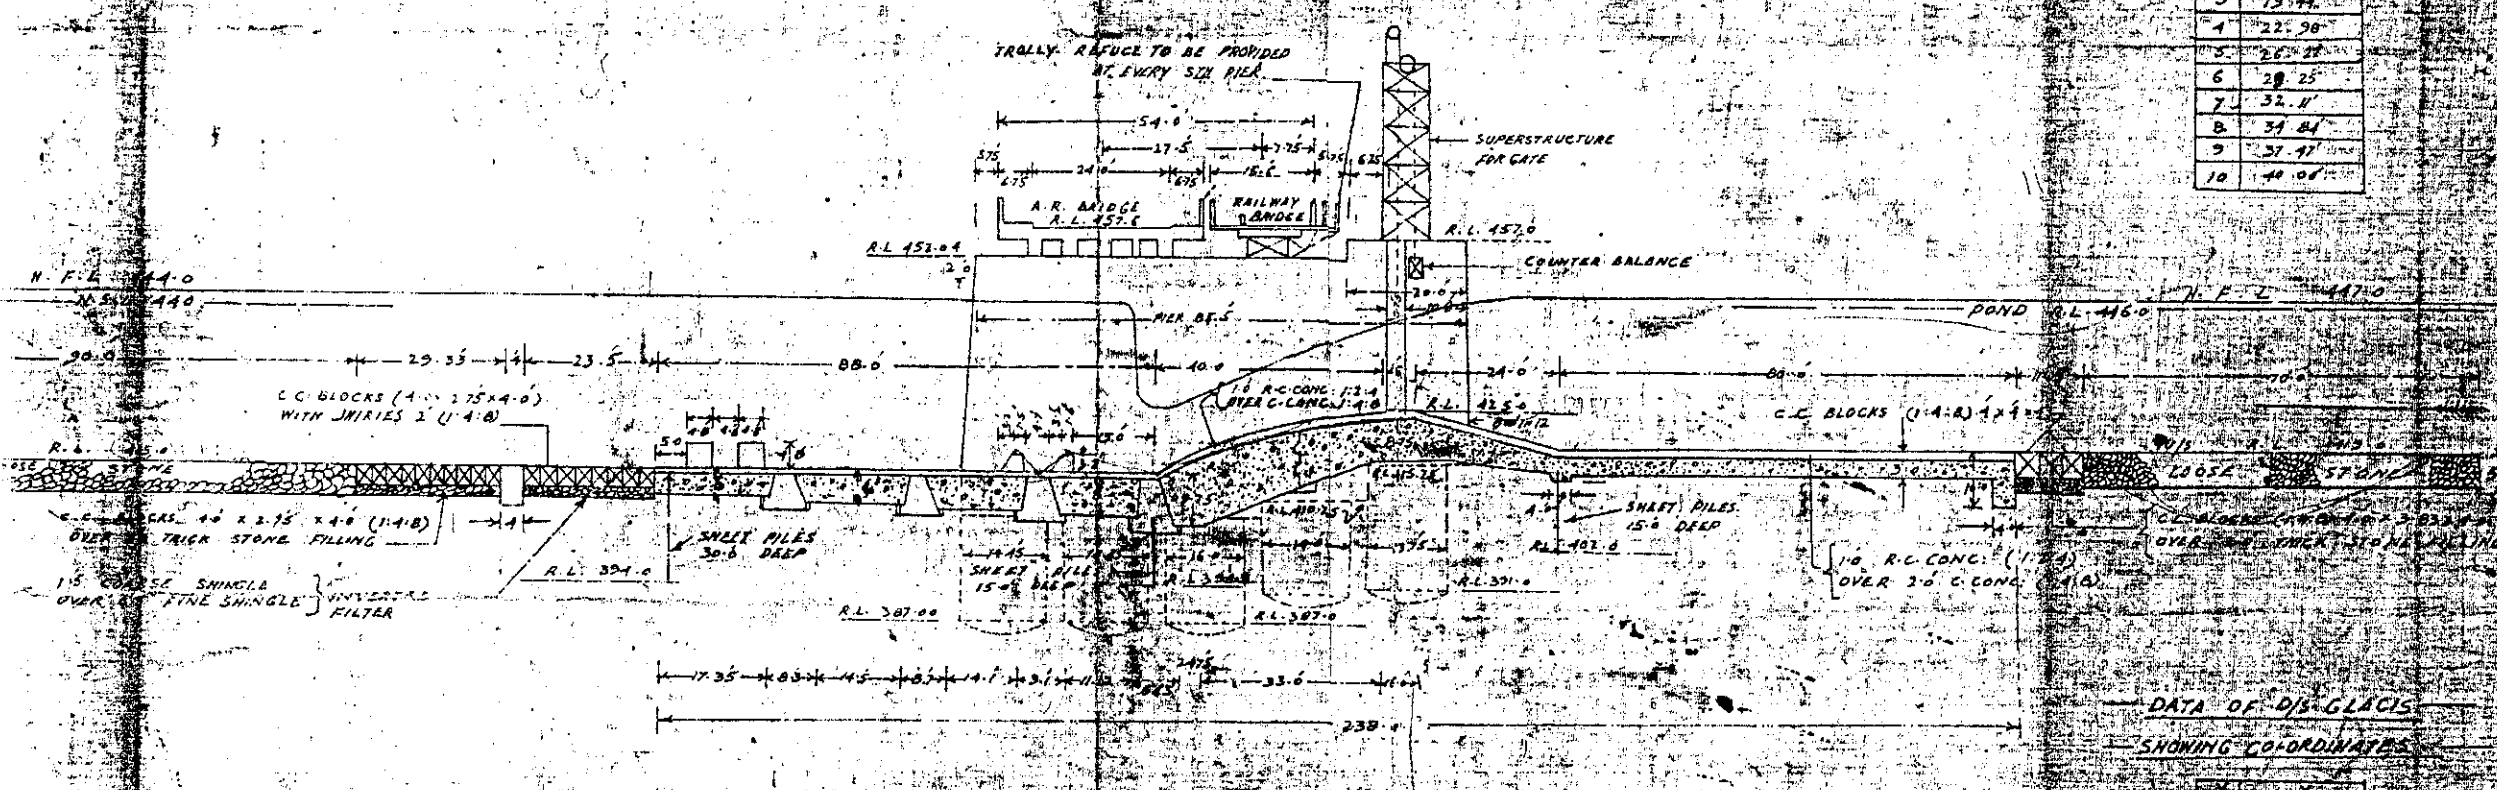
SCALE = 1/500

DATA OF D/S GLACIS
 SHOWING CO-ORDINATE

Y	X
1	10.45
2	15.42
3	19.44
4	22.90
5	26.27
6	28.25
7	32.11
B	34.84
9	37.11
10	44.06

➤	PLAN OF TAUNSA BARRAGE & CROSS SECTIONS THROUGH THE UNDERSLUICE AND THE WEIR BAYS	I
➤	FORMATS OF DAMAGE CONDITIONS - BAY NO. 65	II
➤	FORMATS OF DAMAGE CONDITIONS - BAY NO. 64	III
➤	FORMATS OF DAMAGE CONDITIONS - BAY NO. 63	IV
➤	FORMATS OF DAMAGE CONDITIONS - BAY NO. 62	V
➤	FORMATS OF DAMAGE CONDITIONS - BAY NO. 37	VI
➤	FORMATS OF DAMAGE CONDITIONS - BAY NO. 36	VII
➤	FORMATS OF DAMAGE CONDITIONS - BAY NO. 35	VIII
➤	FORMATS OF DAMAGE CONDITIONS - BAY NO. 10	IX
➤	FORMATS OF DAMAGE CONDITIONS - BAY NO. 09	X

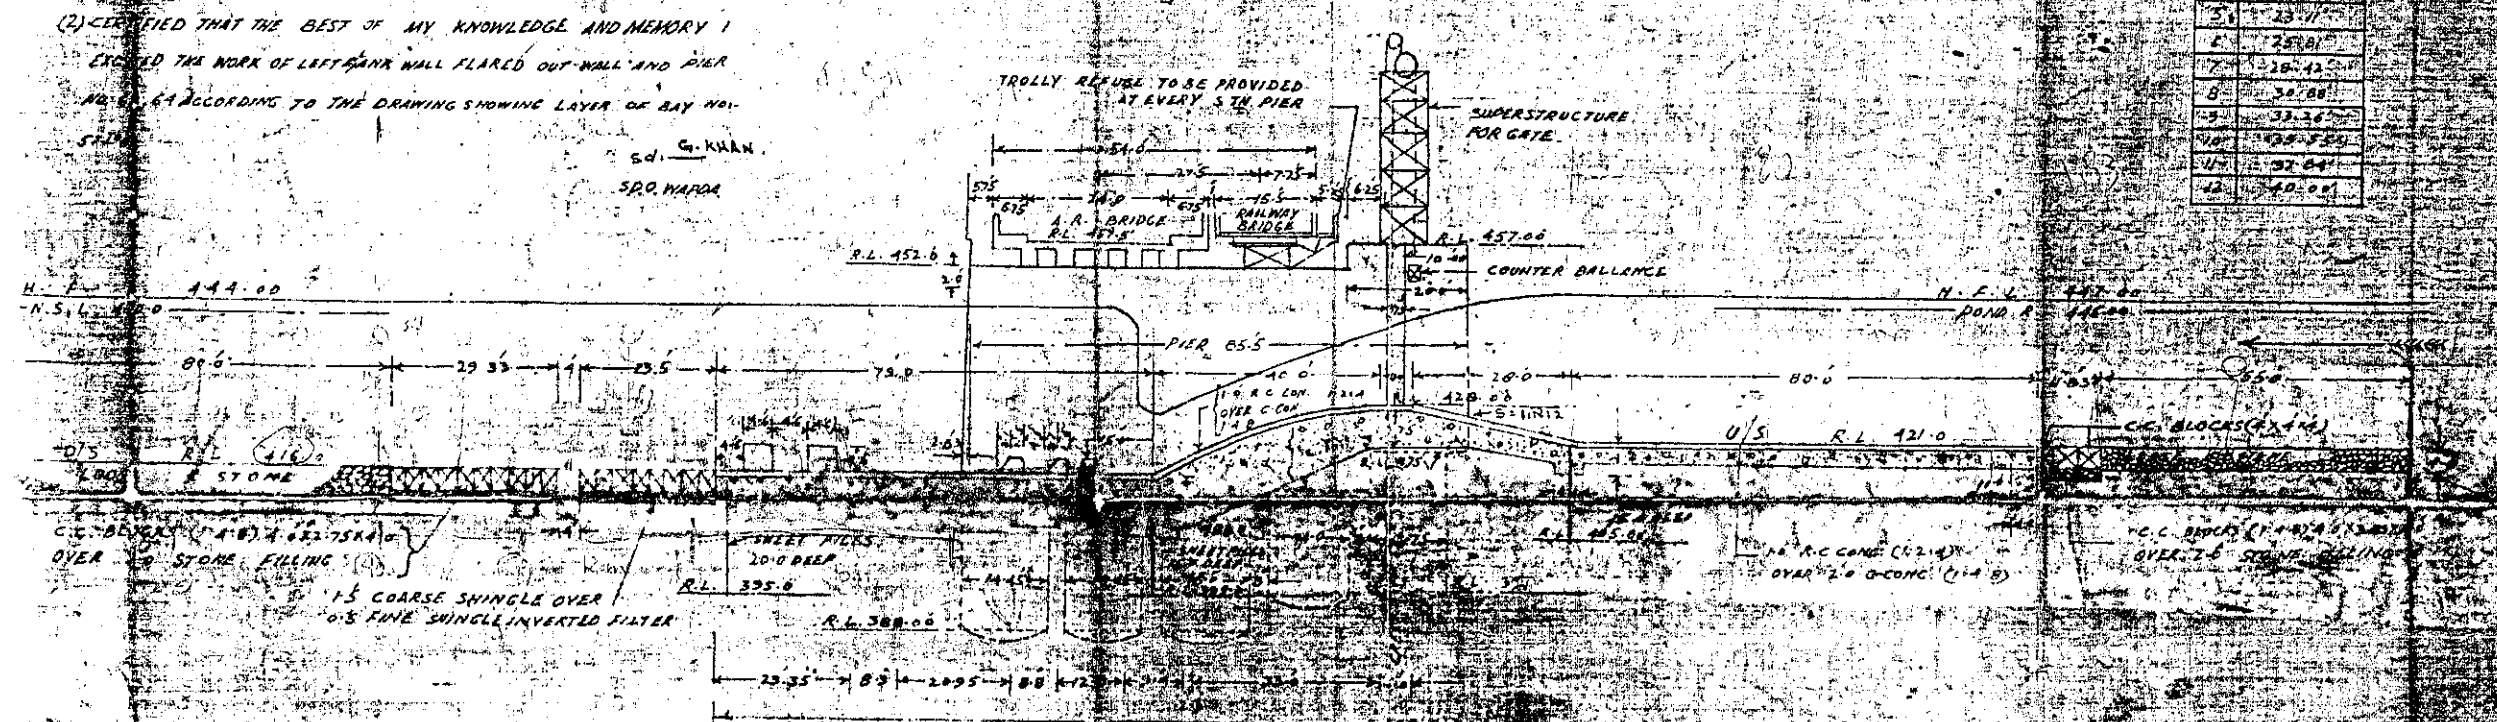
CROSS SECTION THROUGH WEIR OF TAUNSA BARRAGE

SCALE = 1/300

DATA OF D/S GLACIS
 SHOWING CO-ORDINATE

Y	X
1	5.00
2	15.42
3	19.44
4	22.90
5	26.27
6	28.25
7	32.11
B	34.84
9	37.11
10	44.06
