The features of promising potential sites for PSPP

Site Name: JN6

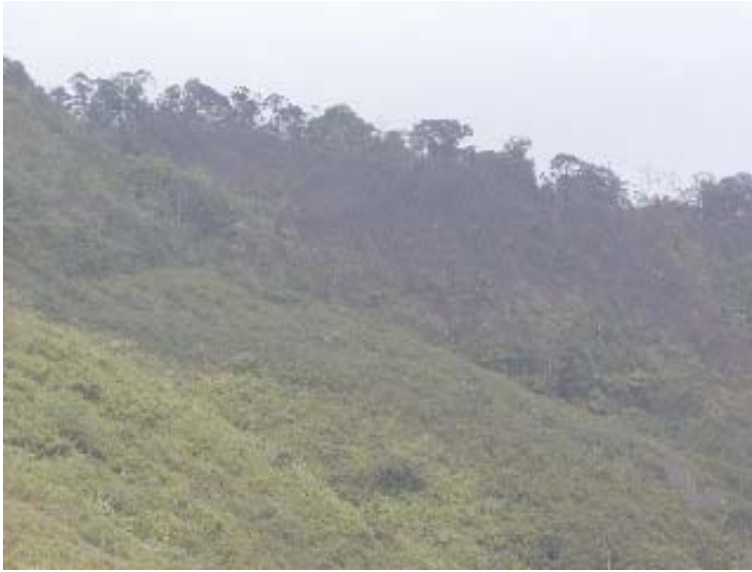
Photo 1

It is necessary to construct a new approach road about 10 km long to the site.
(View from the southern slope of a footpath)

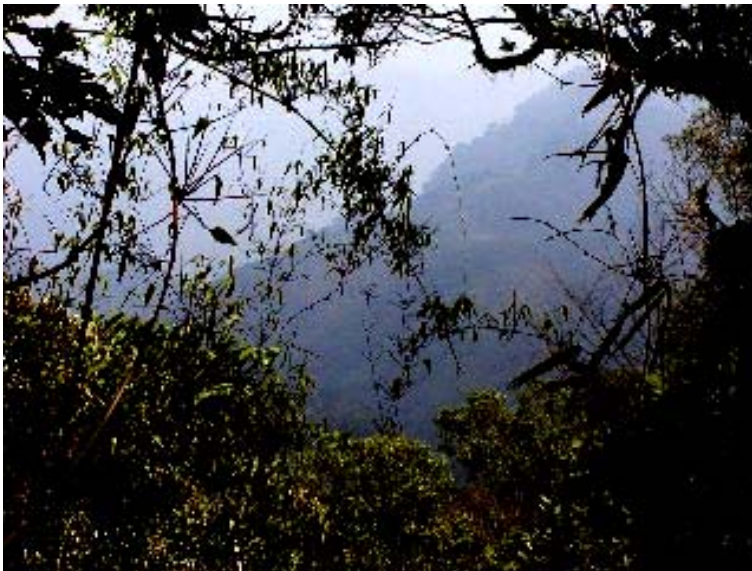
Photo 2

In the case of accessing from the planned lower dam site, it is necessary to construct a new approach tunnel of about 2.5 km long and a new road of about 3 km long.
(View from the top of the right-bank)

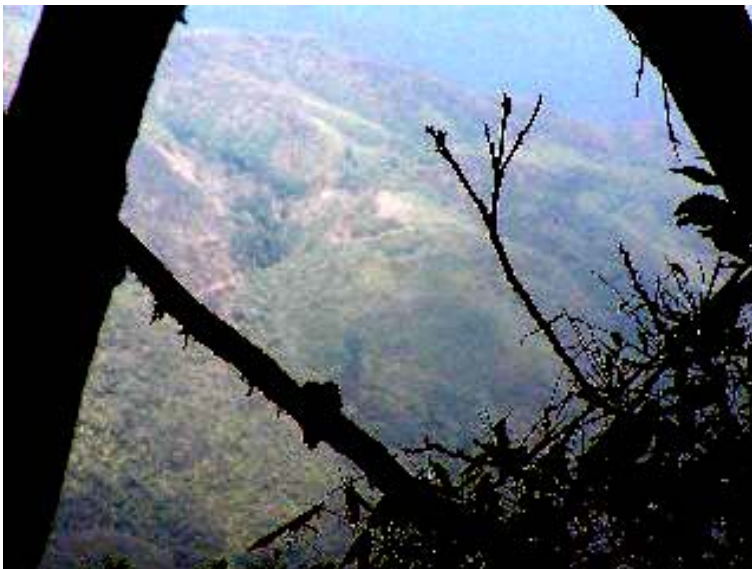
Photo 3

The ridge of the left-bank of the planned upper dam site is thin and has a gentle slope.
(View from the top of the right-bank)

(Upper dam/reservoir)	<ul style="list-style-type: none"> - Crustic acidic tuffs of Cretaceous (K2sb) out crops around the upper Dam site, some porphyritic rocks are found on the ground. Some of the matrix of these volcanics are very soft. - NS system of fault along with the Suoi Kan stream pass through the center of the upper reservoir, a lot of the sheared and altered outcrops are found on the slope of the access road along the river. The weathered zone of the volcanics is relatively thick on the few meters surface. - There are some probability of the cooling joint system in rhyolite and welded tuff in underground. - Recent constructed road from Phu Yen to Suoi Khoang leads us to the 2.5km south of the upper dam site by automobile. But remaining elevation 400m up and 10km horizontally access road will be needed additionally. - Other hand, approach from the lower dam site is more useful than the upper road mentioned above in the point of economically advantages to the underground powerhouse, still require the 2.5km tunnel and 3km road. - It sounds a lot of the quantity of water flows in the river. From the villagers information, three streams are gathers in the upstream of surveyed area. - The left side slope of the upper reservoir is gently and narrow ridge viewing from the right side.

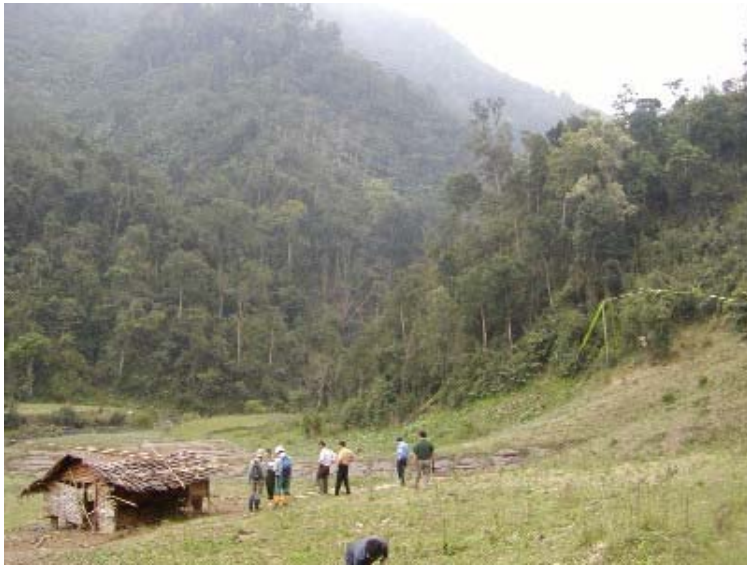
Photo 4

Concrete gravity dam is suitable for this lower reservoir based on the topographical condition.

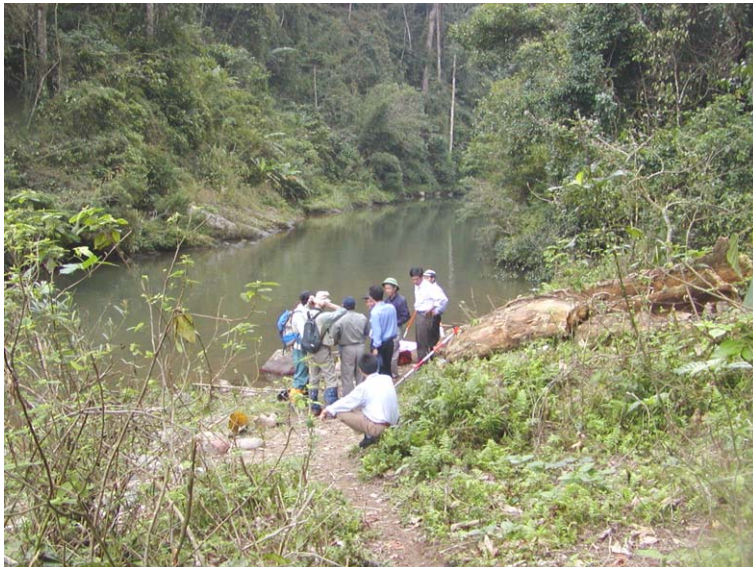
Photo 5

Dam site is located at the same location where MARD plans to build an irrigation dam.

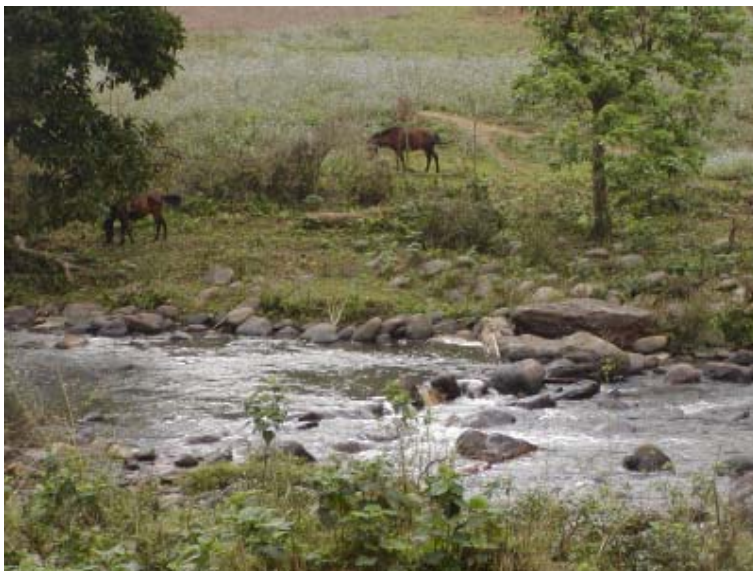
Photo 6

Water flow of the river is about 2.0 m³/s.
