13.4.2 Damage Estimation

13.5 Fire

13.6 Lifelines

13.7 Bridges and Flyovers

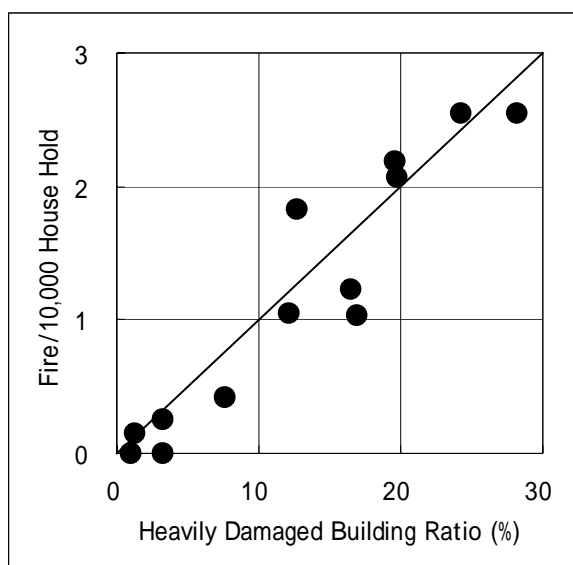
Figure 13.5.3 Relation between Fire Outbreaks and Building Damage by Kobe Earthquake

Most of the fire due to the earthquake occurs from residential buildings. Some fire may occur from chemical facilities or flammable liquid/gas stations but the number is small. Therefore, the correlation of fire outbreak ratio with residential building damage ratio is high. Figure 2.5.3 shows the relation between fire outbreaks and building damage by 1995 Kobe Earthquake. The correlation of these factors is very high.

It is not sure that the relation between fire outbreaks and building damage in Metropolitan Manila is same to the case in Kobe. There may occur more fire than in Kobe considering that many fire occur by electricity leakage or short-circuit after the earthquake. On the contrary, considering that many heating equipment was used in Kobe because Kobe Earthquake occurred in winter, the number of fire outbreaks may be smaller.

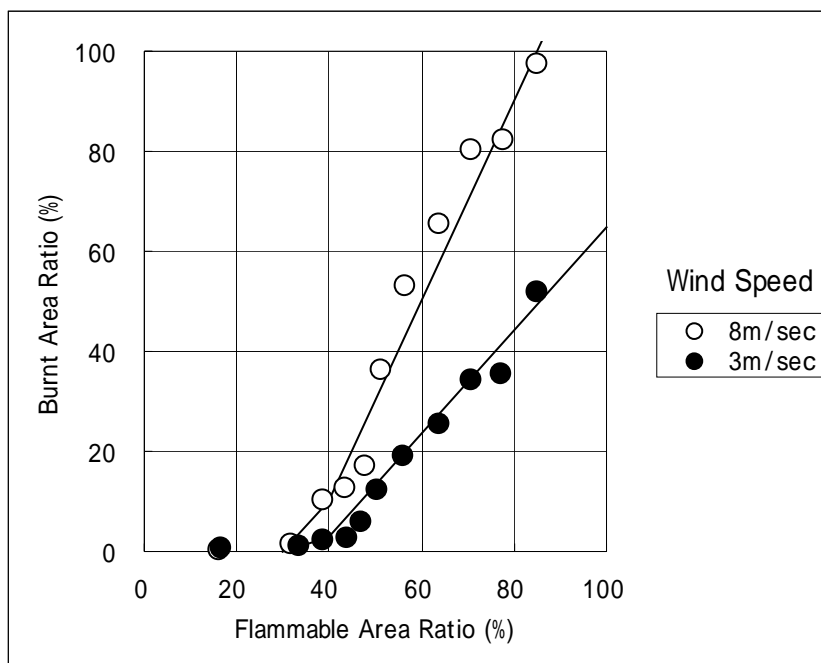
Figure 13.5.4 Relation between Burnt Area Ratio and Flammable Area Ratio

The fire spreading possibility and burnt out ratio without fire fighting activity is affected by building density and ratio of flammable buildings. Figure 13.5.4 shows the result of the numerical simulation on the relation between “flammable area ratio” and “burnt area ratio” by the Japanese Ministry of Construction (1982). The definition is as follows:

The burnt area ratio becomes higher in proportion to a rise of flammable area ratio. The wind speed also affects to the result. If the wind speed is higher, larger area will be burnt out. If the flammable area ratio is less than 30%, burnt area ratio will be 0%. This means that if fire may occur in the area with flammable area ratio less than 30%, it never spread to other buildings.

- All the grids of possible fire spreading suffer fire
- No effective fire fighting activities
- Fire continue till putting out by it self
- Burnt out building number can be estimated with Figure 13.5.4

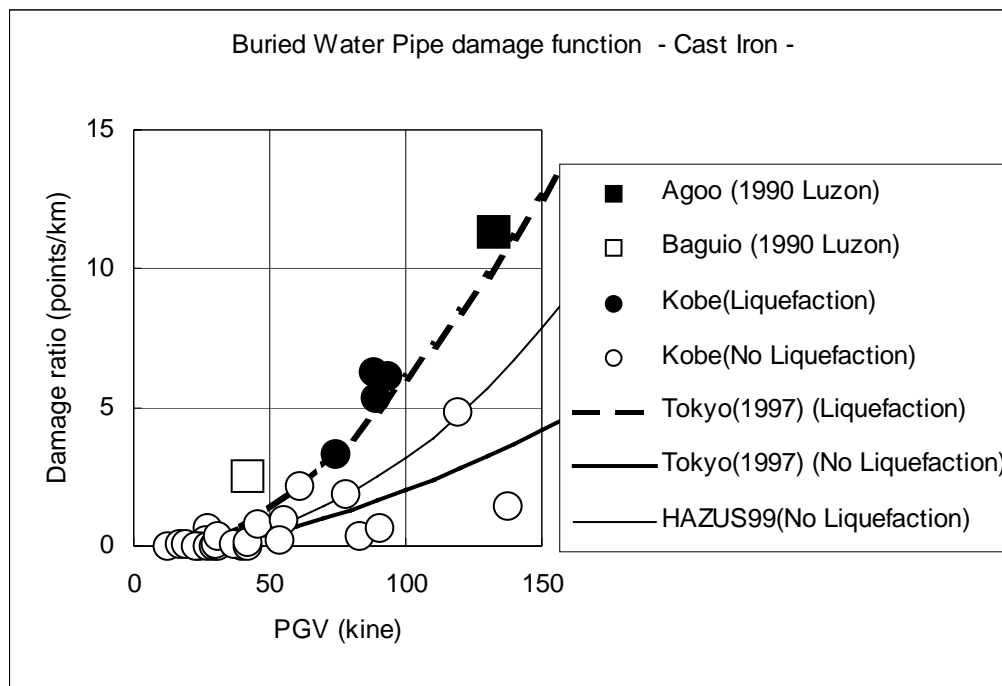
Figure 13.6.1 Damage Function of Water Supply Pipeline

The damage to water pipes in Kobe city in the 1995 Kobe Earthquake is one of the most well known damage examples, and the relation of damage and seismic motion in Kobe and the surrounding area are well studied. Figure 13.6.1 shows the relation between the damage of water supply pipelines and the ground motion in Kobe and other cities compiled by Tokyo (1997). As for the ground motion, PGV (Peak Ground Velocity) is used. This figure also shows that pipeline damage is strongly affected by liquefaction because liquefied soil provides buoyancy to pipeline. The damage function for water supply pipelines were established by Tokyo (1997) and shown in Figure 13.6.1.

The water distribution pipeline damage due to 1990 Luzon Earthquake was reported in several cities, but quantitative damage statistics is almost nothing. The number of damage points and water pipeline length in Agoo and Baguio, written in Philippines Earthquake Reconnaissance Report (1991), is the only available data. Agoo was affected by liquefaction. The damage in these two cities is also plotted in Figure 13.6.1. The PGV in these cities was estimated from the seismic intensity by AIJ (1992) using the empirical formula by Trifunac and Brady (1975). The damage in Agoo is explained by the damage function by Tokyo (1997). The damage ratio in Baguio is higher

than the experience in Japan. Many landslides occurred in Baguio due to the Luzon Earthquake and many water pipelines were reported to be destroyed by landslides. This may be the reason of higher damage ratio than Japan. Based on these considerations, the damage function, shown in Figure 13.6.1, was used for damage estimation.

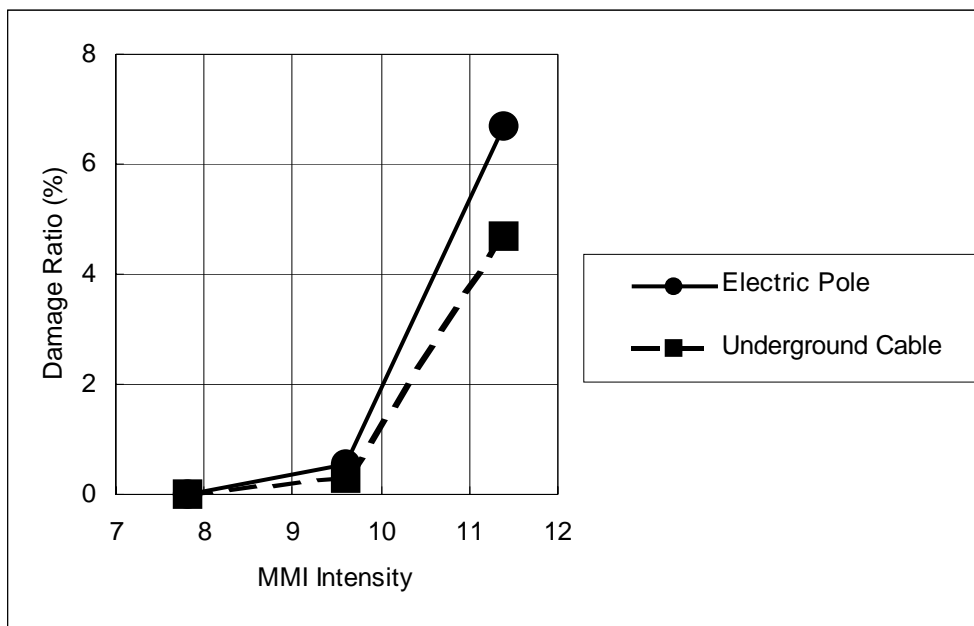
Figure 13.6.4 Damage Function of Electric Power Supply Cable

Figure 13.6.4 is the relation between electric power supply cable damage ratio and seismic intensity due to 1995 Kobe earthquake by Tokyo (1997). The damage of electric power supply cable is limited to the damage that will bring electric power cut off. The effect of liquefaction is shown in Table 13.6.3. The damage was calculated using the damage function by Tokyo (1997).

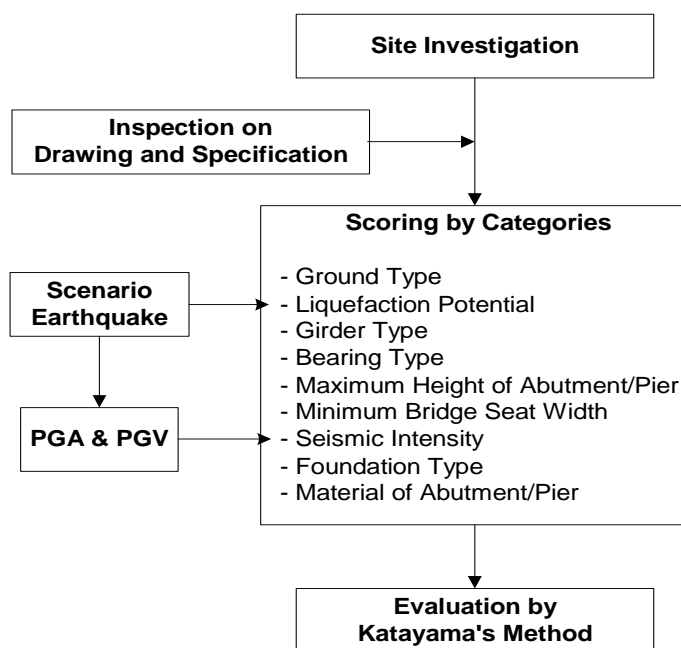
Figure 13.7.1 Flowchart of Stability Analysis of bridges/flyovers

Considering that, the falling-off of the girder can give the most serious effect to the road system. Therefore, a methodology that is proposed by Kubo/Katayama (hereafter referred to as Katayama’s method) is selected in this study because that methodology is very effective for evaluate the bridges on the viewpoint of falling-off of the girder. Schema of this evaluation system is shown in Figure 13.7.1. As shown in Figure 13.7.1, almost necessary data can be obtained by observing the bridges in site except a few items.

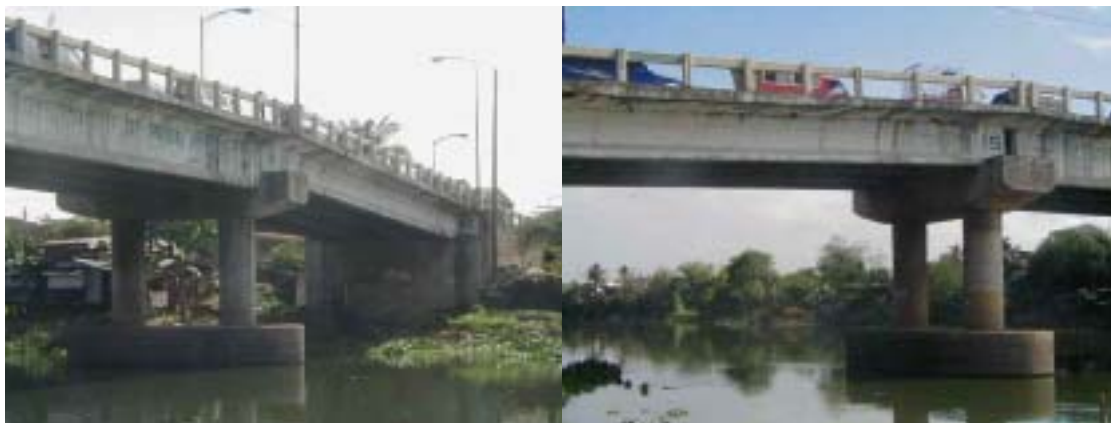
(1) Alfonso Sandoval Bridge (NC-1M-E201)

The evaluated result of this bridge is 55.1, which is the highest score among others. The reason why this bridge possesses the high score is that this bridge is composed of simple girders with slant and spaces between girders, and seat width is rather small. In addition, this bridge is located in the area with very soft ground, high liquefaction potential, and high Seismic Intensity.

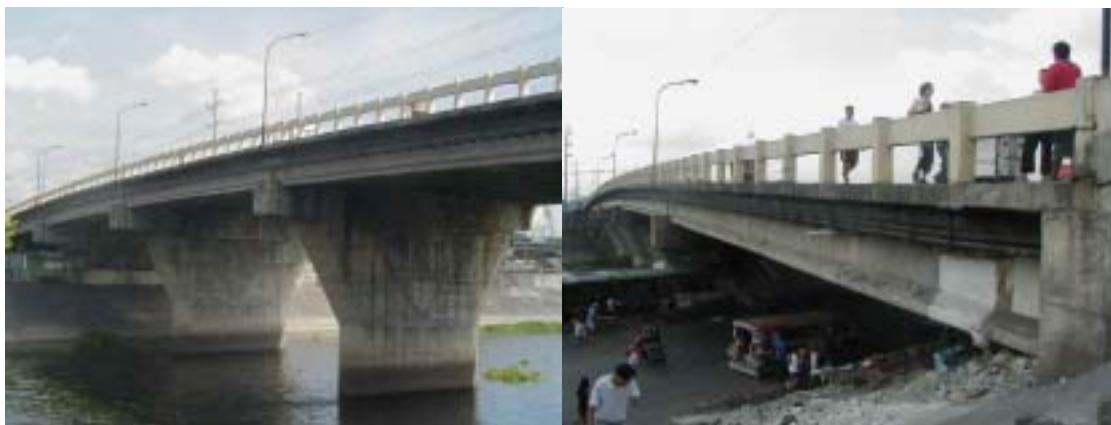
(2) Ortigas Bridge (NC-1M-O102)

The evaluated result of this bridge is 51.0. The reason why this bridge possesses the high score is that this bridge is composed of simple girders with many spans and that pier is comparatively high. In addition, this bridge is located in the area with high liquefaction potential, and high Seismic Intensity.

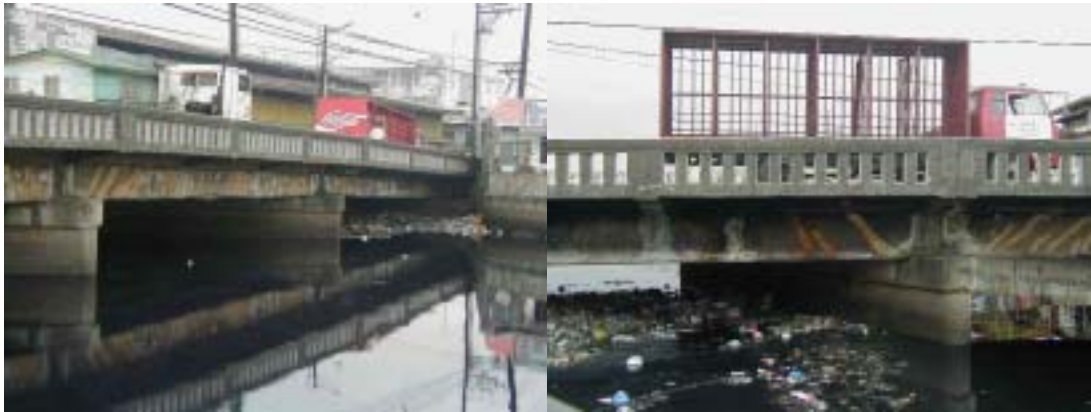
(3) Balut I Bridge (NC-NM-H101)

The evaluated result of this bridge is 37.8. The reason why this bridge possesses the high score is that this bridge is composed of simple girders with little seat width. In addition, this bridge is located in the area with soft ground, high liquefaction potential, and high Seismic Intensity. These 3 items related to natural condition affects very much to this bridge.

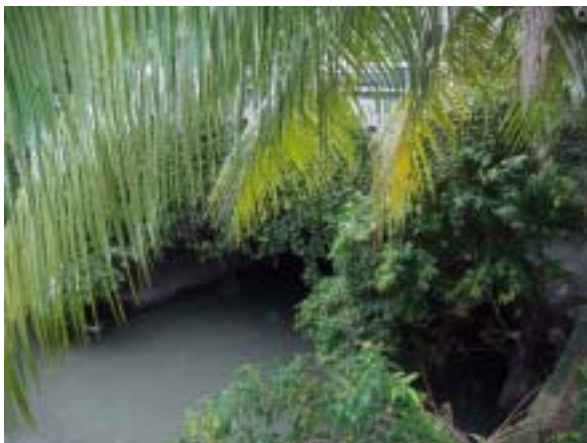
(4) S. Padilla Bridge (NC-SM-S602)

The evaluated result of this bridge is 36.3. The picture can not be observed well on this structure, however, collision of columns can be observed. This bridge has simple girders and ground condition is very bad with high liquefaction potential.

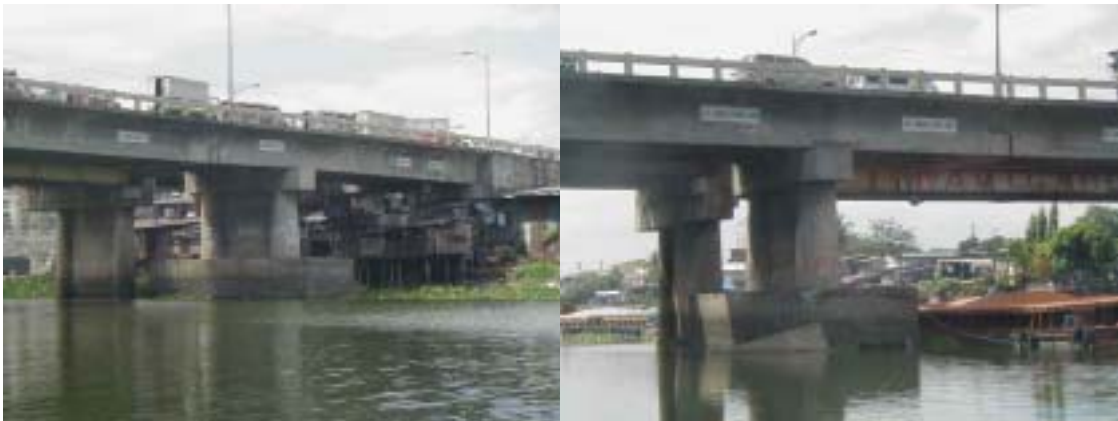
(5) Vargas Bridge (NC-1M-S304)

The evaluated result of this bridge is 34.0. Downstream and Upstream structure of this bridge is different. Girder type of Downstream is Steel Plate with simple girders and Upstream is PC Gerber Girder. The reason why this bridge possesses the high score is that this bridge is composed of simple girders (Downstream) and Gerber girder, which both of structure is weak against earthquake. Also this bridge is located in the area with high liquefaction potential and high seismic intensity. However, this bridge is rather good if any falling off device are added to survive from strong earthquake motion.

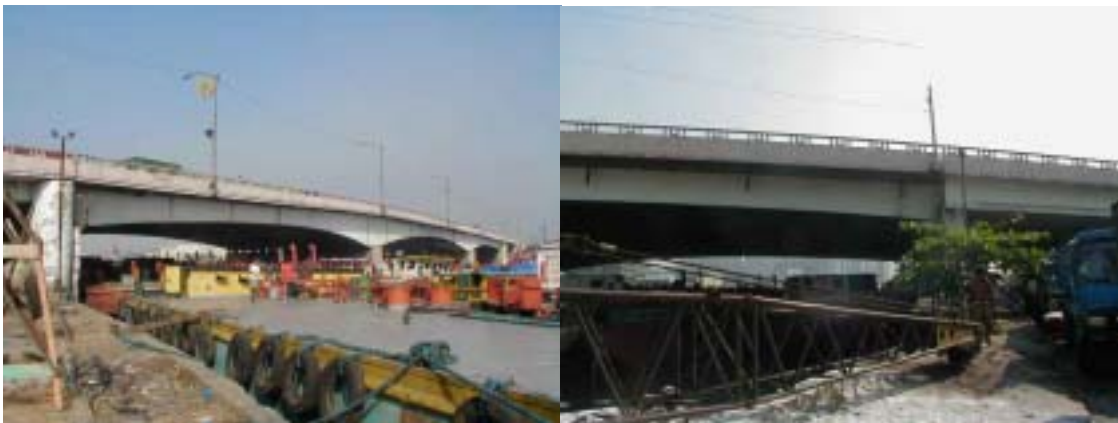
(6) Roxas Bridge (NC-NM-D201)

The evaluated result of this bridge is 31.3. This bridge also has different structure in Downstream and Upstream. However, both of girder type is PC Gerber box girder. According to the past earthquakes, Gerber bridges are very weak against earthquake and this bridge has small seat width. In addition, this bridge is located in the area with high liquefaction potential, and high Seismic Intensity.

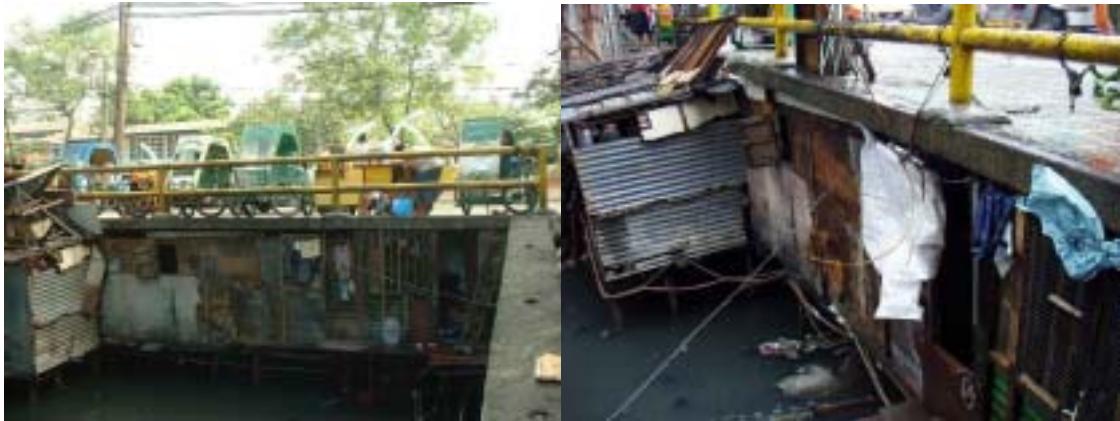
(7) C.M. Recto 2 Bridge (NC-NM-C302)

The evaluated result of this bridge is 31.1. The reason why this bridge possesses the high score is that it is in the area with very soft ground, high liquefaction potential, and Seismic Intensity is high. These 3 items related to natural condition affects very much to this bridge. In addition, since bridge is illegally occupied, any maintenance or inspection of bridge can be undertaken.

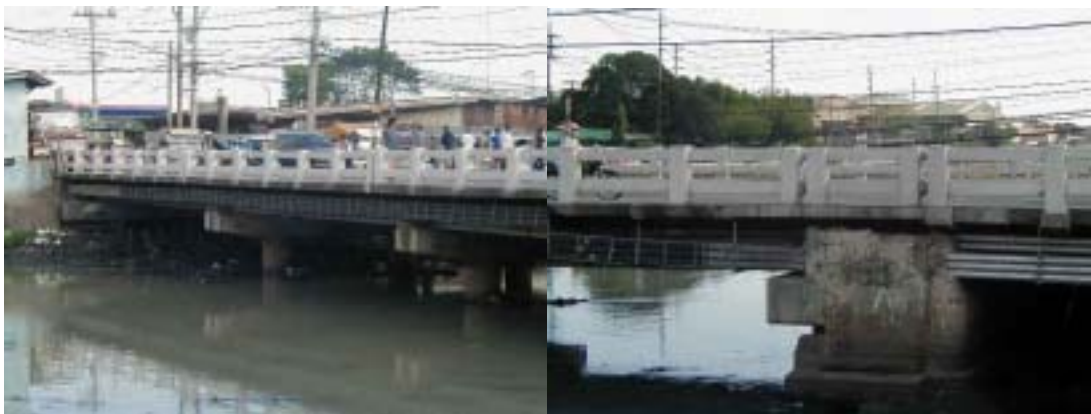
(8) Airport Road Bridge (NC-2M-A201)

The evaluated result of this bridge is 26.1. The reason why this bridge possesses the high score is that it is composed of simple girders with small seat width and fixed girder area. In addition, this bridge is located in the area with soft ground, high liquefaction potential, and high Seismic Intensity. These 3 items related to natural condition affects very much to this bridge.

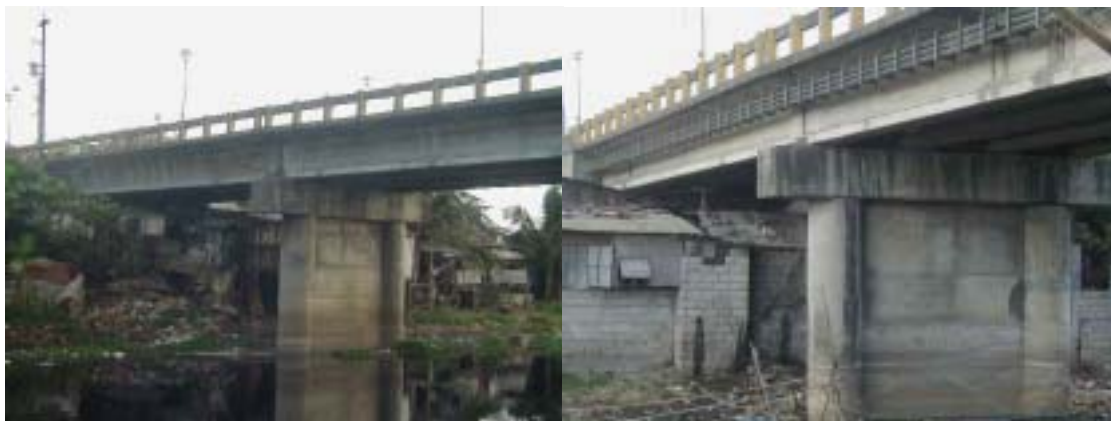
(9) Modesta Bridge (NC-1M-M401)

The evaluated result of this bridge is 26.1. The reason why this bridge possesses the high score is that this bridge is composed of simple girders and that piers are comparatively high. However, compare to the other high score bridges, this bridge is located in the area with medium stiffness ground, medium liquefaction potential, but high Seismic Intensity. With small effort like adding fall prevention material will help avoiding fall of superstructure.
