第II部 マスタープラン

6. 橋梁健全度調査と評価

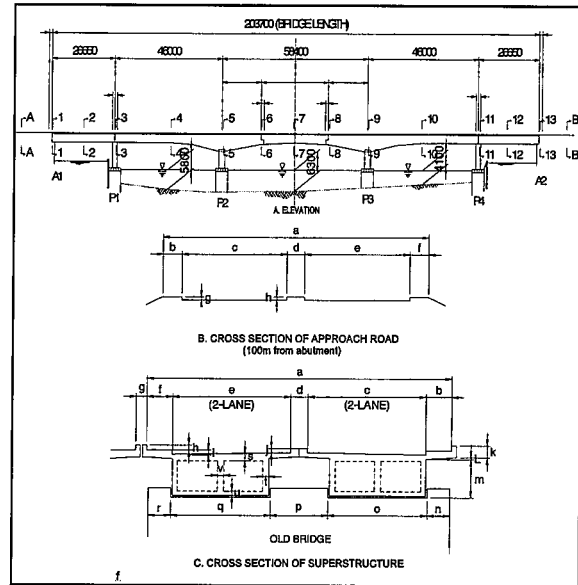
形状寸法調査記録用紙

構造部材の形状寸法を調査し、ロードレディング（LR）を含む構造物の健全度の解析のために橋梁の構造図面を作成した。ただし、基礎工のように計測ができない構造部材の形状寸法は、復元設計を実施し、仮定した。

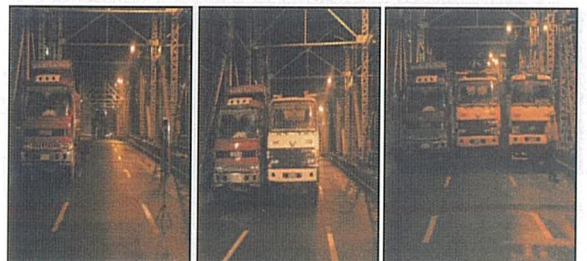
トラック荷重の段階载荷

- ・静的载荷試験
構造物のモデル作成及びロードレイトイングに使用するためのデータを得る目的で行う試験である。
この試験を実施した橋梁は、次の通りである。
アヤラ橋およびランビンガン橋

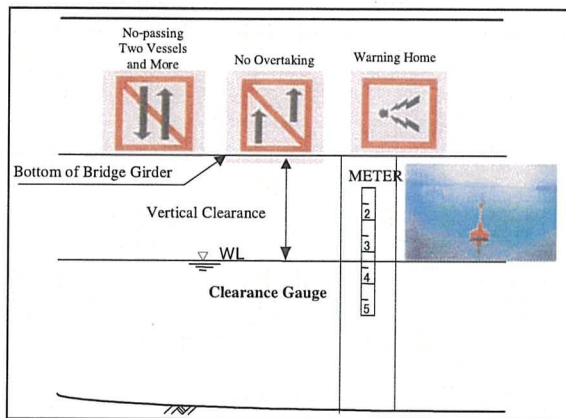
安全 航行のための標識とマーク

橋梁と船舶との衝突を防止するために、下記のような管理上の対策を実施することは重要であり、現実的で経済的でもある。

- ・ 非通行地帯の設置
- ・ 追越禁止帯の設置
- ・ 警告帯の設置
- ・ 航路限界ゲージの設置
- ・ 警告ブイの設置

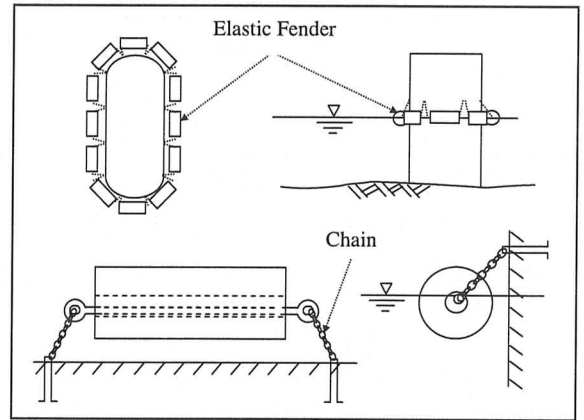
浮き防舷材

橋梁桁防護工
