# **CHAPTER 7**

## **BRIDGE CONDITION SURVEY AND DESIGN PRESUMPTION**

#### 7.1 PRESENT CONDITION SURVEY

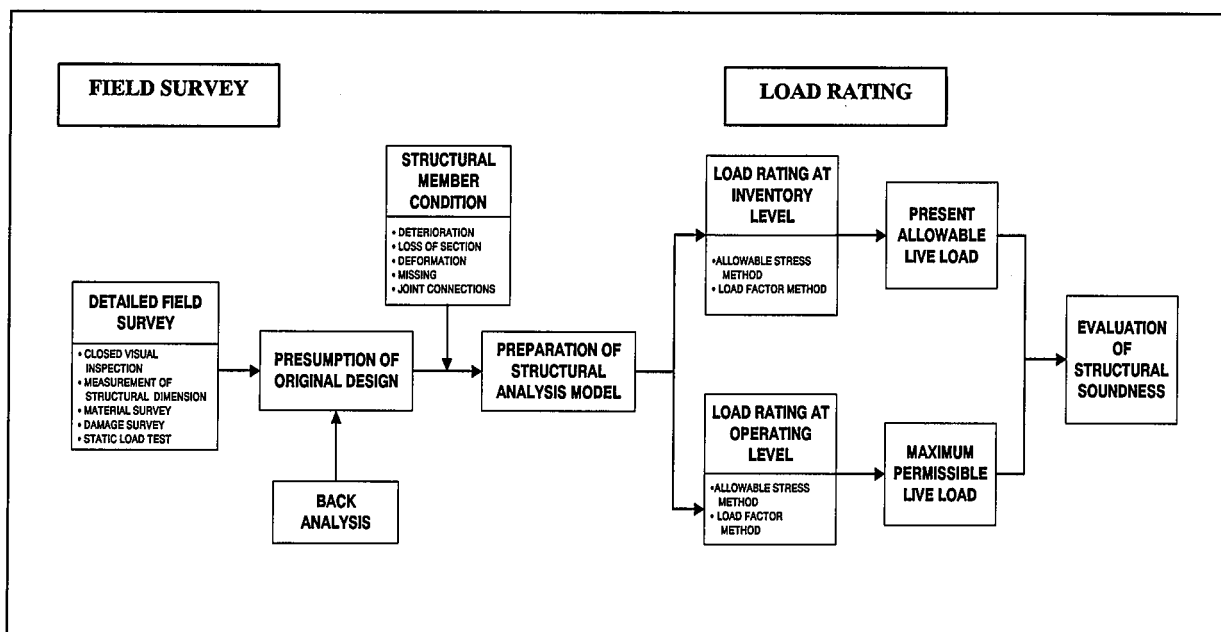
Figure 7.4.1-1 Flow of Load Rating for Superstructure

The flow of load rating and evaluation of bridge soundness is presented in **Figure 7.4.1-1**. For bridges with complete maintenance and inspection records and information, the load rating will be straight-forward considering the present condition of the bridge members. However, when the bridge data are not available, field survey and presumption of original design is necessary. The Presumption of Original Design, as discussed in **Section 7.3**, will have to be done using the data gathered from field survey and measurements.

Load ratings were evaluated at two levels – the *Inventory Level* and the *Operating Level*. The methods used for load rating evaluation include the allowable stress, the load factor, and the load and resistance factor methods. The results of the load rating evaluation indicate the present allowable live load and the maximum permissible live load of the bridge.
