CHAPTER 9

COMPARATIVE STUDY ON IMPROVEMENT MEASURES

9.1 BASIC POLICY AND EVALUATION CRITERIA

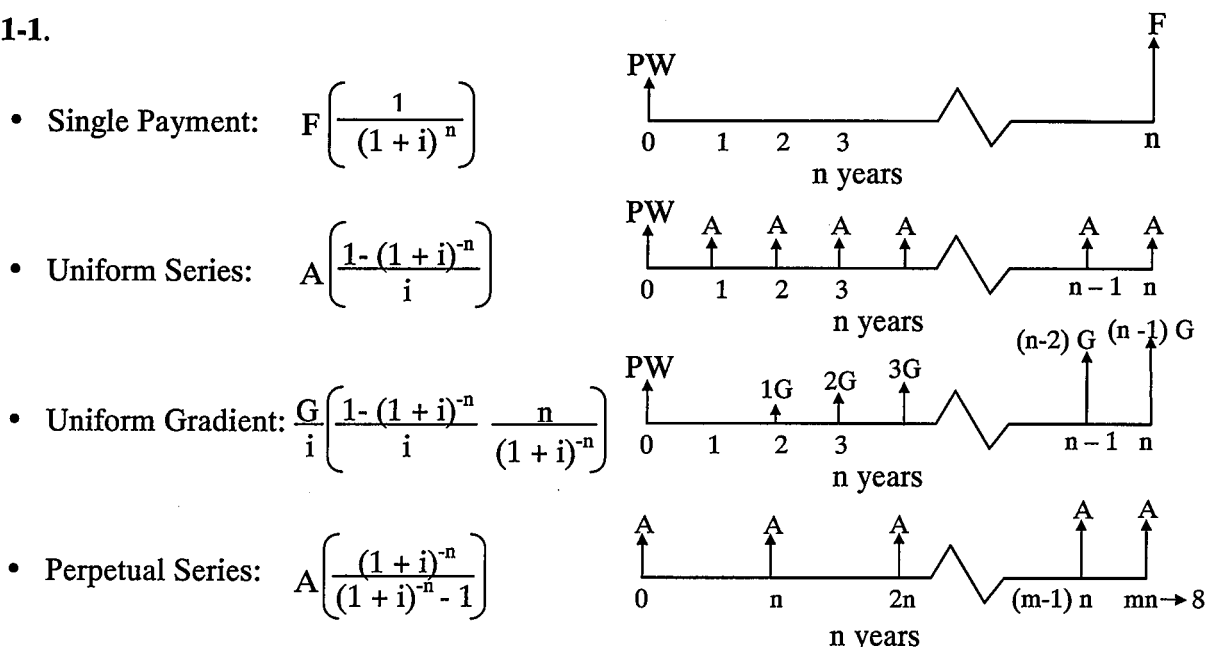
Typically, future costs include maintenance, future rehabilitation expenditures, salvage value at the end of the useful life, and probable replacement costs. In lifecycle cost analysis, future cost must be discounted to a present worth before they are combined with present costs. Basic formulas for converting future sums into present worth by discounting are presented in **Figure 9.3.1-1**.

Figure 9.3.1-1 Present worth calculated by discounting (i = effective interest rate)

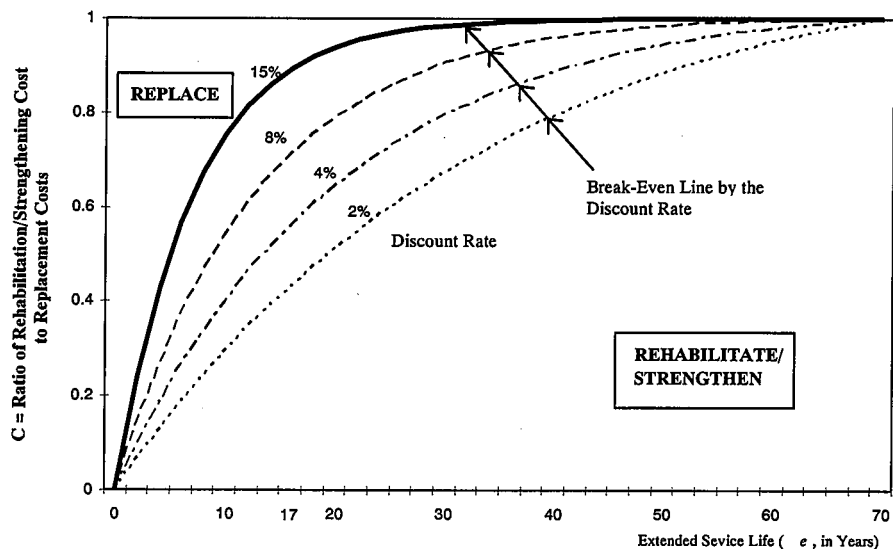
The parameter C with the discount rate is plotted in **Figure 9.3.2-5** versus the service life “e” extended through rehabilitation, assuming that SL (service life) of the superstructure equals to 67 which is calculated with formula (9.3.2-1).

If the point B/A plots below the lines which are the break-even line between replacement and rehabilitation options, the solution to rehabilitate is cost effective; if it falls above the lines, it is cost effective to replace.

Figure 9.3.2-5 Evaluation on Alternative Improvement Strategies

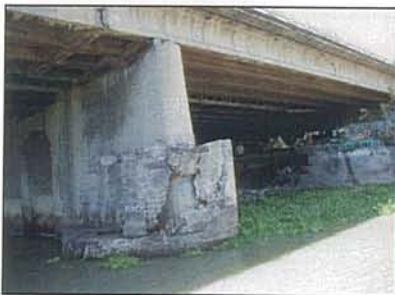
Picture 11.2.1-1 RC Fender Type Connected with Expanded Footing (Guadalupe Bridge)

- Expanded Footing : Jones Bridge, Nagtahan Bridge, Lambingan Bridge, Bambang Bridge, Vargas Bridge (Downstream Side), Rosario Bridge
- RC Fender Type Connected with Expanded Footing : Guadalupe Bridge
- RC Fender Type Independent from Footing : C-5 Bridge
- Wooden Fender Type Independent from Footing : Bambang Bridge

Pictures 11.1.2-1, 2 and 3 shows damages to typical pier protections.

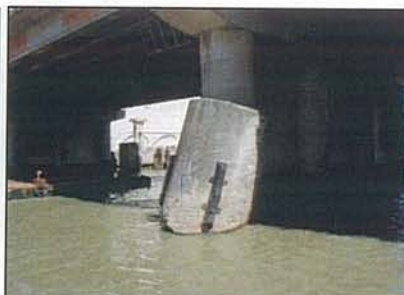
Picture 11.2.1-1 RC Fender Type (C-5 Bridge)

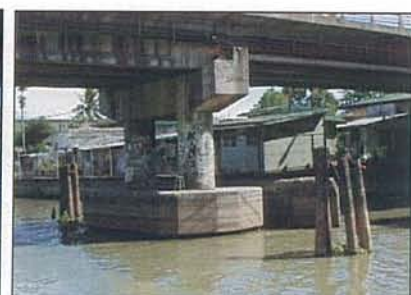
Picture 11.2.1-3 Expanded Footing and Wooden Fender Type

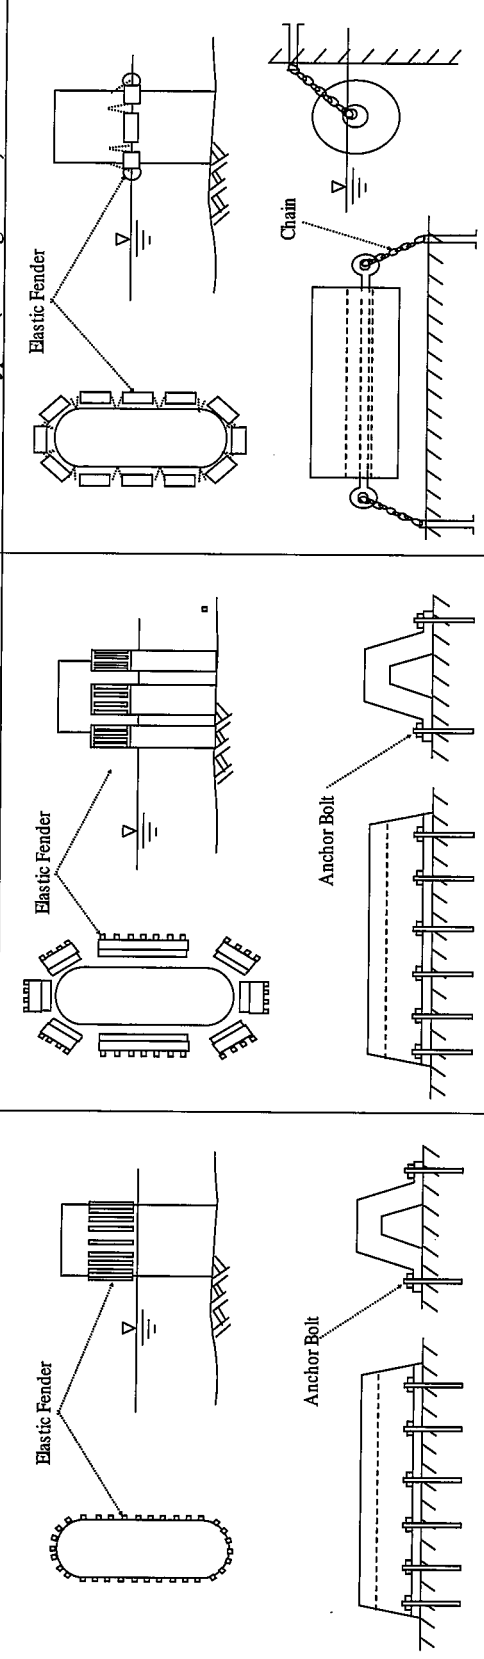
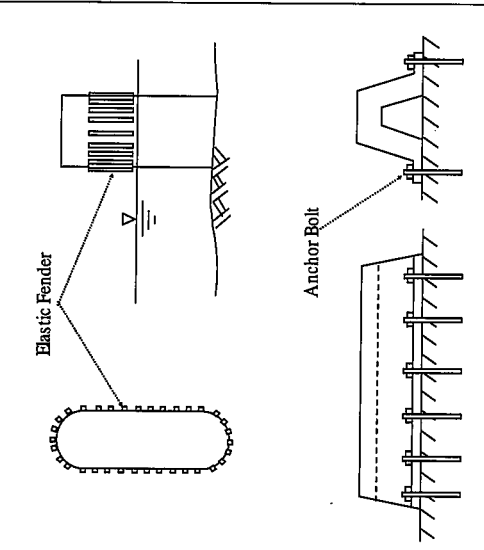
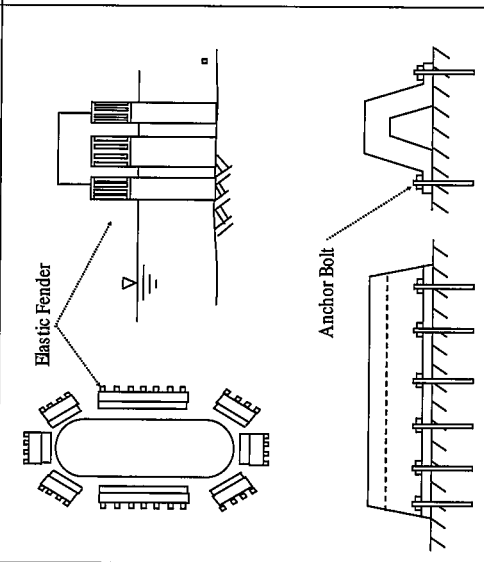
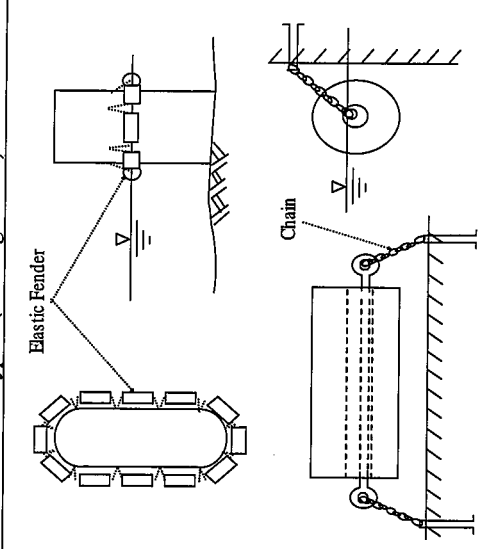
Table 11.4.2-1 Comparison of Protection Types of Pier

Fender Structure	Elastic fenders are attached to bridge pier/abutment by anchor bolts.	Independent Dolphin fenders are installed around pier/abutment	Floating fenders are attached to pier/abutment by chains.
Effect to the Bridge Structure	This type of fender has slightly less energy absorption than Type 3 because the fenders are attached directly to the bridge structure.	This type of fenders protects the bridge most effectively among the 3 types, because the fender structures are independent from the bridge structure.	This type has a slightly higher energy absorption properties than type 1, because the fenders are attached by chains.
Effect to the Vessel	Due to the same reason as above, it gives a slightly higher reaction to vessels than type-3	Based on actual PCG's experience, this type of fender was not immediately repaired and sometimes buried under water when damaged. The unrepaired fenders, especially buried ones, are quite dangerous to navigation. Due to this reason PCG does not recommend this type of fender.	Due to the same reason as above, it gives a slightly lower reactions to the vessel than type-1.

Effect to the River Flow	The effect to the river flow is negligible. However, its structure slightly disturb the river flow compared with Type 3, as it is fixed to piers/abutments.	This type of fender disturbs river flow and increases water level in case of flood.	The effect to the river flow is negligible.
Construction Cost	US\$50,000 per linear meter including installation	US\$100,000 per 50 linear meter including installation and foundation.	US\$50,000 per 50 linear meter including installation.
Maintenance	Replacement of damaged fenders/anchor bolts	Replacement of damaged fenders/anchor bolts and rehabilitation of the supporting structures.	Replacement of damaged fenders/chains.
Rating and Remarks	<p>2</p> <p>This type of fenders mitigates the impact of vessel collision and prevents major damages to pier/abutment. However, this type is slightly less effective to the collision impact and affects river hydraulics/navigation.</p>	<p>3</p> <p>This type of fender is the most effective for the protection of pier/abutment against vessel collision. However, this is not recommendable from the viewpoint of navigation and flood control. Besides, the cost of installation and maintenance is the highest among the three (3) types.</p>	<p>1</p> <p>This Type is recommendable, because this type is most effective to collision impact and slightly affects river hydraulics/navigation.</p>

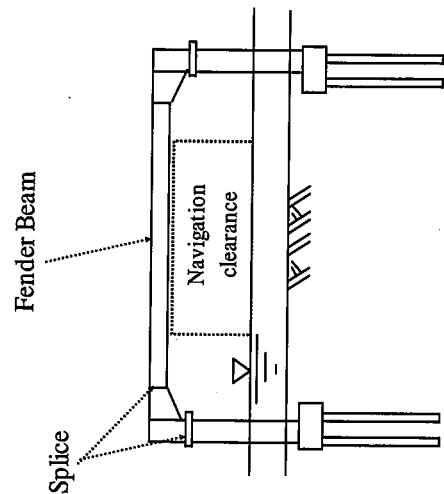
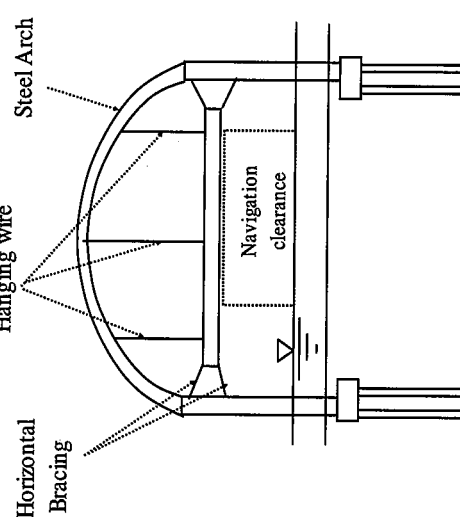
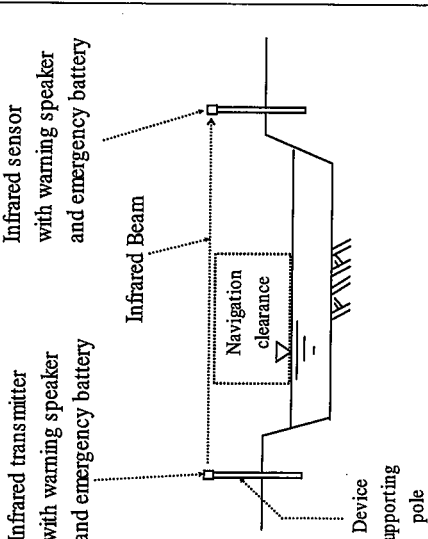
Table 11.4.2-2 Comparison of Protection Types for Bridge Girder

Structure / Effect	<p>Structure: Two steel columns support a fender beam. The beam is connected by splices as to minimize damage on vessels.</p> <p>Effects: This type of fender has strong impact on vessel. Possibility of inflicting damage to vessels is slightly higher than Type 2. This system can partially absorb collision impact of accidentally drifting vessels.</p>	<p>Structure: Two steel columns support a steel arch. The columns and arch support a fender beam with wires to minimize damage to vessels.</p> <p>Effects: This type of fender has strong impact on vessels. Possibility of inflicting damage to vessels is slightly lower than Type 1. This system can partially absorb collision impact of accidentally drifting vessels.</p>	<p>Structure: The transmitter and sensors are supported by supporting poles on the river banks. The speaker automatically gives warning against vessels having illegal height.</p> <p>Effects: There is no possibility to inflict damage to vessel. However, this system cannot prevent collision in case of accidentally drifting vessels during typhoon. The speaker automatically works when the sensor detects an illegally navigating vessel.</p>

Appearance	Impair Landscape	Impair Landscape	Not Impair
Cost	5.5MP per frame	6.5MP per frame	1.2MP per whole system
Maintenance	Repair works needed after collision	Repair works needed after collision	Routine system maintenance (including electricity)
Rating	2	3	1 (Recommendable)
