CHAPTER 14

COMPARATIVE STUDY ON IMPROVEMENT MEASURES

14.1 POLICY FOR IMPROVEMENT

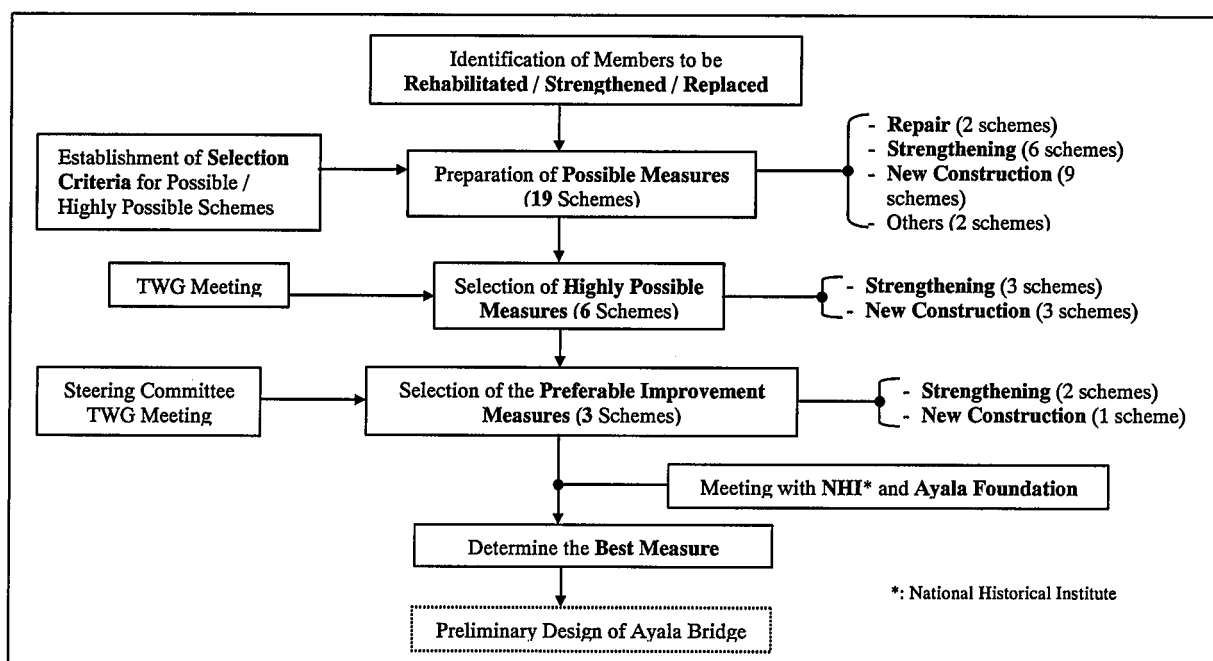
Figure 14.1.1-1 Flow Chart on the Best Improvement Scheme

The best scheme of the improvement measures for Ayala Bridge was selected and recommended following the process as shown in **Figure 14.1.1-1**.

The reasons for having taken the process above are as follows:

- To propose as many schemes as possible in order to reflect various opinions and ideas in the improvement schemes.
- To make balance among engineering, economic and historical aspects, because the Ayala Bridge has been listed as an important historical structure by NHI.

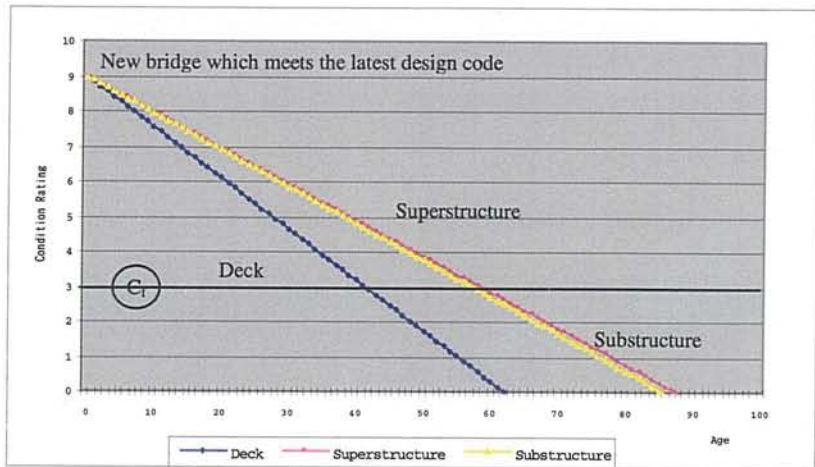
Figure 14.3.2-1 Deterioration Curve by Transportation System Center (TSC)

As mentioned in **Chapter 9.3**, the Transportation Systems Center (TSC) Deterioration Study in USA has developed empirical equation of bridge deterioration relating deck, superstructure and substructure condition rating.

Using the equation of bridge condition rating described in **Chapter 9.3**, the developed model for standard deterioration curves of deck-superstructure and substructure can be illustrated in **Figure 14.3.2-1**.

Taking into consideration the bridge condition in the Study Area, the service life of the bridge can be estimated if the Level 2 of condition rating is assumed to be acceptable level.

In this Study, Level 2 was regarded as the unacceptable level (C_f) considering the present situation of this country as described in Section 9.3.2.

Deck: 58 years, Superstructure 67 years, Substructure 87 years

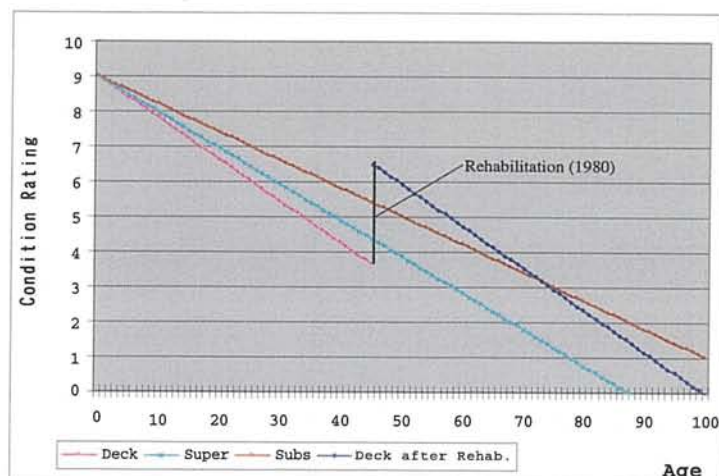
Figure 14.3.2-2 Deterioration Curve of the Ayala Bridge

Taking into account the bridge condition survey in this study, the bridge deterioration model mentioned above can be generally applied to the Ayala Bridge. The equation adopted is as follows:

Substructure = $9 - 0.08 \times (\text{AGE})$

According to the historical records of rehabilitation, the rehabilitation for the deck was implemented during 1980's. So the deterioration curve of the Ayala Bridge can be illustrated in Figure 14.3.2-2.

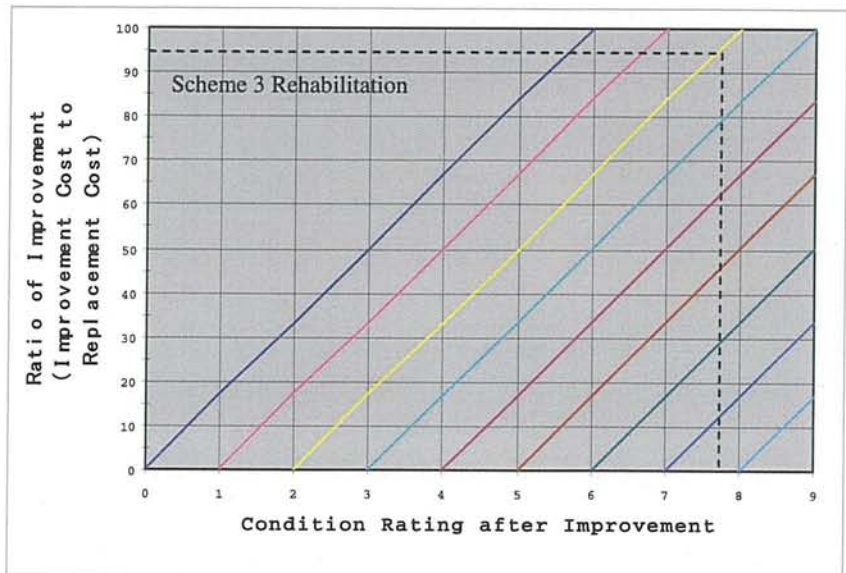
Figure 14.3.5-1 Relationship between Investment Cost and Improvement of Condition Rating

The relationship between improvement cost of the Ayala Bridge and improvement of condition rating is illustrated in Figure 14.3.5-1. If the improvement cost is invested to the Ayala Bridge, it is expected to extend the service life of the bridge, as shown in Figure 14.3.5-2. The results

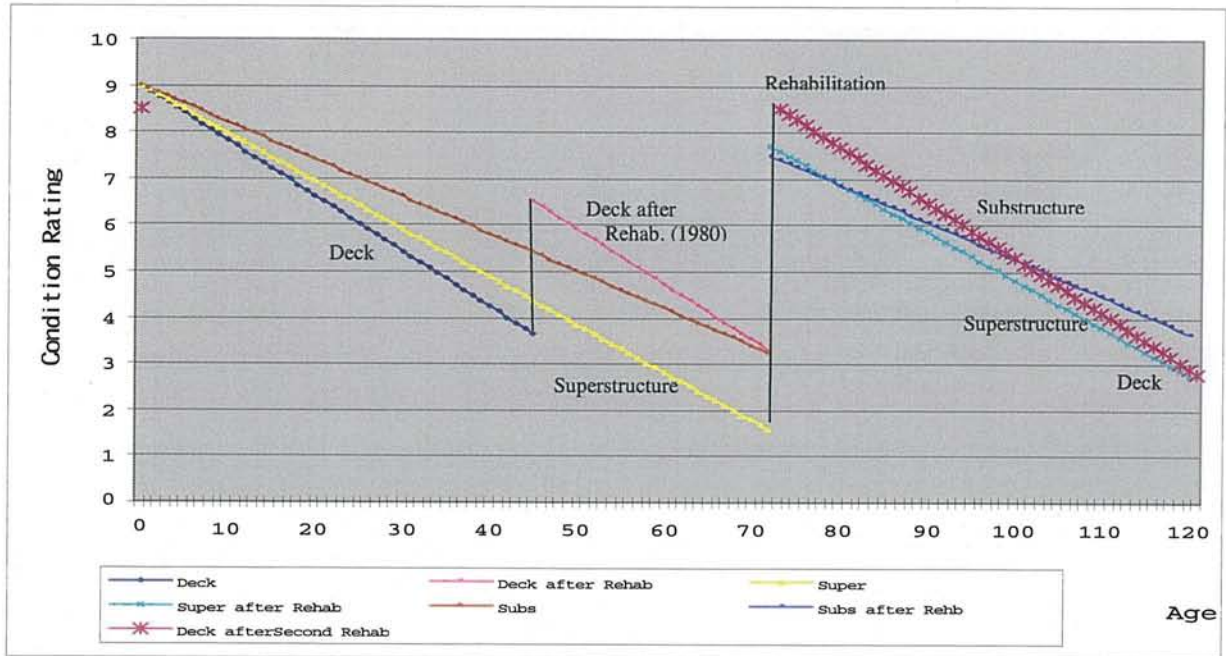
Figure 14.3.5-2 Deterioration Curve after Implementing Scheme S3

of extended service life of the improved bridge are shown in Table 14.3.5-3.

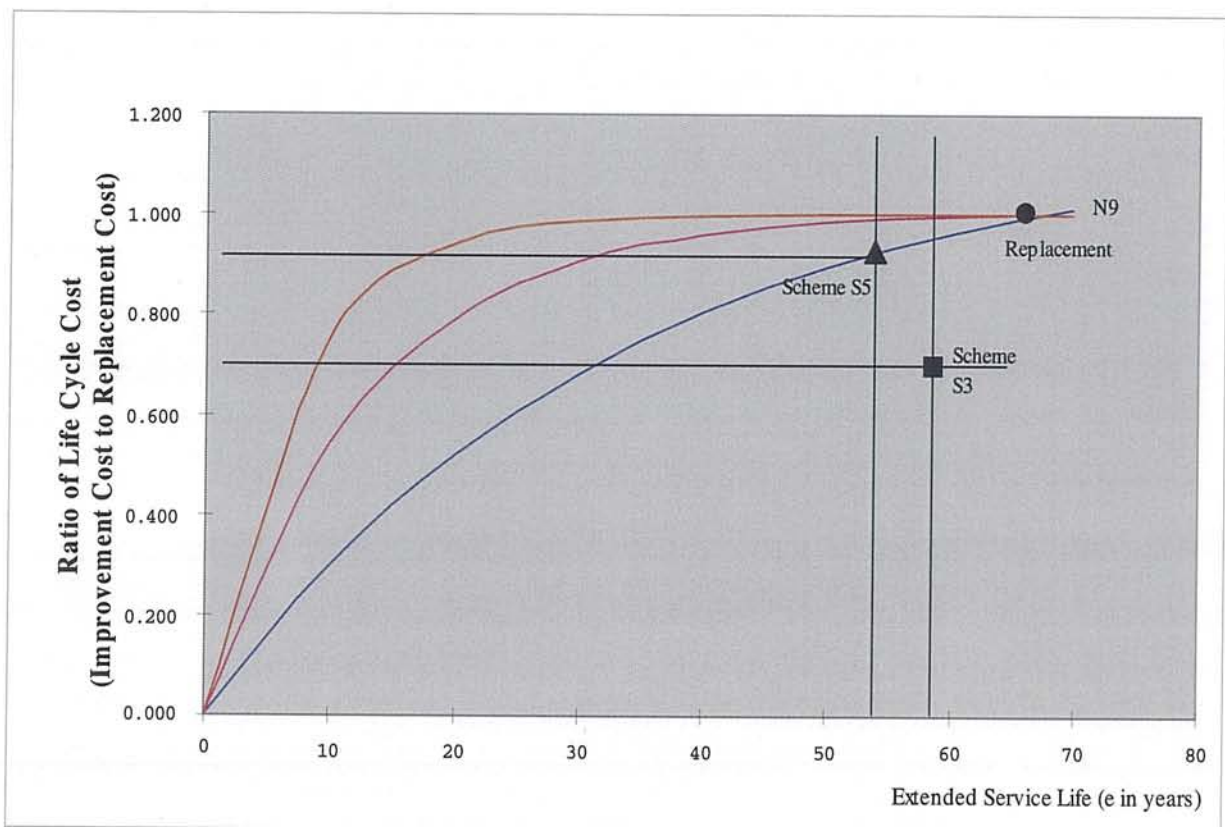
Figure 14.3.6-1 Life Cycle Cost Evaluation on Alternative Improvement Scheme for the Ayala Bridge

Figure 14.3.6-1 shows the life cycle cost evaluation of the Ayala Bridge.

As revealed in **Table 14.3.6-1** and **Figure 14.3.6-1**, the Scheme S3 is the most cost effective scheme among the alternative schemes.
