A9.3 GEOTECHNICAL INVESTIGATION

The Improvement of Sewerage and drainage System
For The Havana Bay In The Republic of Cuba

GEOTECHNICAL INVESTIGATION

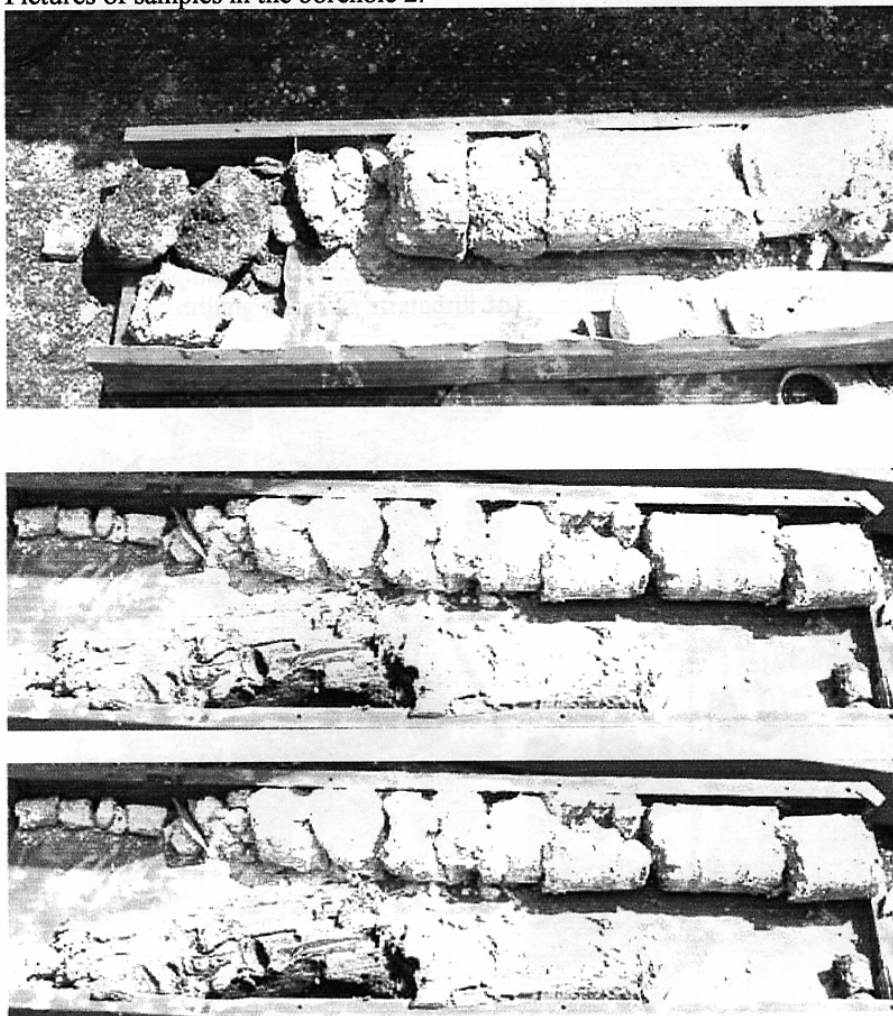
Fotos del muestreo en la cala 2.
Pictures of samples in the borehole 2.

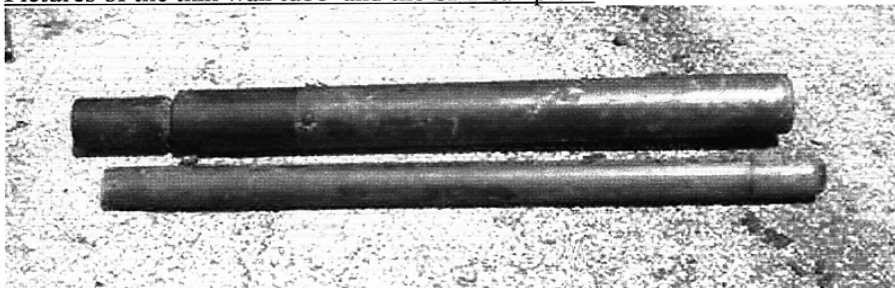
Fotos del muestrador de paredes finas y la cuchara o muestrador de tubo dividido.
Pictures of the thin wall tube and the SPT samplers.

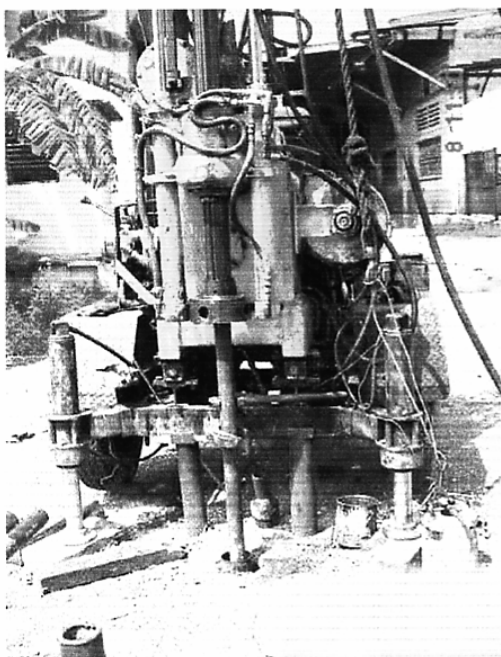
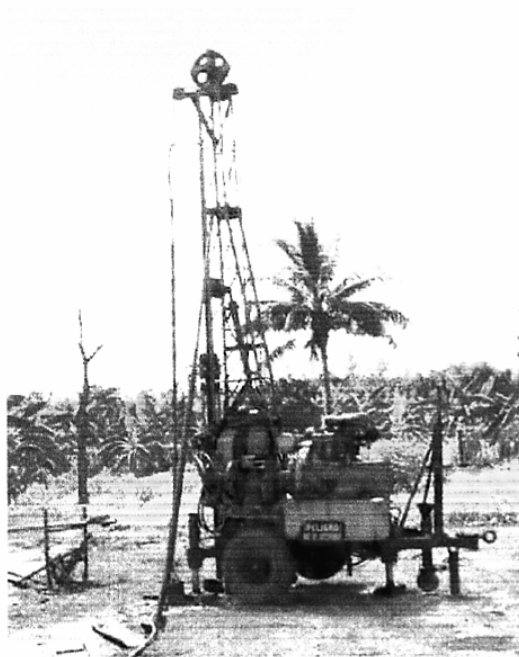
Fotos de la máquina perforadora empleada (Stratadrill 36)
Pictures of the drilling machine (Stratadrill 36)
