**THE STUDY
ON
MEKONG RIVERBANK PROTECTION AROUND
VIENTIANE MUNICIPALITY
IN
THE LAO PEOPLE'S DEMOCRATIC REPUBLIC**

**FINAL REPORT
VOLUME 4
SUPPORTING REPORT**

**NIKKEN Consultants, Inc.
NEWJEC Inc.**

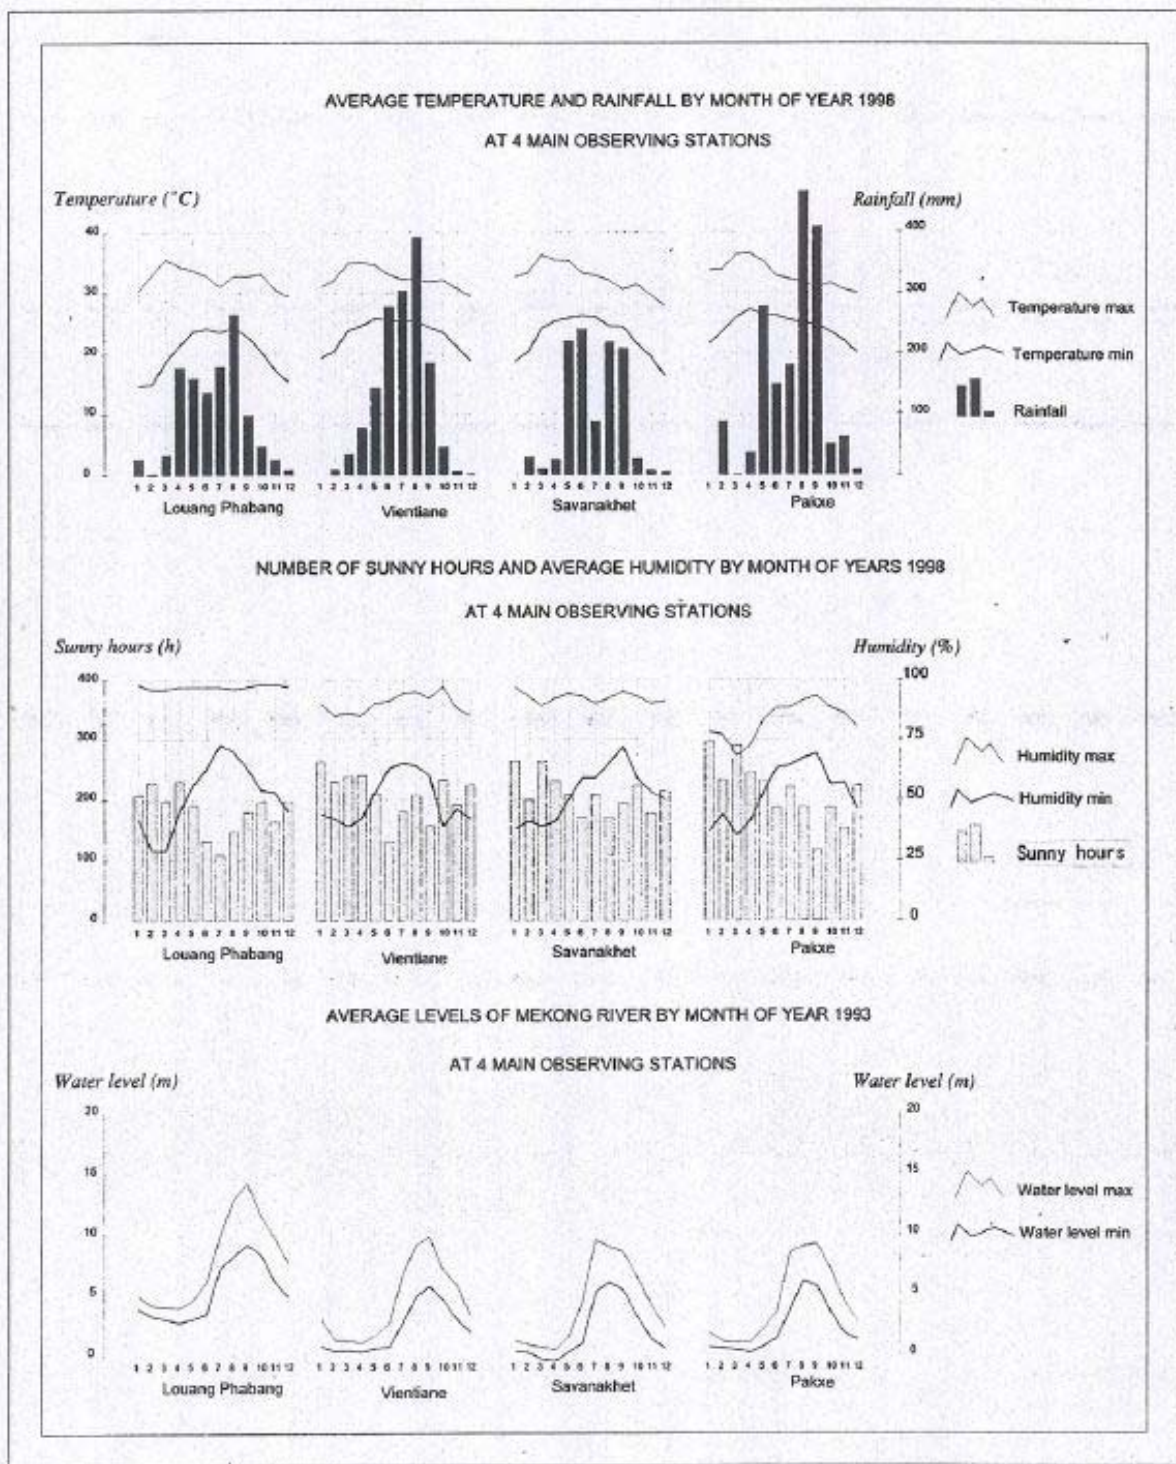
Figure 1.2 Hydro Meteorological Condition at 4 Main Observing Stations

The monthly maximum and minimum temperature, monthly rainfall, the monthly maximum and minimum humidity with monthly amount of sunny hours at the 4 main observing stations in 1998 are shown in Figure 1.2. The monthly maximum and minimum water level of Mekong River at the 4 main observing stations in 1993 are described in parallel in this figure. At Vientiane, the monthly maximum temperature exceeds 30°C, and the minimum temperature exceeds 20°C excluding in December.

The rainfall shows the tendency to concentrate from May to September. The monthly maximum and minimum humidity show the same tendency as the monthly rainfall, but monthly sunny hours show the tendency opposite to those data. The change in the monthly maximum water level of each observing station has the tendency which shifts by one month delay of the monthly rainfall.

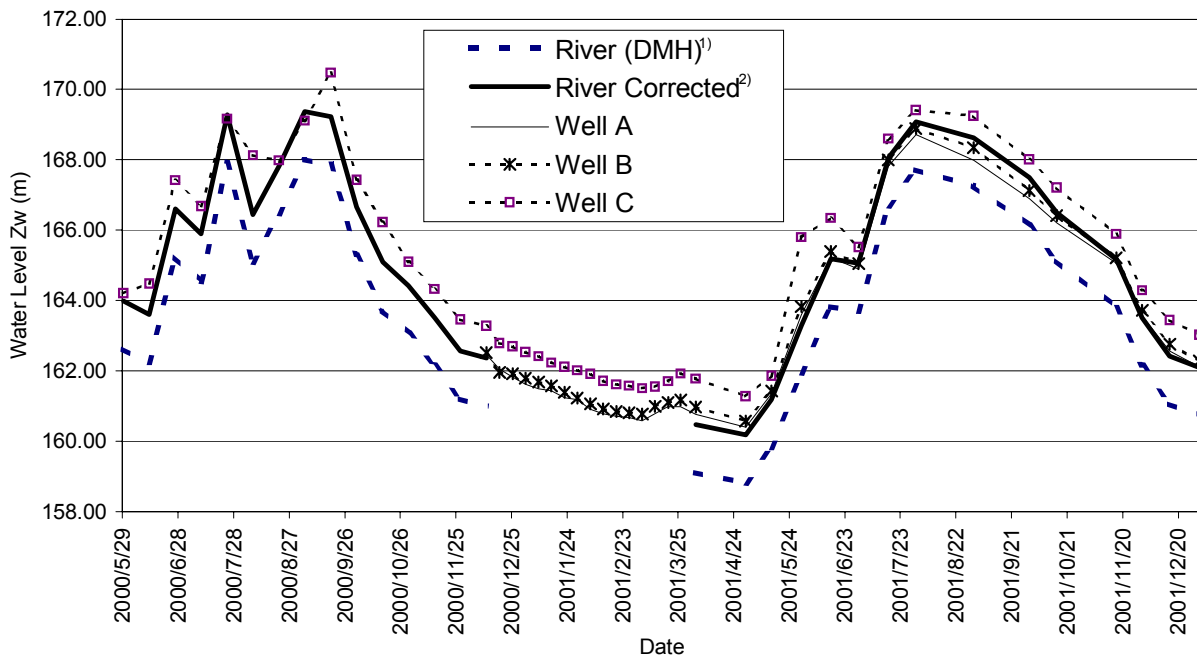
Figure 1.9 River Water and Groundwater Level Variation

The location map and results of the measurement of Mekong River water level and groundwater level at Wat Sibounheuang in Vientiane are shown in Figures 1.8 and 1.9 according to the monitoring report made by Infrastructure Development Institute - Japan.

The groundwater level strongly depends on the water level of Mekong River. It is thought that the coefficient of permeability of the ground in this district is comparatively large so that high pore water pressure is not generated. It is necessary to investigate more to discuss the situation of the whole area of the investigation object region.

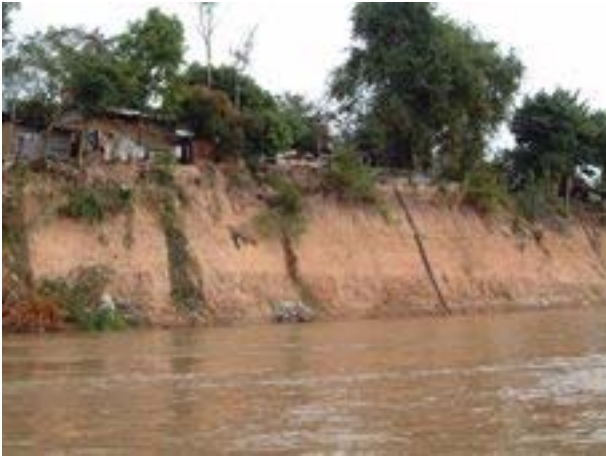
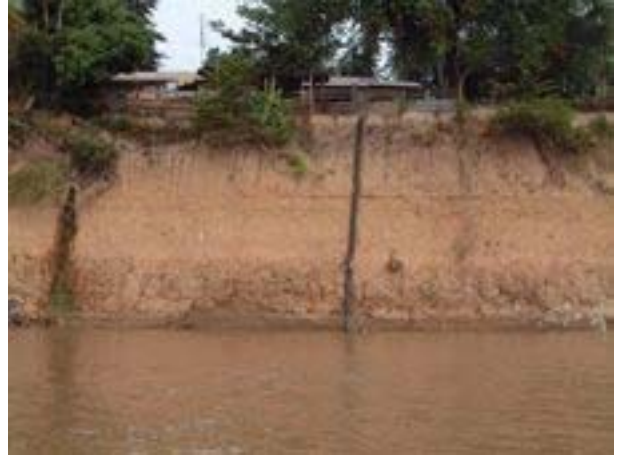
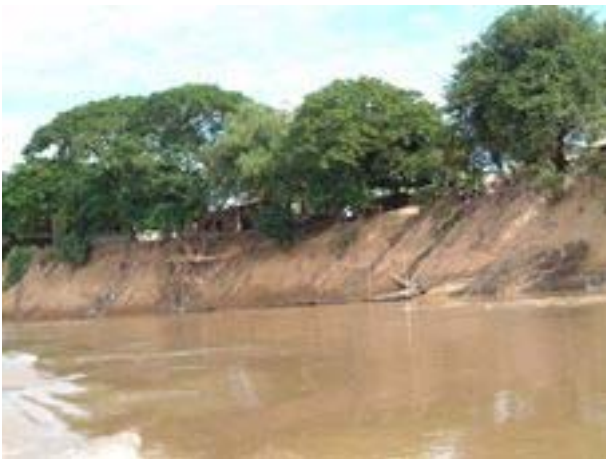
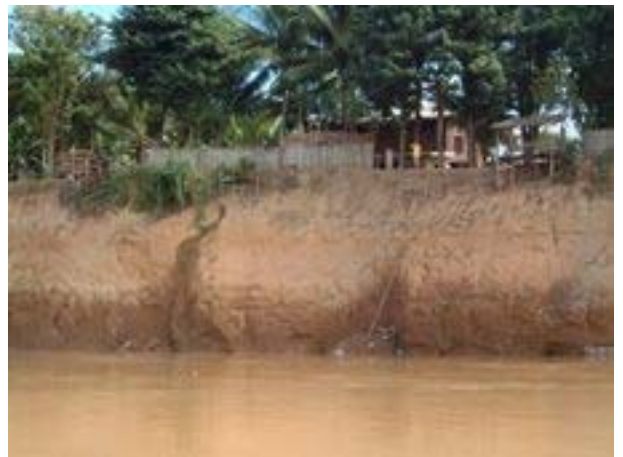
Downstream of Sibounheuang Site
(around KM1588)

(Close-up of Riverbank Cliff)

Near Boo Site (around KM1574)

Figure 2.4 (1/2) Photos of Vertical Riverbank Cliffs

The riverbanks severely eroded in the Study Area forms vertical cliffs mostly. Photos of typical vertical cliffs are shown in Figure 2.4. According to the IDI Report of Test Works for Bank Protection (March 2000), the geological formation of riverbank generally consists of sandy gravel layer covered with of 6 m to 8 m deep clayey soil on the top as shown in Figure 2.5. The conditions of riverbank and layers are similar for the whole reaches of the Study Area. These bank materials are not consolidated and easily be eroded.

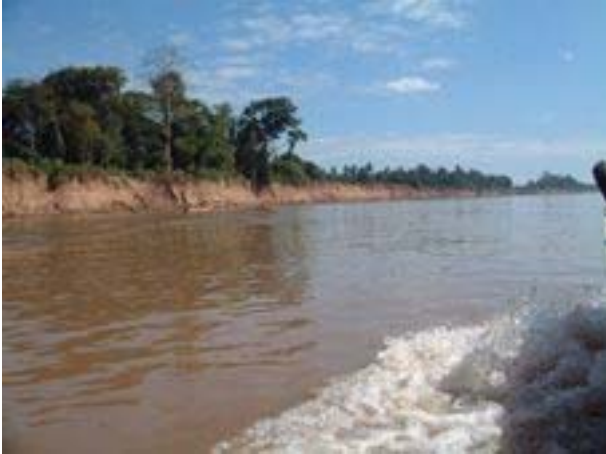
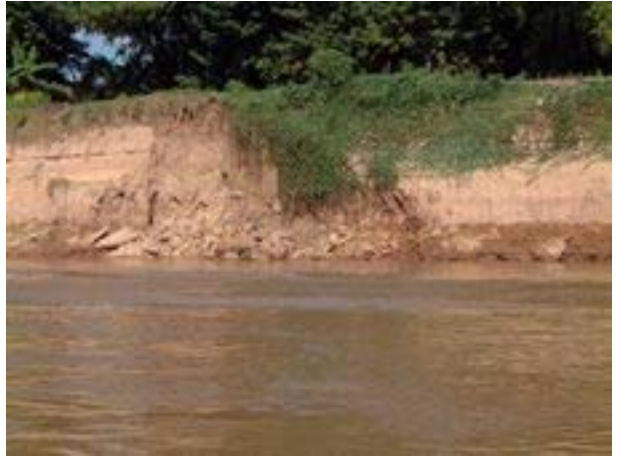
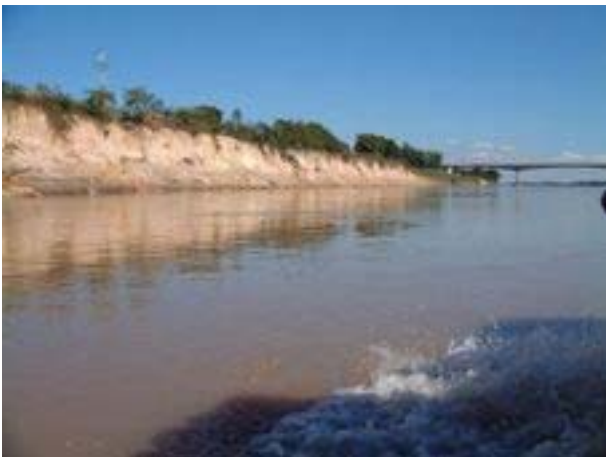
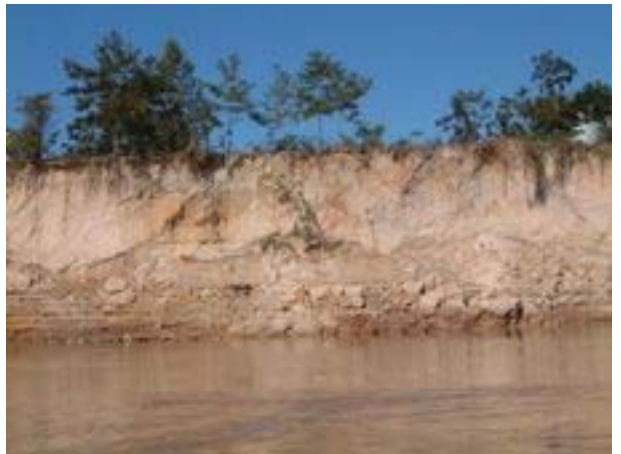
Near Ban Hom Site (around KM1565)

(Close-up of Riverbank Cliff)

Near Ban Dongphosi Site (around KM1551)

Figure 2.4 (2/2) Photos of Vertical Riverbank Cliffs

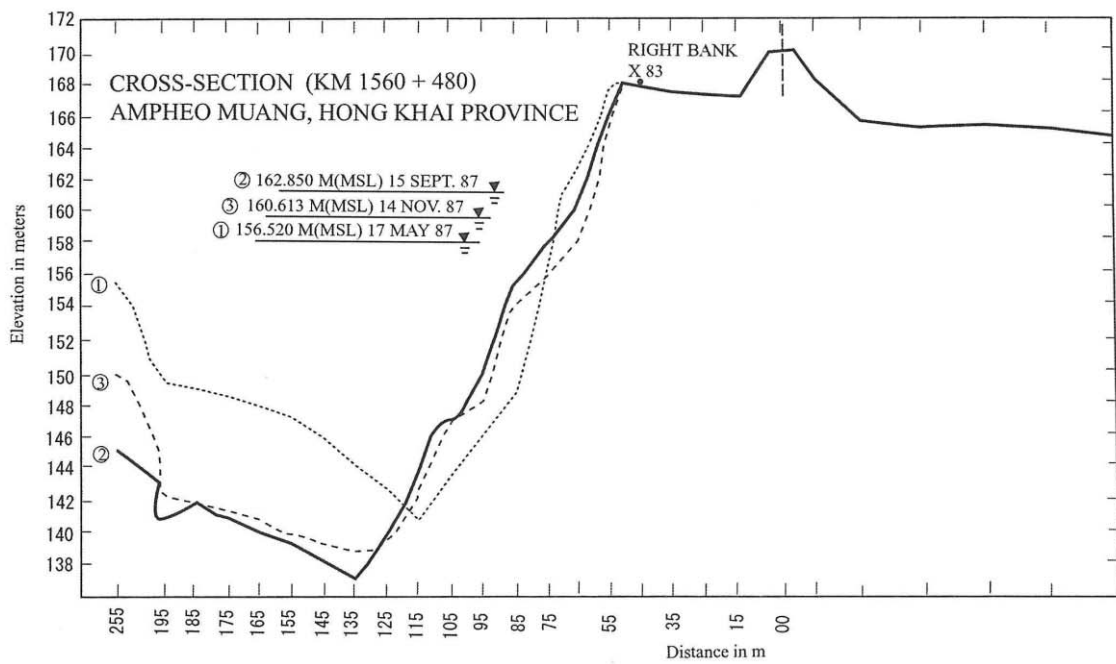
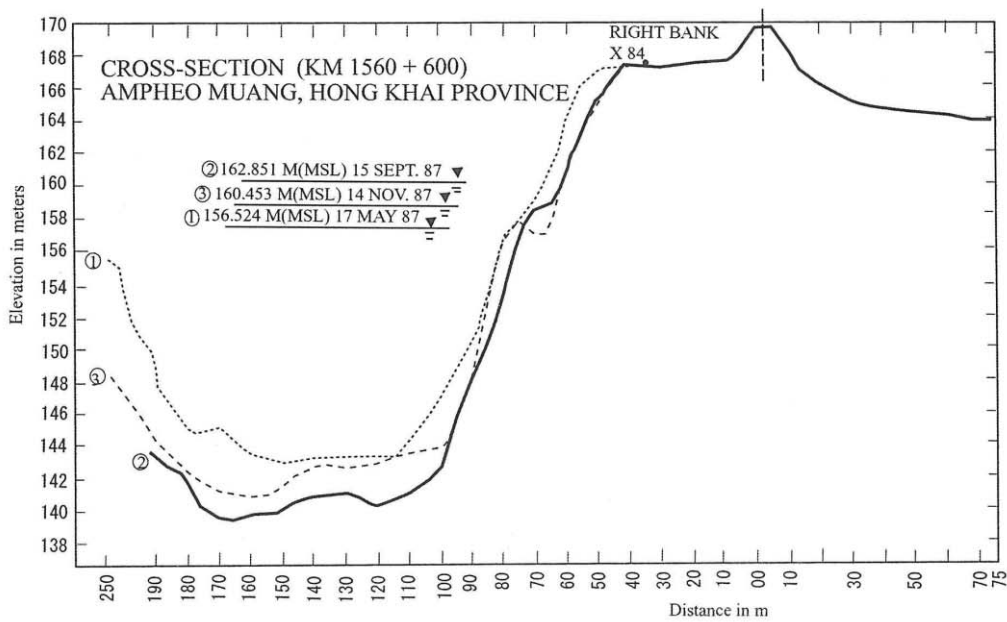
Figure 2.8 Changes in Riverbed throughout a Flood Season

River sections surveyed in different time of a year are shown in Figure 2.8, excerpting from “Completion Report for Pilot Project Stage I of Mekong River Bank Protection (Basin-Wide: May 1988)”. These are the riverbank sections surveyed at three sections in May (dry season), September (flood season), and November (end of flood season) in 1987. It is noted that the lowest riverbeds in dry season are deepened around 4 m in flood season.

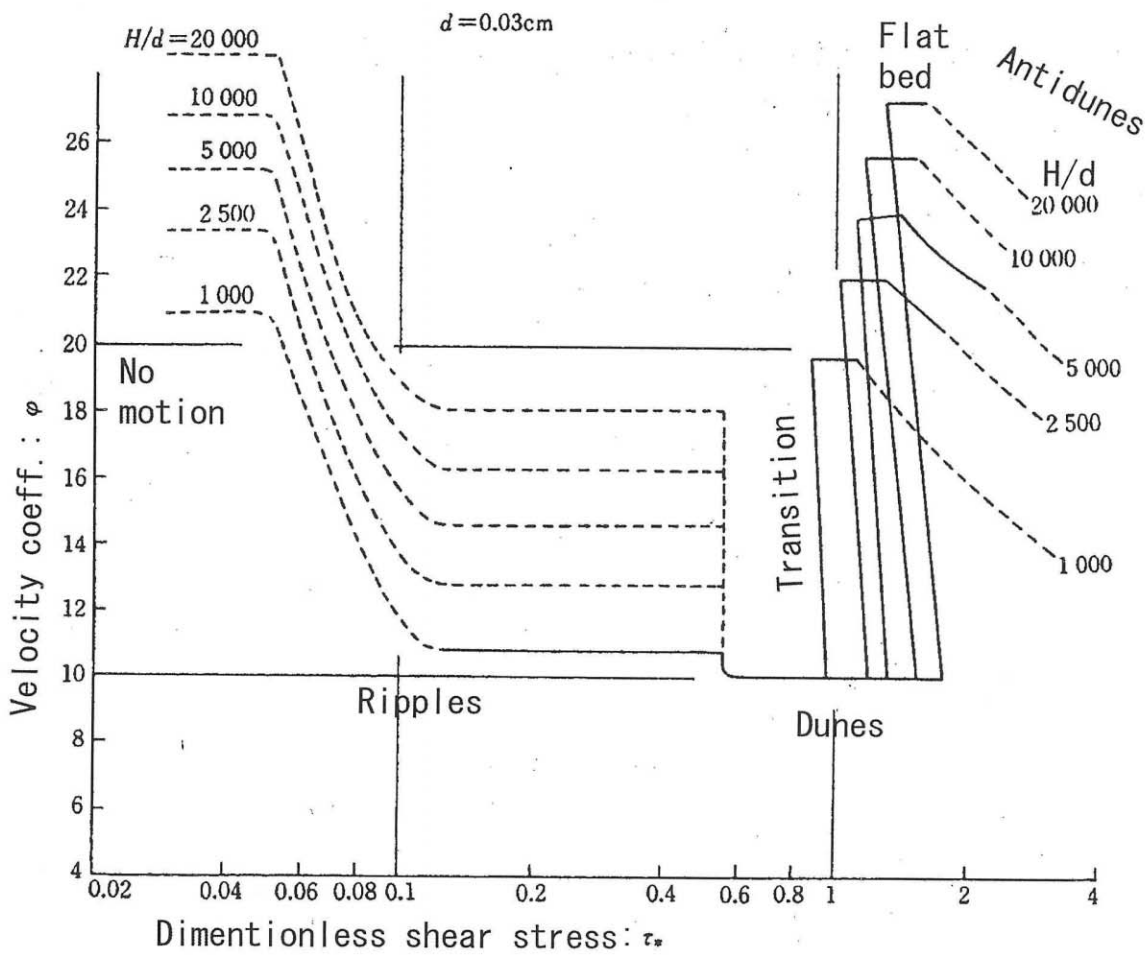
Figure 2.11 Riverbed Form and Resistance to Flow

Sediment flow conditions: Applying the parameters to the empirical relationships (refer to

Figures 2.10 and 2.11), sediment flow conditions under bankful flow and frequent flood flow conditions were estimated as follows:
