RIVERBANK PROTECTION MASTER PLAN

**THE STUDY ON MEKONG RIVERBANK PROTECTION
AROUND VIENTIANE MUNICIPALITY
IN THE LAO PEOPLE'S DEMOCRATIC REPUBLIC**

**FINAL REPORT
VOLUME 4
-SUPPORTING REPORT-**

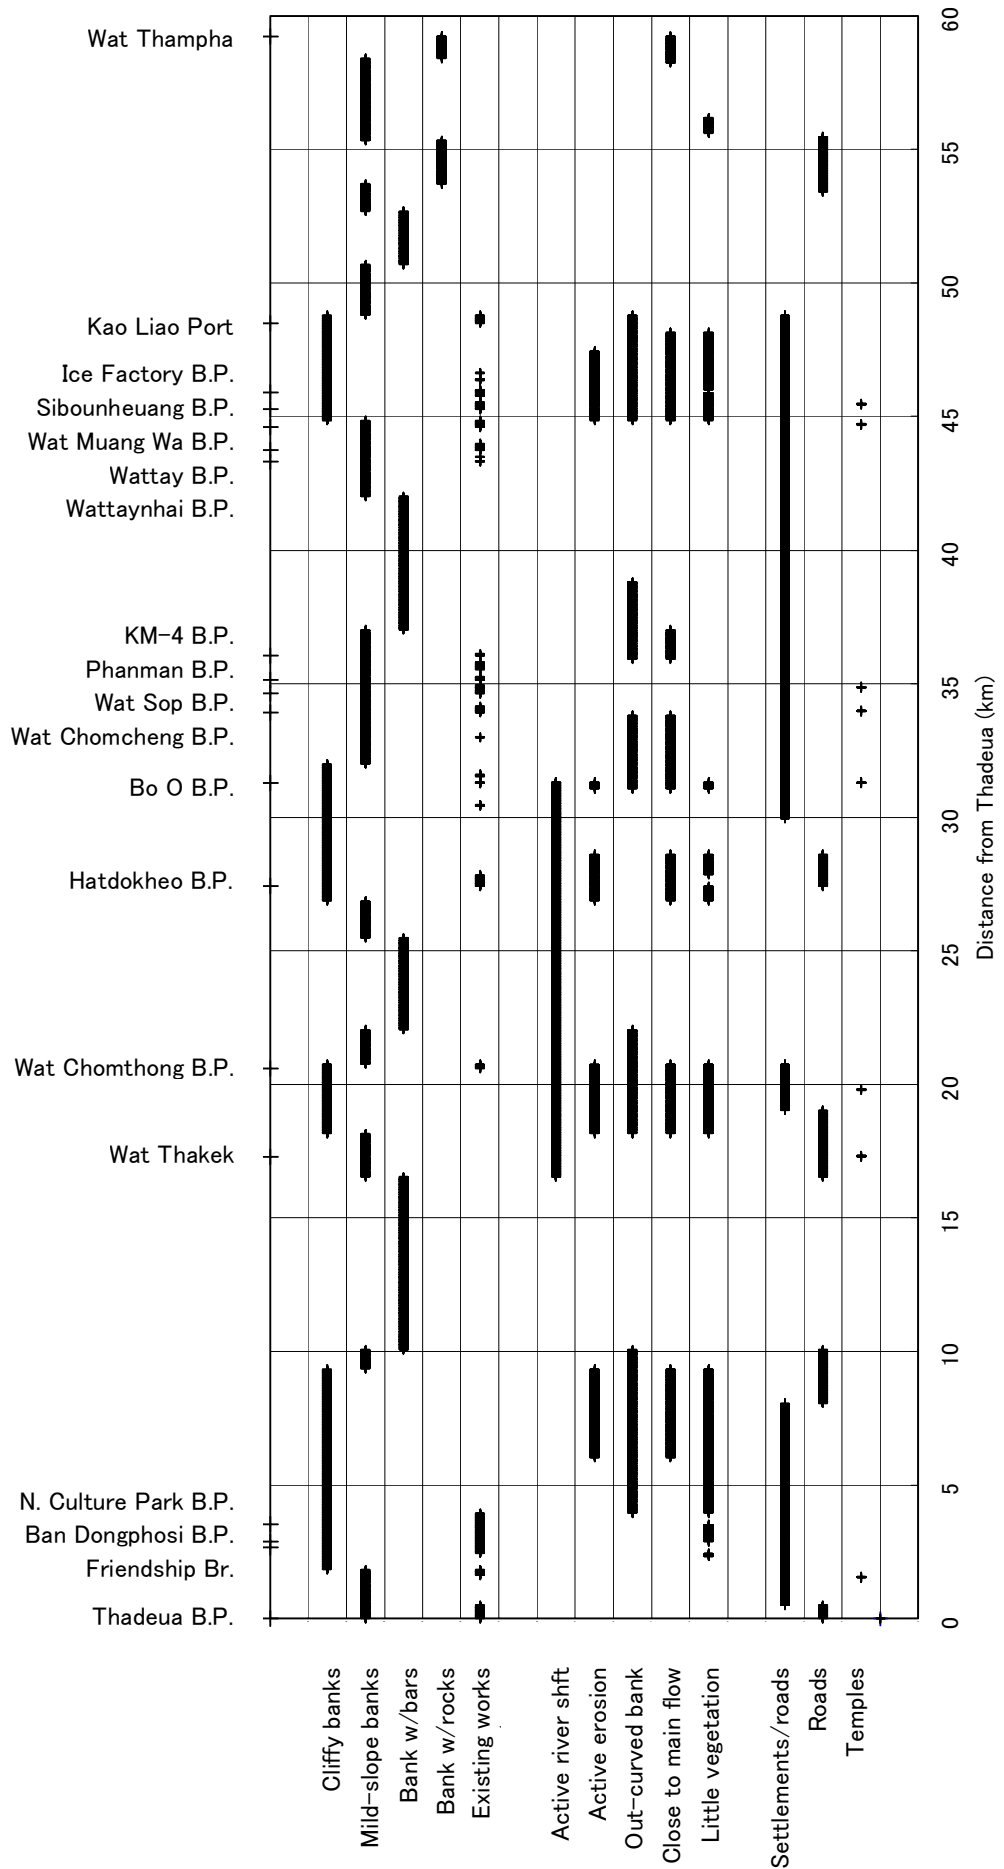
Figure 3.1 Summary of Riverbank Conditions

Figure 3.1 is the summary of riverbank conditions evaluated for the items mentioned above, and the location of KM-posts and other major objects are shown more specifically in figure 3.2. The distributions of types of riverbank are also shown in the figure. Table 3.2 is a summary table of existing bank protection works. Locations of the existing works were measured at field by a portable GPS-set.
