**JAPAN INTERNATIONAL COOPERATION AGENCY (JICA)**

**WATER AND SEWAGE COMPANY OF KERMAN (WSCK)**

# **THE STUDY ON RECONSTRUCTION PLAN FOR BAM WATER SUPPLY SYSTEM**

## **FINAL REPORT**

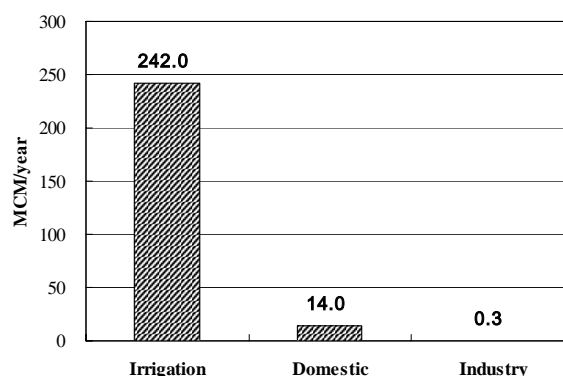
**Figure 3.1 Water Consumption**

As the precious resource, groundwater has been extracted by the qanats and wells, and has been utilized for irrigation, domestic and industrial purposes. The total discharge amount is estimated to be 256.3 MCM per year as minimum. The consumption of each water use is shown in Figure 3.1. Most of groundwater extracted, i.e. 94.4%, was consumed in irrigation purpose. For the irrigation purpose, the amount of 141 MCM of groundwater is extracted from qanats and the amount of 101 MCM of groundwater is extracted from wells. For the domestic and industrial use, the groundwater is extracted only from wells.

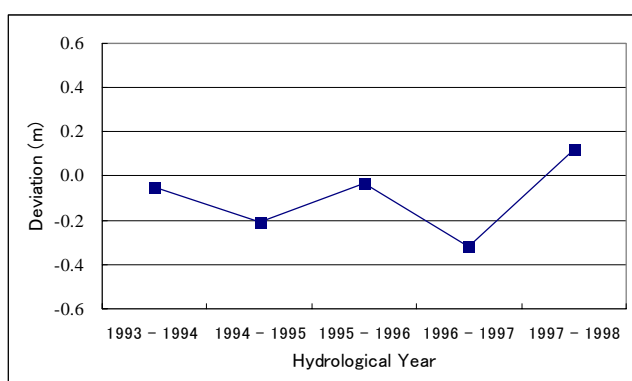
Figure 3.7 Groundwater Level Deviation of Each Hydrological Year

No matter the groundwater-rich condition Bam and Baravat surrounding area, a tendency of lowering groundwater level has been observed during recent drought. This means water balance of the study area is a minus value. For example, Figure 3.7 shows a deviation of monthly average groundwater level at the beginning of each hydrological year. The lowering is not always clear from each datum, but the tendency can be read despite the observation period of the data being before recent drought. There are a lot of qanats for irrigation in Bam and Baravat surrounding area, and their amount of discharge is significantly affected by groundwater level. Therefore, the groundwater use under strict watershed management is essential to

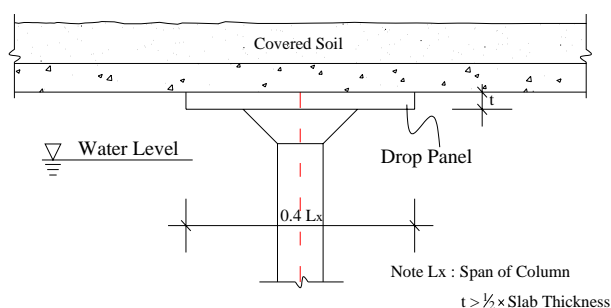
Figure 5.1 Flat Slab with Drop Panel for Water Reservoir

According to the collective typical drawings on ground type water reservoir published by MPO, top slab is supported by columns directly. In this case big shear force acts on the top slab at columns. Flat slab with drop panel for water reservoir is recommended as shown below.

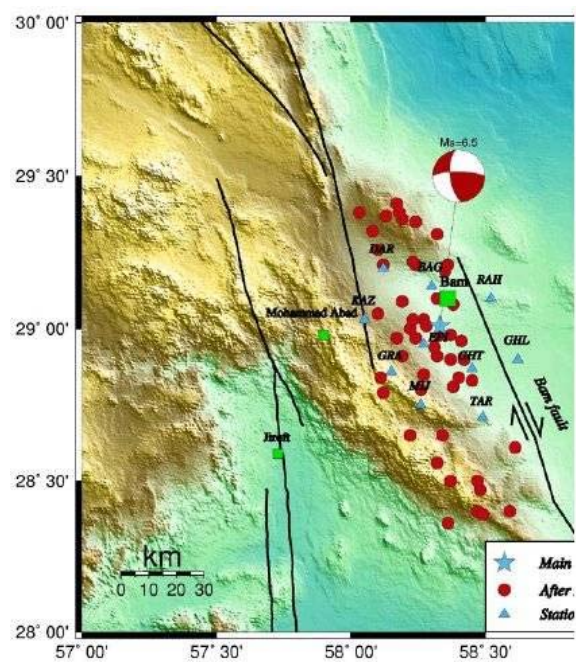
Figure 1.2.2 Bam Fault and Epicenter

The report of IIEES is shown in Figure 1.2.1 regarding the epicenter and focal mechanism of the earthquake, and that of USGS is shown in Figure 1.2.2. Figure 1.2.3 shows the distribution of fault-slip estimated using the inversion analysis by Yuji Yagi. The analysis of stress change on the fault plane due to fault slip done by Yagi is also shown in Figure 1.2.4.

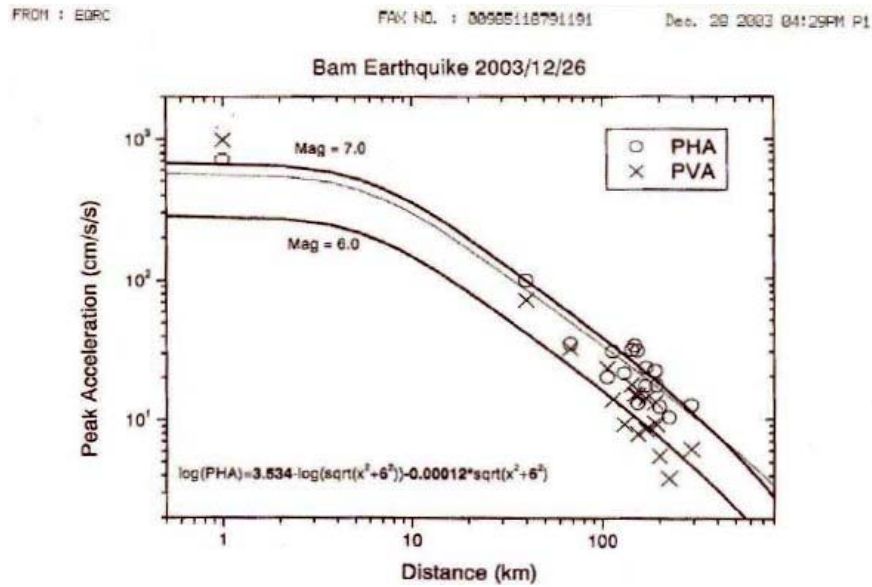
Figure 1.2.5 Attenuation Curve

The largest value for horizontal peak ground acceleration is recorded at No.1 site, which is shown in Table 1.2.1. No.1 site is located at 14 km from the epicenter and it recorded 799.06gal. Attenuation curve is summarized in Figure 1.2.5. Figure 1.2.6 shows the distribution of the macro seismic intensity of the earthquake analyzed by IIEES.

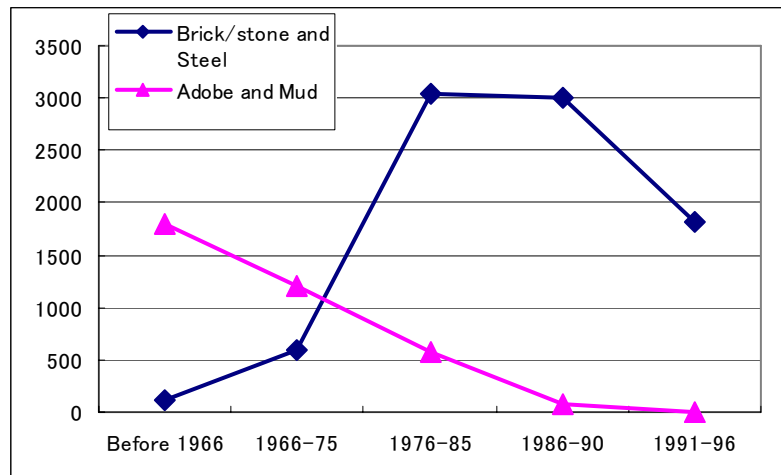
**Figure 1.2.7 Residential Buildings Categorized by Year Build and Structure Type**

Figure 1.2.7 shows the trend of typical structure and material of residential buildings over the decades. As it shows, the combination of adobe and mud used for residential buildings has decreased significantly over the years, and since 1986 it has not been used as much as before. Brick/stone and steel has taken the place of adobe and mud significantly since 1966 and has become the core structural material for building residential housings.
