## E.4.4 DRAINAGE CHANNELS

### (1) Drainage Network

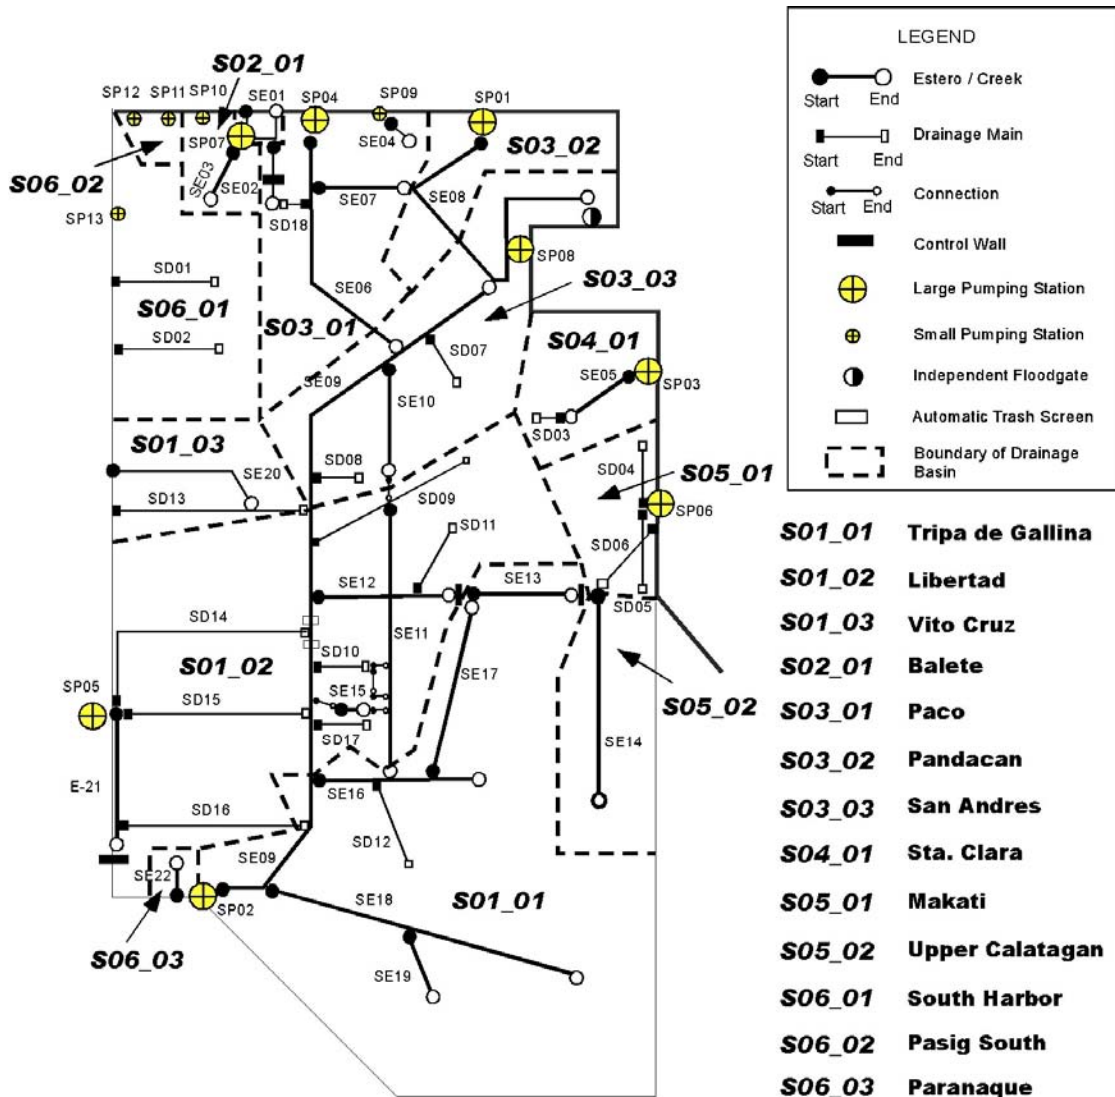
**Figure E.4.12 Schematic Diagram of Drainage Network in South Manila**

Note: The boundary between S01\_01 and S01\_02 is quite unclear. The stormwater collected through SE13, SE17, SE16, SD12 may be drained by SP05(Libertad Pumping Station).

Numerous drainage channels exist in the study area, and those connections are very complicated. In the present study, totally 74 km in length for esteros/creeks and 35 km in length for drainage mains have been identified based upon the results of previous studies, especially SEDLMM (2000), and the drainage inventory and maps provided by MMDA. The fieldworks have been also conducted to confirm those connections by the Study Team with the help of MMDA. The results have been summarized as schematic diagram of existing drainage network for the North Manila and South Manila as shown in *Figures E.4.11* and *E.4.12*, respectively. The figures also show the definition of the start and end points of each estero/creek and drainage main. Drainage channels have been further divided to channel sections as shown in *Figure E.4.13*.
