E.5 DRAINAGE IMPROVEMENT PLAN

E.5.1 BASIC CONCEPT AND CONDITIONS FOR FORMULATING DRAINAGE IMPROVEMENT PLAN

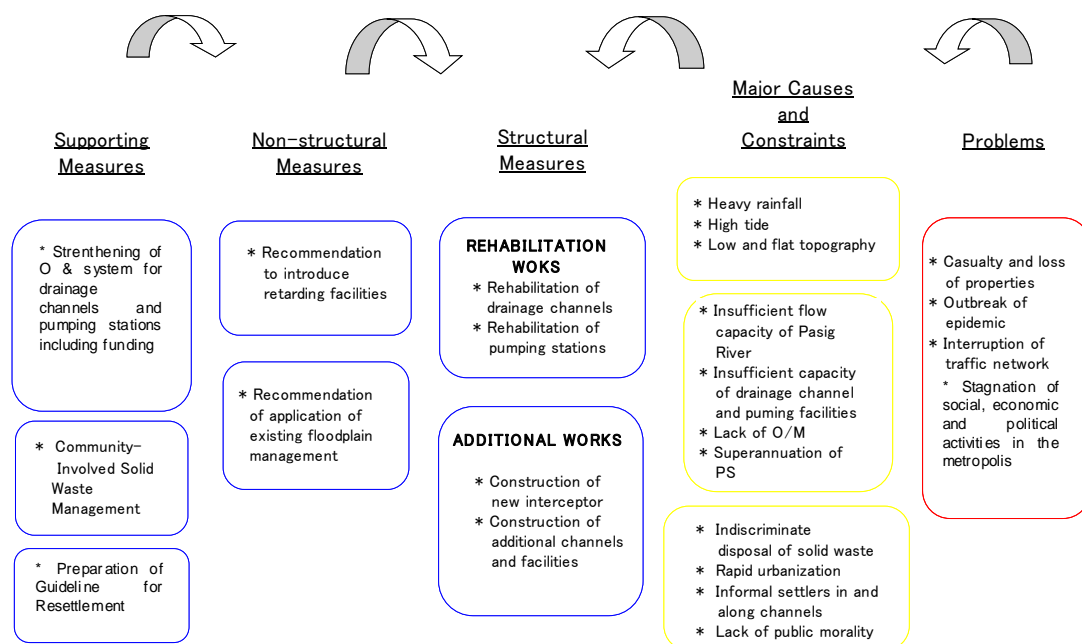
Figure E.5.1 Measures of Drainage Improvement

Figure E.5.1 shows the relationship among the three measures in the drainage improvement plan.

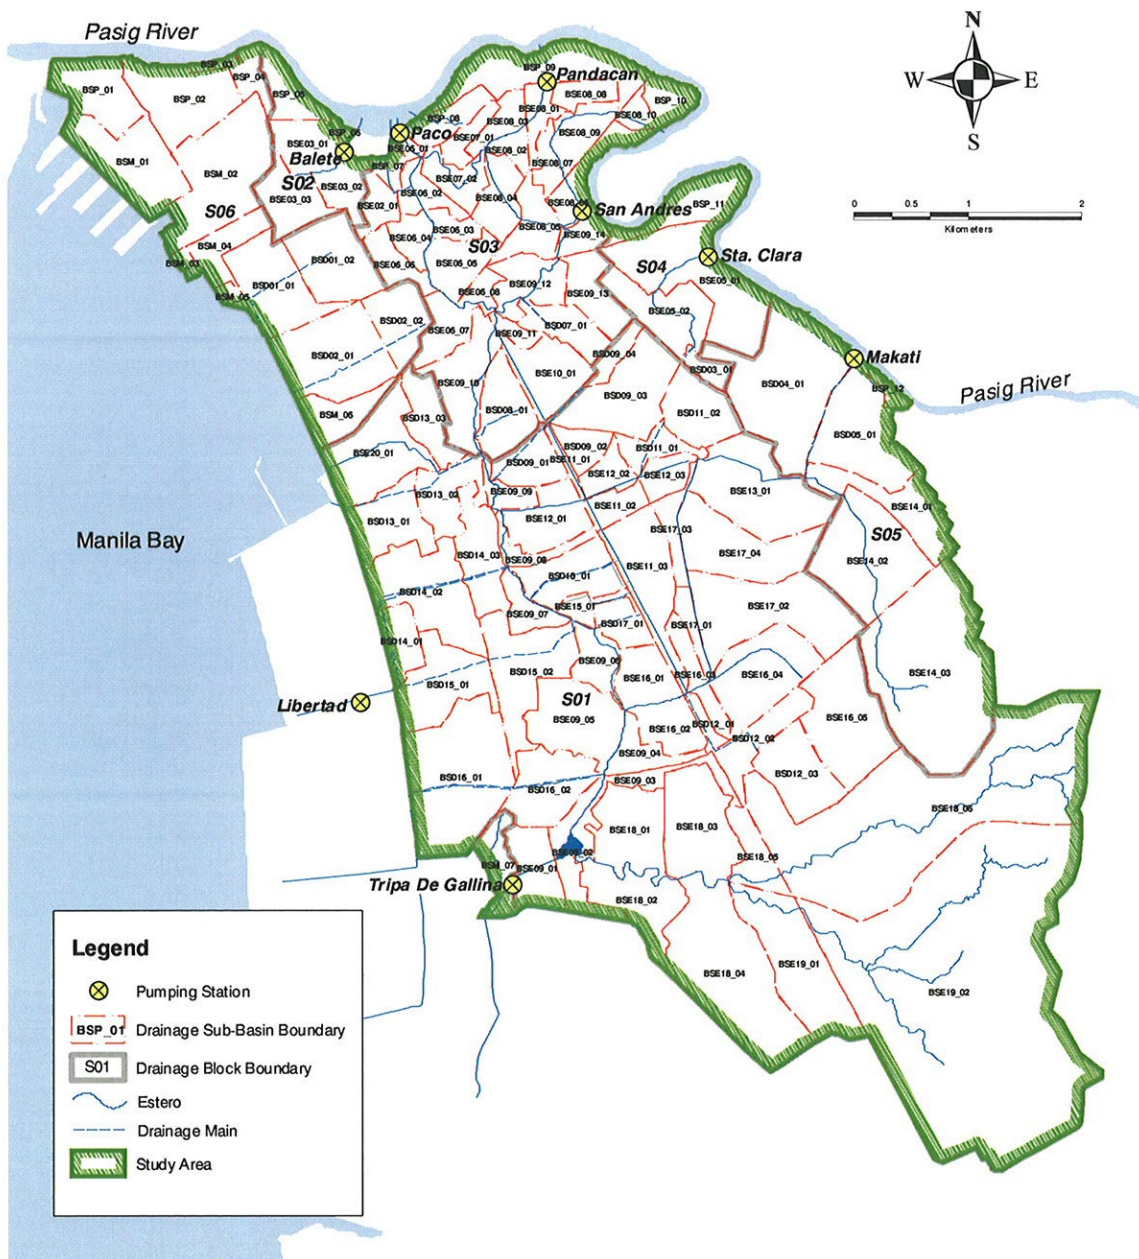
Figure E.5.6 Drainage Block and Sub-Basin for Proposed Drainage Scheme (2/2)

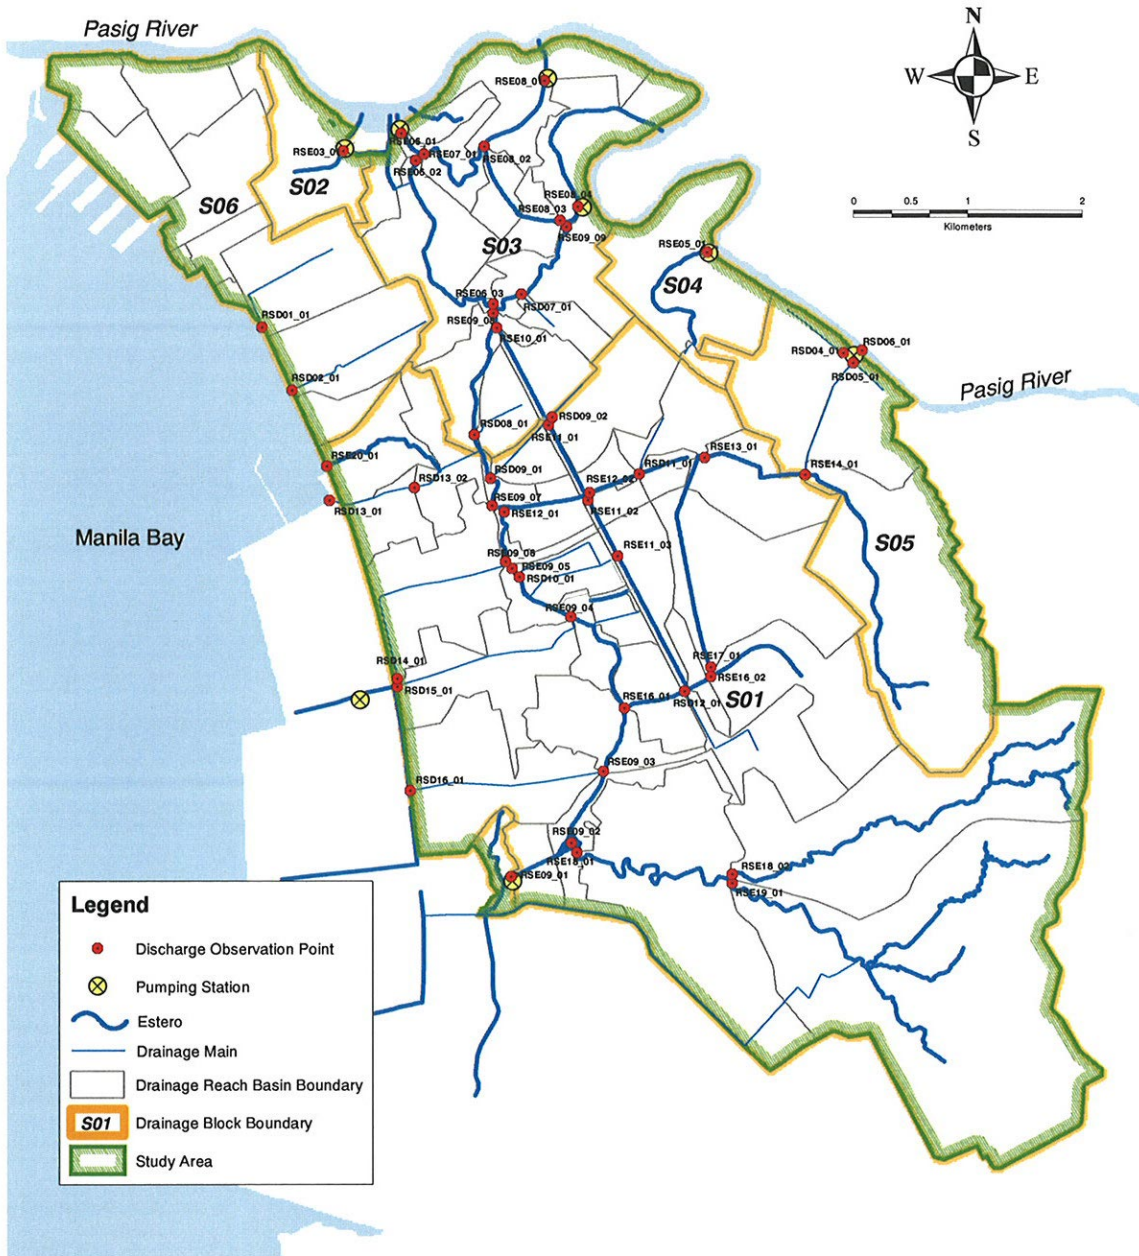
Figure E.5.7 Location of Discharge Observation Points in the Proposed Drainage Scheme (2/2)

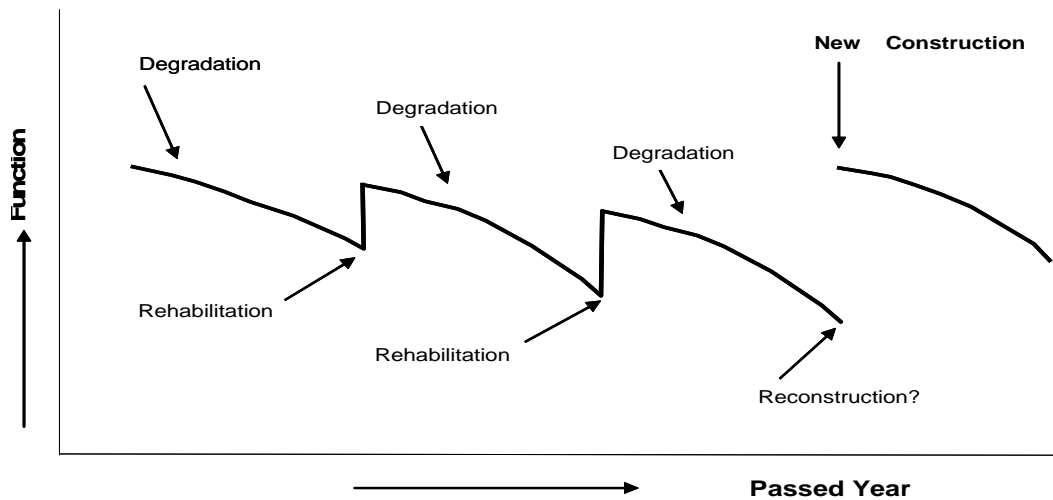
Figure E.5.9 Concept of Degradation of Pumping Equipment and Appurtenant Facilities

It is generally reported that the lifespan for drainage pump equipment and appurtenant facilities and for electrical apparatus is around 20 and 10 years, respectively. It would be required for pump equipment and appurtenant facilities, used for more than 20 years, to be repaired or replaced in order to operate a pumping station in good condition from the mechanical, electrical and economic viewpoints. The electrical apparatus should also be replaced in general. The concept of degradation and timing of repair/replacement is shown in *Figure E.5.9*.
