M. GUIDELINE FOR DRAINAGE IMPROVEMENT

M.2 INVESTIGATION, PLANNING AND DESIGNING OF DRAINAGE IMPROVEMENT

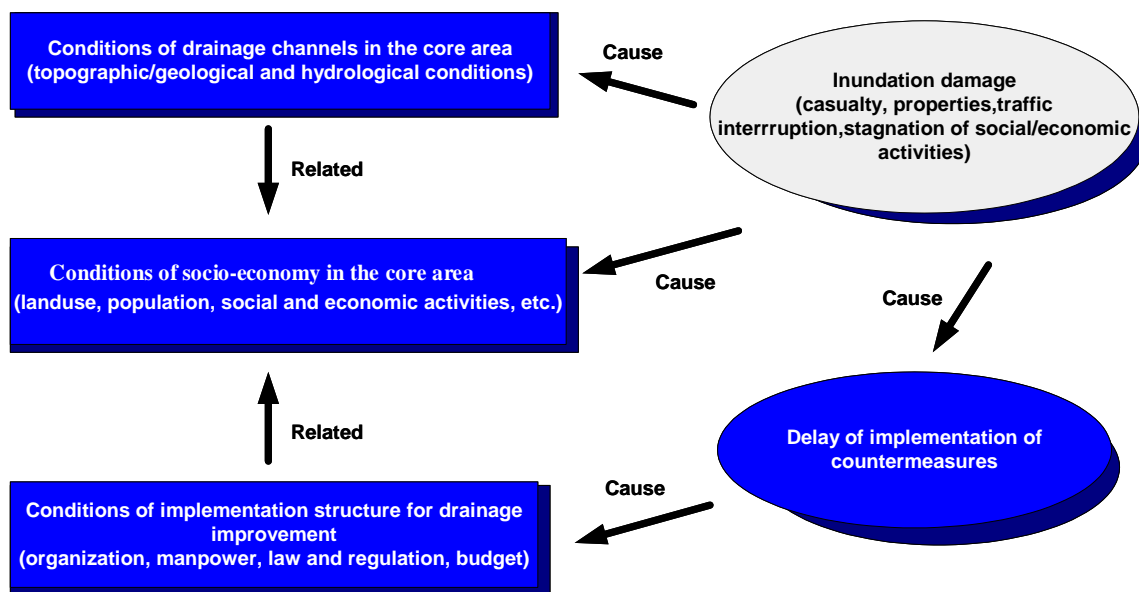
Figure M.2.8 Drainage Problem Structure

The core area of Metropolitan Manila has been mostly developed within the low-lying area formed by interaction of the behaviors of Pasig-Marikina River and the tidal action of Manila Bay. In view of geomorphologic and metrological characteristics in the core area of Metropolitan Manila, it can be said that the core area is subject to frequent flooding and inundations. Such vulnerability against flooding and inundations is encouraged by other social characteristics of densely populated areas extended over the core area, delay of implementation of countermeasures, improper and lack of operation and maintenance activities, etc. In addition, various illegal social activities are observed in the present system. They are dumping of solid waste and industrial waste, encroachment of houses and structures, etc. Thus, there are complicated circumstances behind the present drainage situations: “Mega city Metropolitan Manila” facing “Mega Problems”. As a basic reference, the root of drainage problems in the core area of Metropolitan Manila is categorized as shown in *Figure M.2.8*.

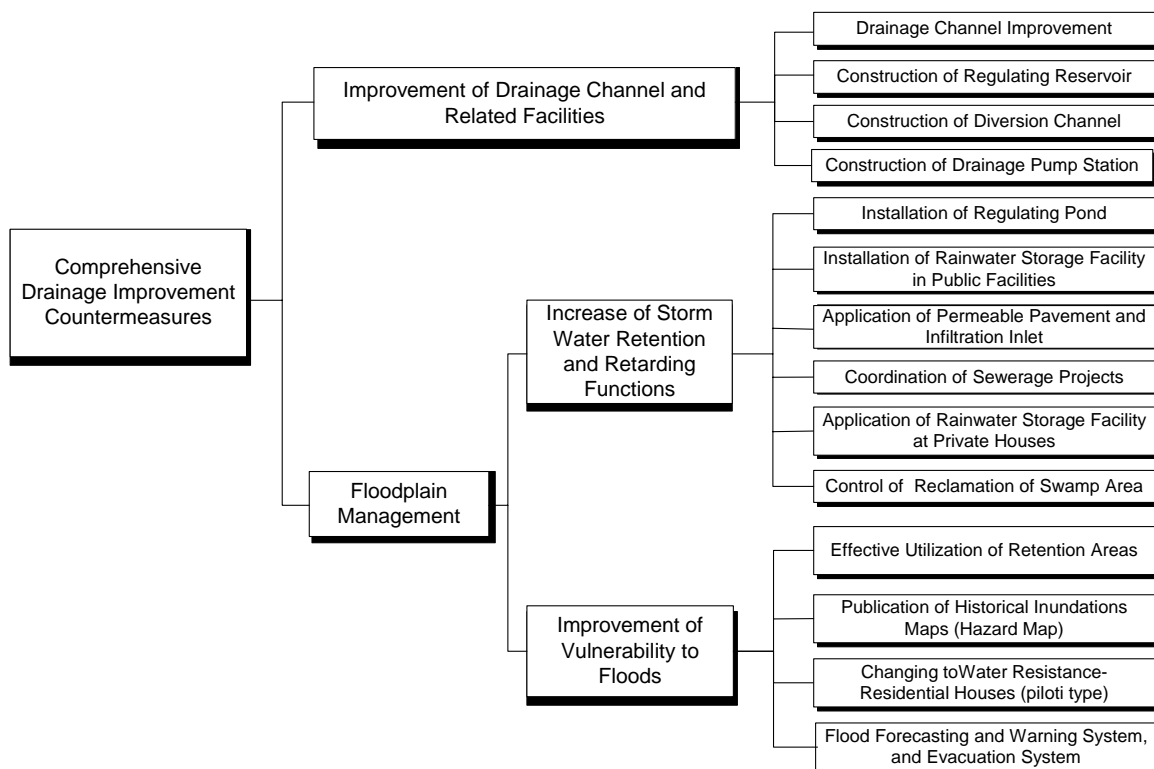
Figure M.2.16 Various Measures of Drainage Improvement

As a reference, various other measures of drainage improvement are presented in *Figure M.2.16*.
