BASIC DESIGN STUDY REPORT  
ON  
THE PROJECT  
FOR  
THE IMPROVEMENT OF NORTH DOCK OF PELELIU STATE  
IN  
THE REPUBLIC OF PALAU

JAPAN INTERNATIONAL COOPERATION AGENCY

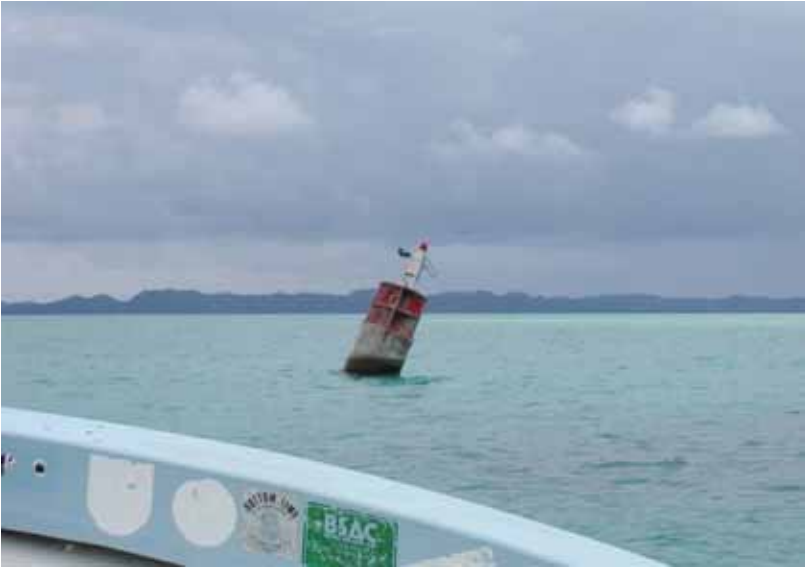
A photograph taken from the perspective of someone on a boat, looking out at a navigation aid. The aid is a cylindrical buoy with a red top and a white bottom, floating in clear, light blue water. In the background, there are low mountains under a cloudy sky. The boat's edge is visible in the foreground, featuring a green sticker with the text 'B5AC'.	<p>Navigation Aid (Entrance of access channel) Daytime</p>

Navigation aid in the entrance of the access channel is a navigation buoy which is still working. The working condition was confirmed at night investigation on August 17th and 22nd, 2005. Light of it was weak and difficult to identify at night or raining time. There are red and green small lights on the navigation poles No.16 located the turning corner of the access channel. Also, these lights were slightly twinkling when the night investigation was carried out on August 22, 2005.

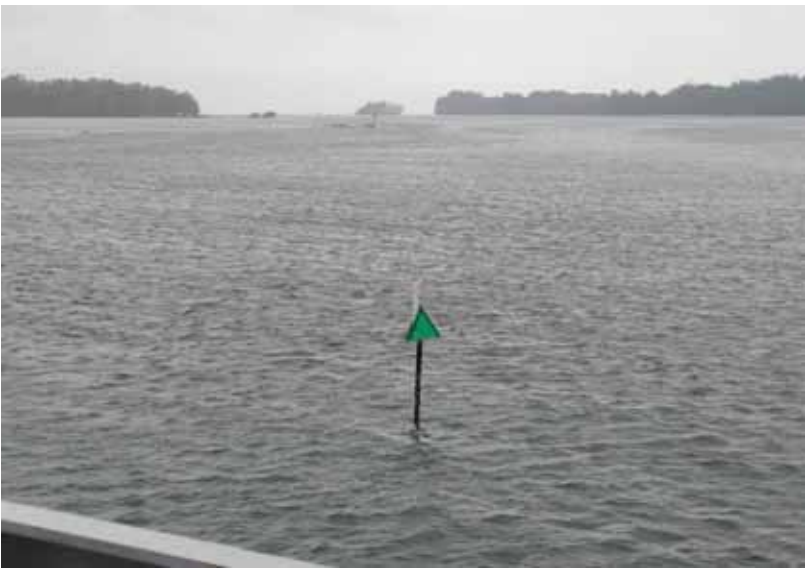
Photo-4

A photograph of a navigation pole in a wide body of water. The pole is a thin black vertical post with a green triangular marker at the top. The water is a greyish-blue, and the background shows a distant shoreline with trees under an overcast sky.	<p>Navigation Pole (Turning Point No.16G) Daytime</p>

A photograph of the same navigation pole as in the previous image, but taken in the late afternoon. The water is a deep, dark blue, and the sky is a uniform, dark blue, indicating twilight. The pole and its marker are still visible but less distinct due to the low light.	<p>Navigation Pole (Turning Point No.16G) Late Afternoon</p>

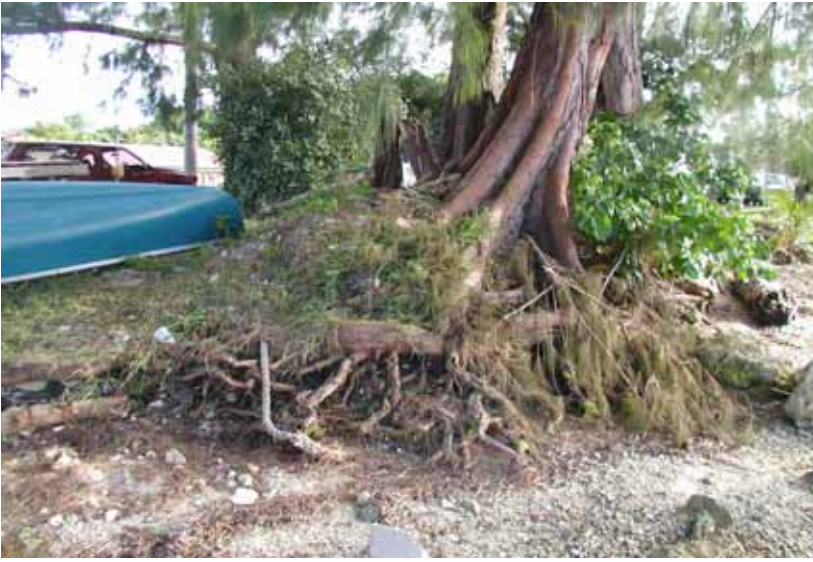
East Coast of North Dock  
in Peleliu State  
Some trees show their roots  
because of serious corrosion  
by waves.

Boats berthing to existing floating jetty or going vessels in access channel should be protected from the damages by the fallen trees.

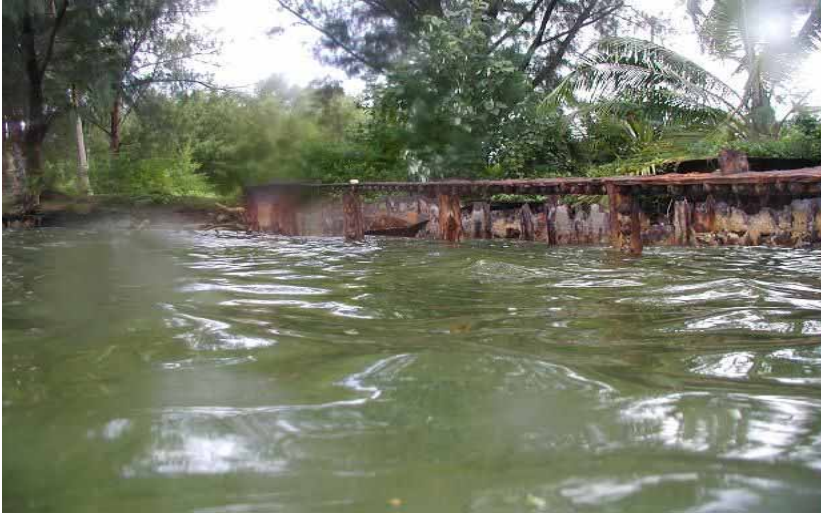
East Coast of North Dock  
in Peleliu State  
Sinking Barge

- a) There is no house along East ward coast of North Dock.
- b) Average distance from road edge to East ward coast is 11m.
- c) There are remaining structures of temporary jetty and sunken barge along the coast.
- d) It is difficult to find the remarkable changes of contour line or shore line as the comparison of topographic map between 1999 and 2005.
- e) Angle of fore shore in 2005 is supposed to be steeper in 2003 by the comparison of photographs.
- f) The serious erosion can be found at their roots of two big trees. They are standing along the coast less than 34m Eastern ward of existing pier of North Dock.

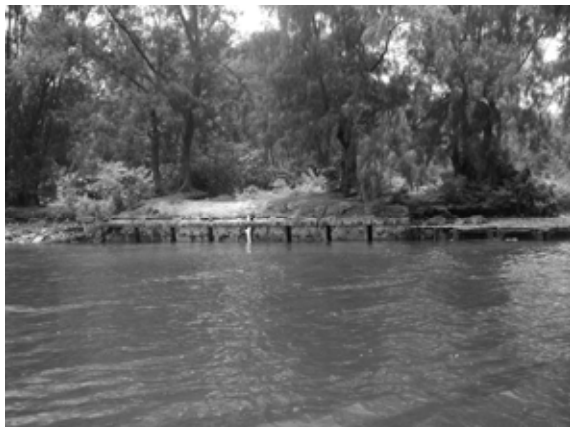
ODESANGEL\_DIL, major RoRo vessel begun its service on November 26 of 2004, conduct loading and unloading the cargo at existing natural ramp-way located in 140m Eastern coast from North Dock

**Photo 2.1.3(2)-1 Existing Ramp-way**

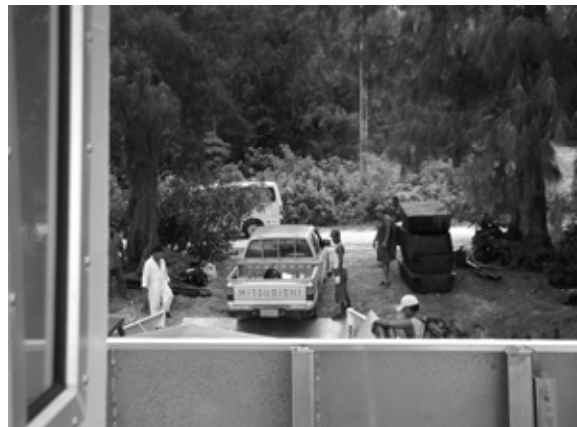
**Photo 2.1.3(2)-2 Unloading Scene**

Vessel has to berth at right angle to the shore line during her cargo handling operation at the site. Wind, current and wave from West will force the vessel drift to East during her works. During the works, captain has to control the vessel with sensitive maneuver which operates and controls twin engines, power and steering of rudders to maintain the direction of vessel to be at right angle to the coast.

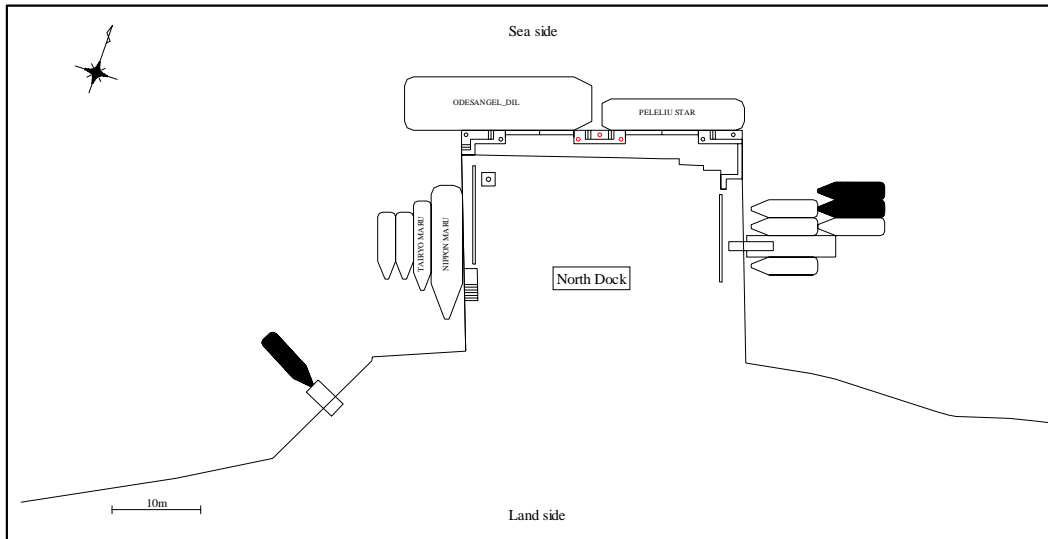
Berthing pattern as daily average during field investigation in Peleliu in the vicinity of North Dock is shown in Figure 2.1.3(2)-1.

**Figure 2.1.3(2)-1 Berthing pattern in the vicinity of North Dock**

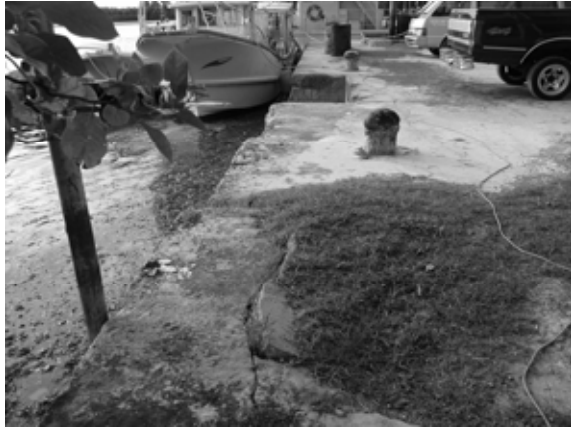
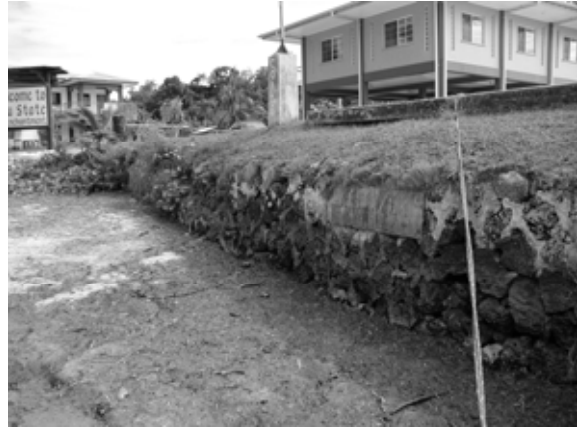
Aging of the structures of West berth, East and West revetments in North Dock have been proceeding. 7 bits are workable, however they have been corroded.

**Photo 2.1.3(2)-3 Existing West Birth      Photo 2.1.3(2)-4 Existing East Revetment**

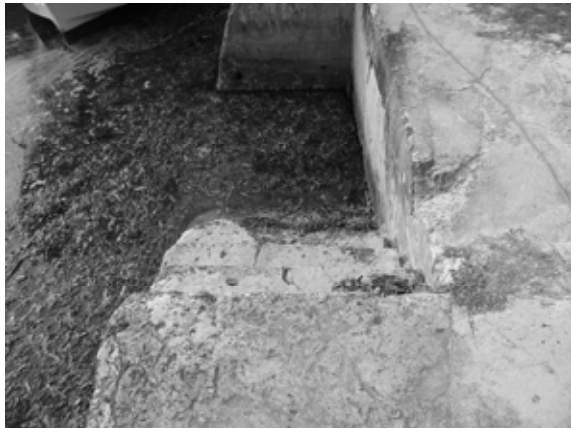
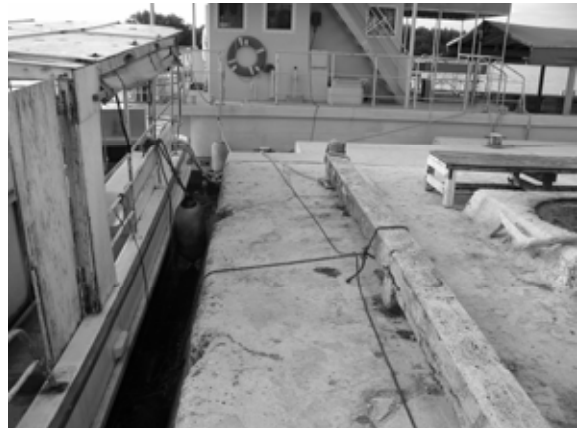
Moreover, weathering of the concrete at West berth and East revetment in North Dock has been proceeding. Concrete under the signboard of Peleliu State has been damaged and material of base course has been sucked out.

**Photo 2.1.3(2)-5 Existing West Steps      Photo 2.1.3(2)-6 Existing West Birth**

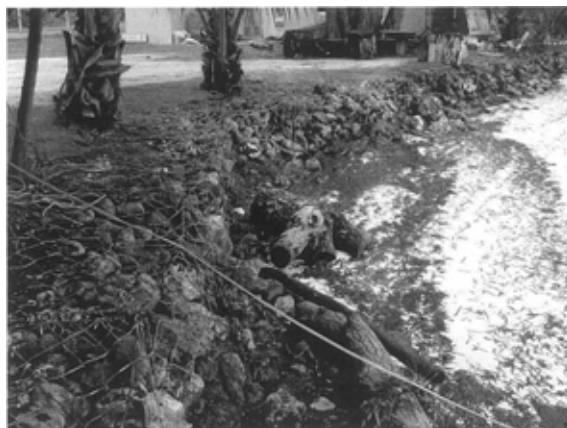
Gabion, steel mesh of revetment structure, at the seaside of fishery complex located in West of North Dock has been broken and its inner stones have been exposing.

**Photo 2.1.3(2)-7 Gabions in West Coast of North Dock**

Existing coastal revetment made by gabion will be replaced by concrete masonry revetment.

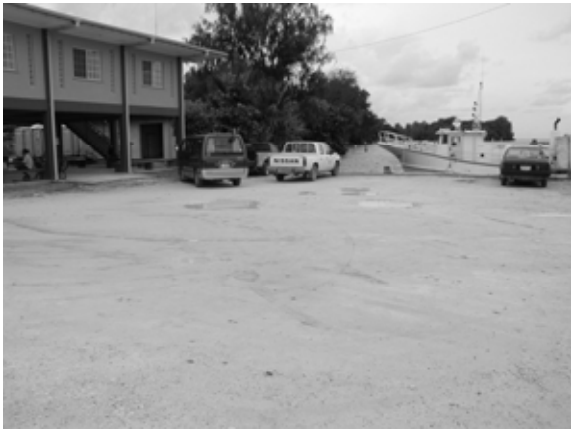
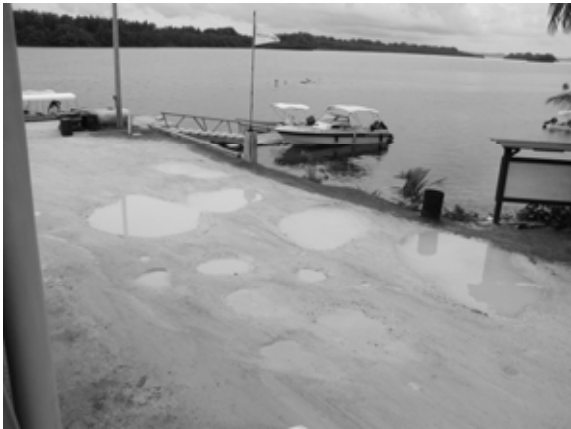
Apron is not paved and coral sand of the base course material is exposed. There are bumps and pot holes here and there in North Dock and they become the obstacle

for the smooth cargo handling. Also, foundation of North Dock has been excavated by wheels because large pot holes have been existed.

**Photo 2.1.3(2)-8 Existing Apron (North)    Photo 2.1.3(2)-9 Existing Apron (East)**

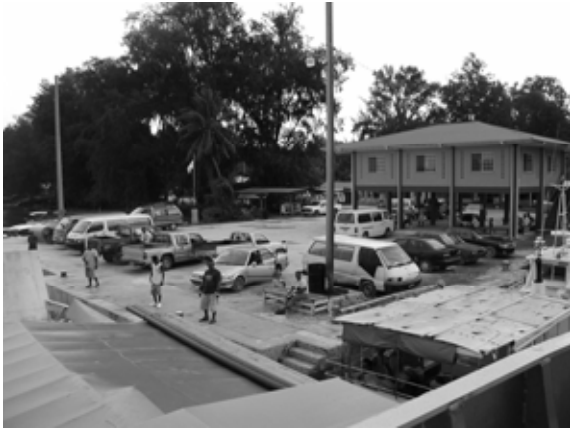
There is a light fixed pole in the corner of west and north berth in North Dock. This pole with light will be removed because the pole will be obstacle for the traffic of new ramp-way.

**Photo 2.1.3(2)-10 Existing Light (Workable in August, 2005)**

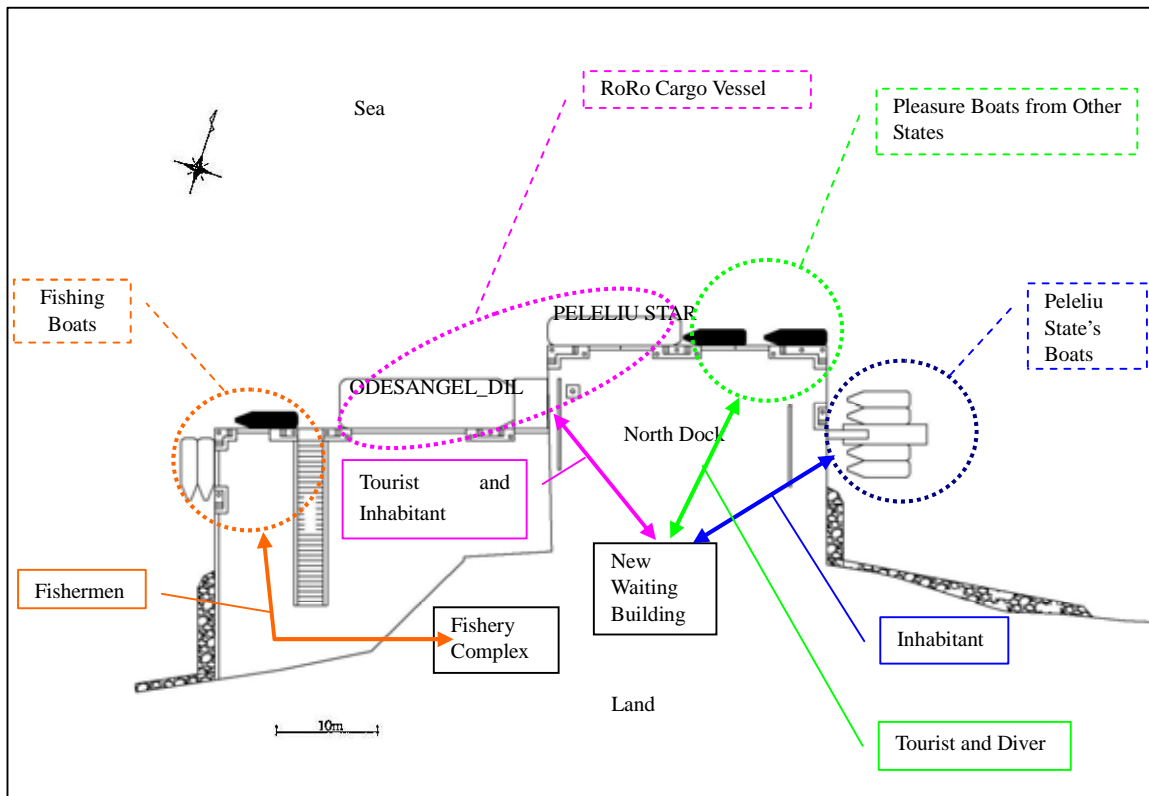
According to these arrangements, 2 berths in North side of the pier and 1 berth of West side of the pier will be utilized for the berthing of temporary calling fishing boats and pleasure boats. Berthing pattern as daily average after extension of Pier and idea of zoning after berth extension is shown in Figure 2.1.3(2)-2.

**Figure 2.1.3(2)-2 Zoning of Extended Pier in North Dock**

- a) Mitigation concept of berthing congestion based on average number of berthing boats
  - (i) Under the present circumstance, western side of existing pier will be reclaimed and extended the pier for mitigation of the congestion of North Dock. Three berths will be always secured for the boats coming from other states to mitigate the congestion of berthing boats.
  - (ii) For the mitigation of congestion in existing pier, it is recommended that NIPPON MARU and TAIRYOU MARU which are not currently operating condition and moored in the pier will be moved to South Dock.
  - (iii) As already described, the ramp-way will be constructed at the western reclaimed area of North Dock for the cargo loading of ODESANGEL\_DIL and its direction will be from East to West considering the predominant wind direction.

- (iv) Now, PELELIU STAR will be moored at Western side of North berth in North Dock. And it is recommended that 4 boats will be moored 2 by 2 by parallel berthing at both side of Peleliu State's floating jetty after dredging vicinities basin of the jetty.
- (v) Finally, extended area of the pier needs to include one berth where 2 boats can be moored by parallel berthing anytime. Western berth located in extended pier will be used for the above mentioned purpose.

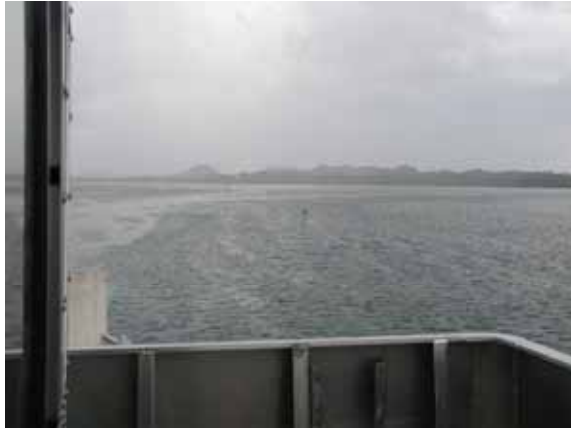
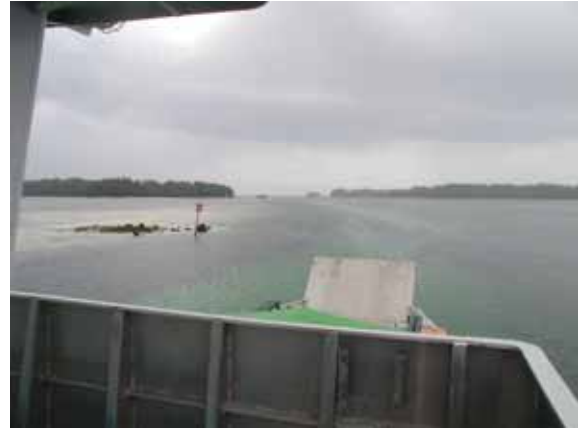
**Photo 2.1.3(2)-11 Navigation Pole No.16    Photo 2.1.3(2)-12 Navigation Pole No.20**

As the result of comparison of the sounding maps between 1999 and 2005, depositing sand in the vicinity of navigation poles No.10, 16, 20, 22 and 24 and North-Eastern cape of Peleliu State was found significantly.

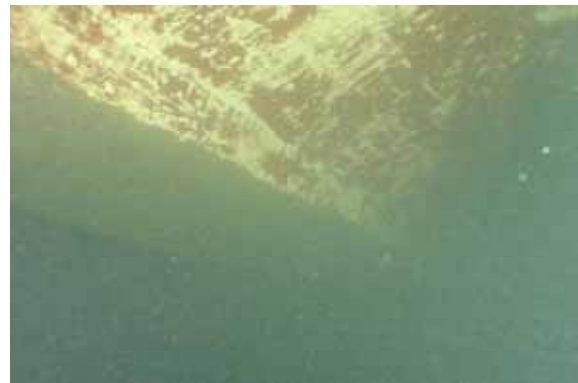
**Photo 2.1.3(2)-13 Bottom of ODESANGEL    Photo 2.1.3(2)-14 Bottom of P.Star**

There are more than 10 scratched marks on seabed made by the keels and bottoms of ODESANGEL\_DIL and PELELIU STAR according to the diving investigation on August 28.

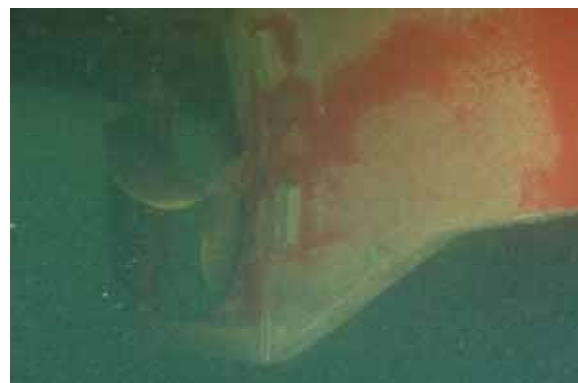
Propellers and rudders of ODESANGEL\_DIL are stuck out from vessel bottom and steel protectors of propellers and rudders are scratched by touching the seabed.

**Photo 2.1.3(2)-15 Twin Propellers**

**Photo 2.1.3(2)-16 Protector of Propeller**

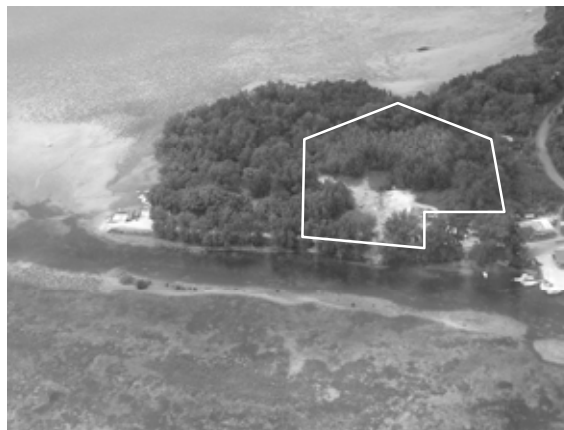
Prospected site for temporary construction yard as the dumping site is located 50 m from South East of North Dock. Area of the site is approximately 19,000m<sup>2</sup>, however, the dumping area will be limited because half of the area is covered by trees.

**Photo 2.1.3(2)-17 Prospected Site of Temporary Yard**

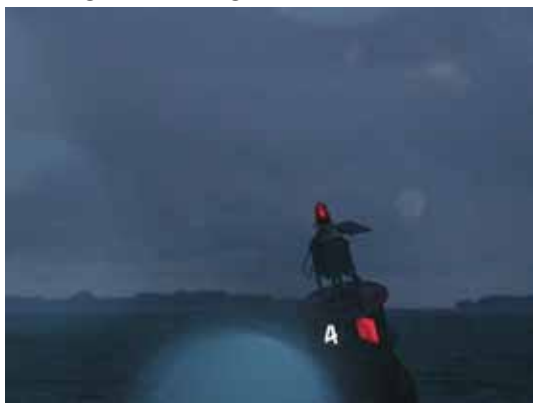
**Photo 2.1.3(2)-18 Navigation aid Buoy in Rainy Night Photo 2.1.3(2)-19Navi.Pole No.16 in Rainy Night**

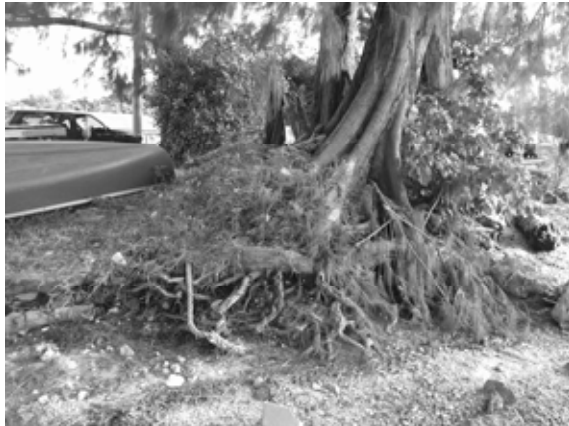
Photo 2.1.3(2)-21 Eroded Tree at 33m from Pier

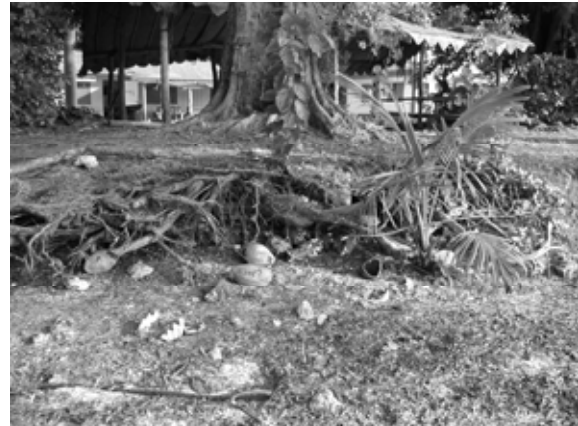
Photo2.1.3(2)-22 Eroded Tree at 20m from Pier

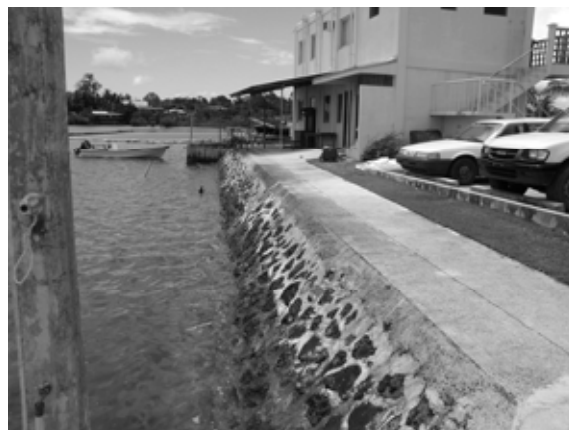
**Photo 2.1.3(2)-23 Example of Sloping Revetment with Concrete Masonry**

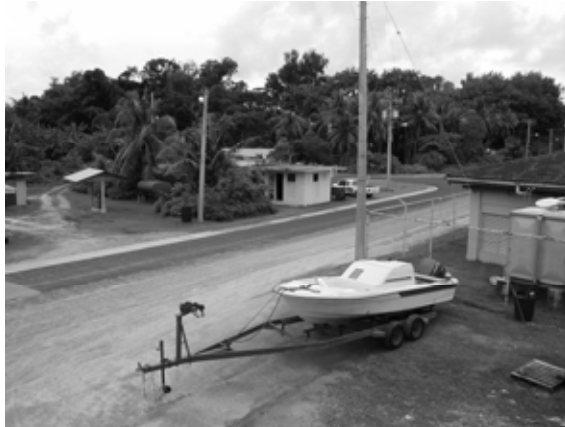
There are existing slipway located at East and West side of North Dock utilizing natural slope in private lands. It is necessary to use vehicle and boat trailer to load and unload the boats in the existing slipway. There are 11 trailers in Peleliu State. 10 trailers are privately owned and 1 trailer is belonging to Peleliu State.

**Photo 2.1.3(2)-24 Boat Trailer of Peleliu State**

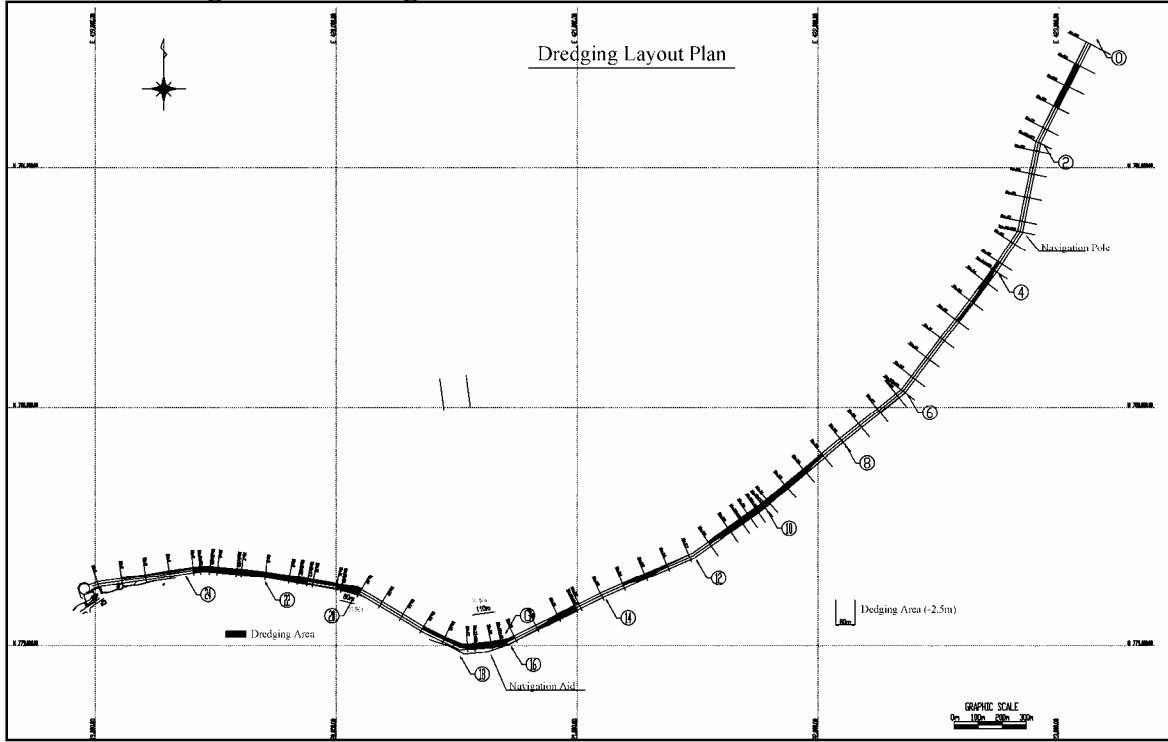
According to the results of on-board investigation and interview to the captain, dredging area in turning basin is designed as 22.5m in radius which is same to the previous North Dock project as described above.

- (b) Shallow area with mangroves located in Northern of North Dock has been reserved as the preserved area by Bureau of Arts and Culture and Peleliu State Government. To avoid the dredging works of this area, said scale of dredging for turning basin is designed.

Figure 2.2.2(3)-1 Dredging Layout Plan
