CHAPTER 5 MULTI-PURPOSE BUILDING AND ISLAND OFFICE

CHAPTER 6 ISLAND HARBOURS AND CAUSEWAYS

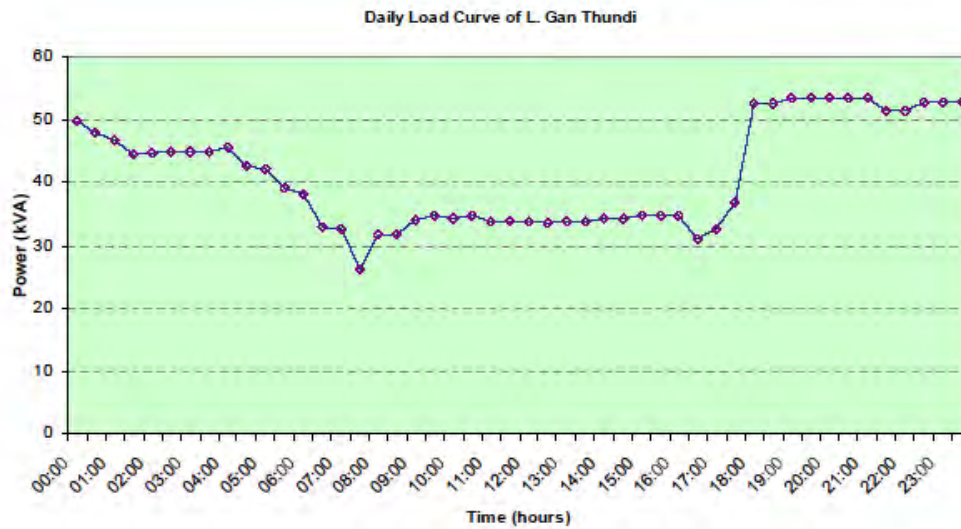
The island (Gan-Thundi) has four generators in total: 2 x 60 kVA, 85 kVA and 140 kVA; and the power system is not synchronized. The nighttime electricity load to the island is provided by the biggest generator (140 KVA – DEUTZ) and daytime load is met by two smaller generators. As the system is not synchronized, the two daytime generators feed power to the grid separately using different feeders. The estimated load pattern of the island from the data collected is shown in the figure below. Based on the estimated load pattern there is no need to run two generators during day time because just a smaller generator would be enough to cover the daytime load.

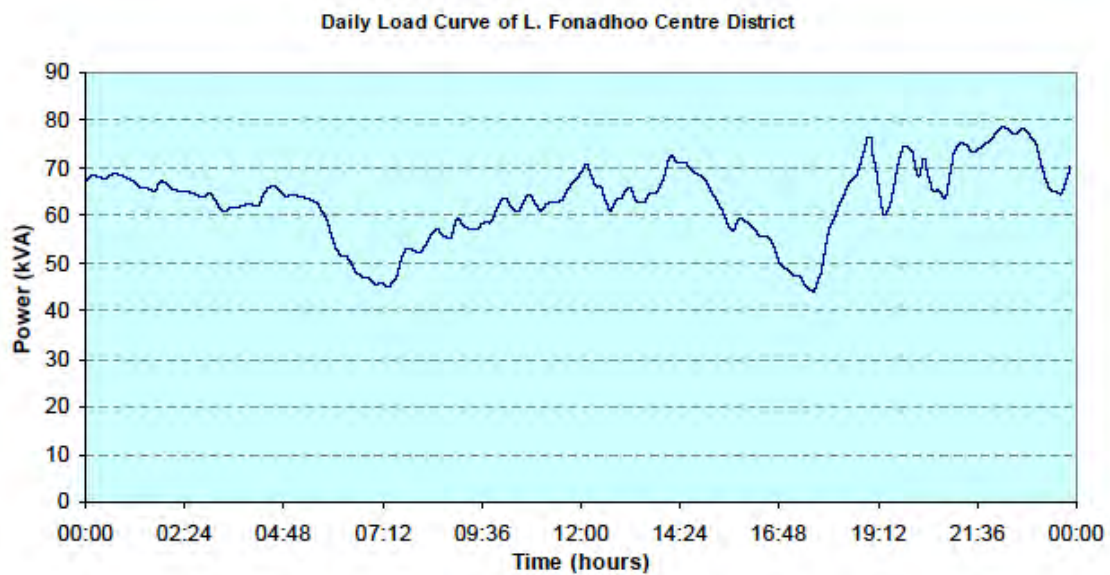
The Fonadhoo Island has three powerhouses located at the three wards of the island. The central ward's powerhouse is planned to supply power for the upcoming island office. The central ward's powerhouse has three generators: 108 kW, 40 kW and 96 kW. The system is non-synchronized so that only one generator is used at a time. A typical daily load curve of the island measured is given below.

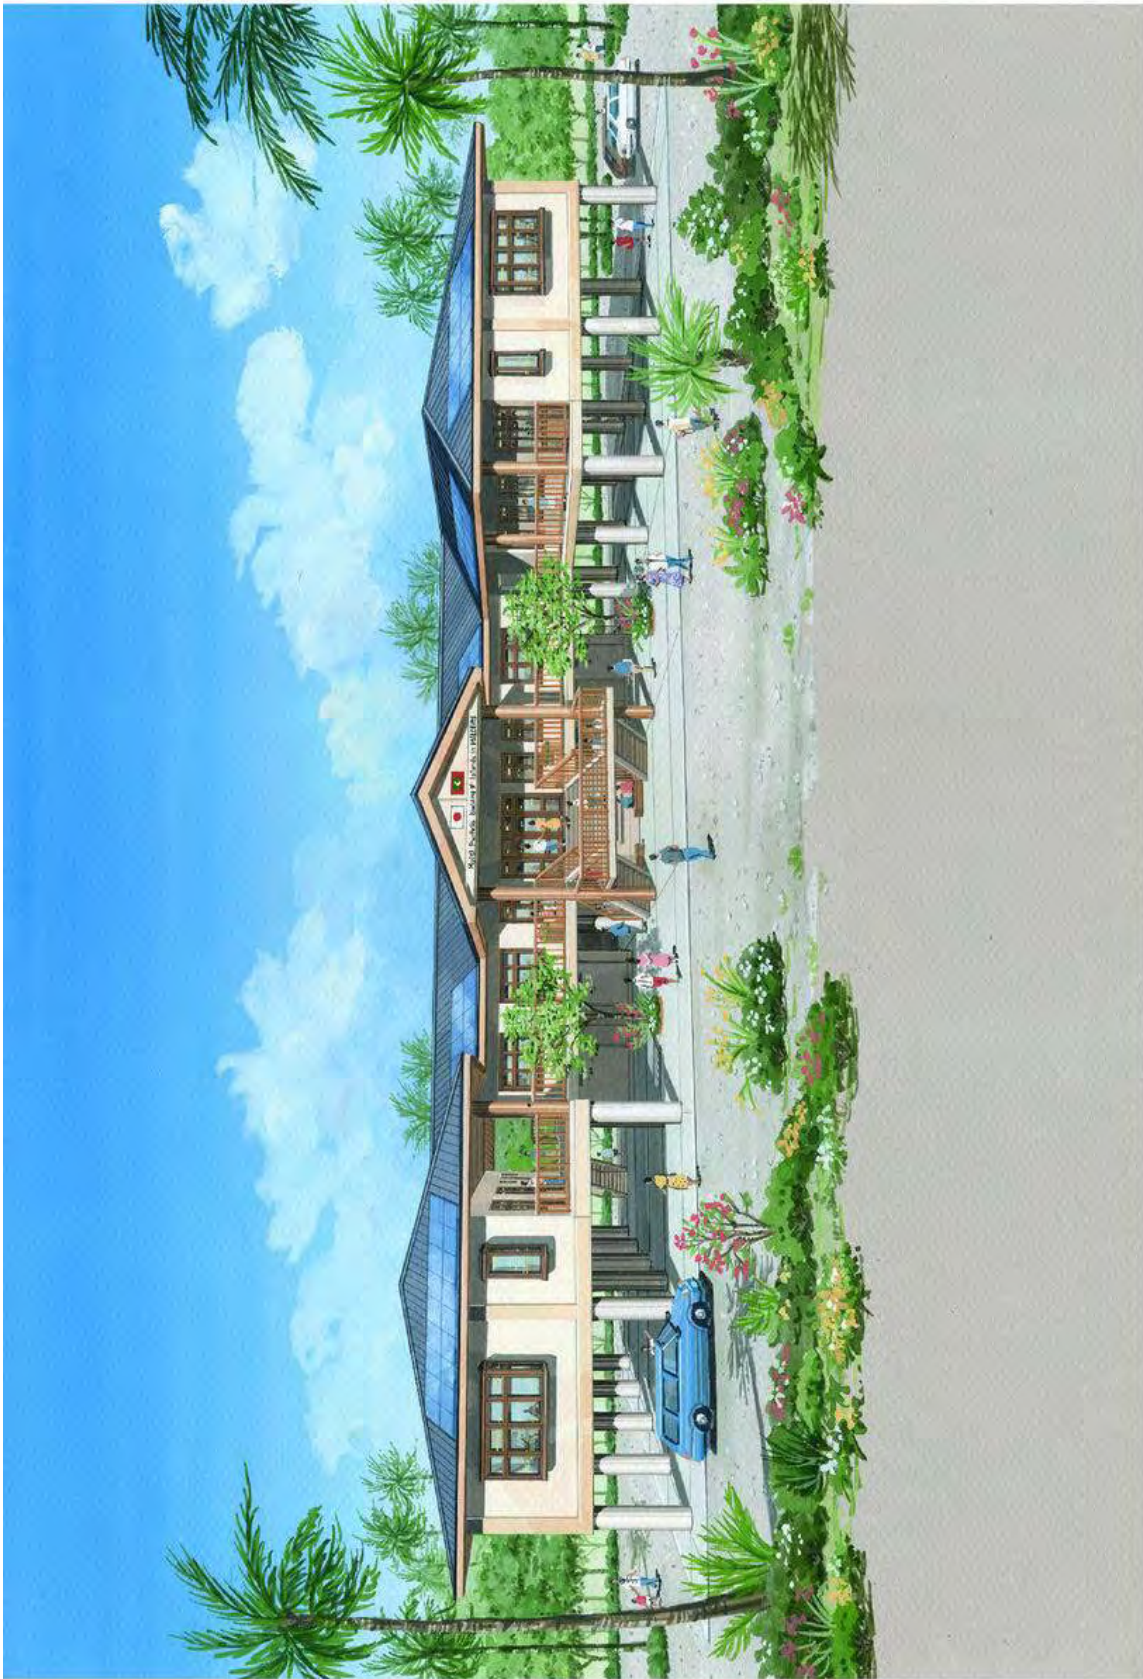
Multi-purpose Building : Thundi, Gan Isalnd, Laamu Atoll

Figure 5.3 Perspective Drawing of the Multi-purpose Building

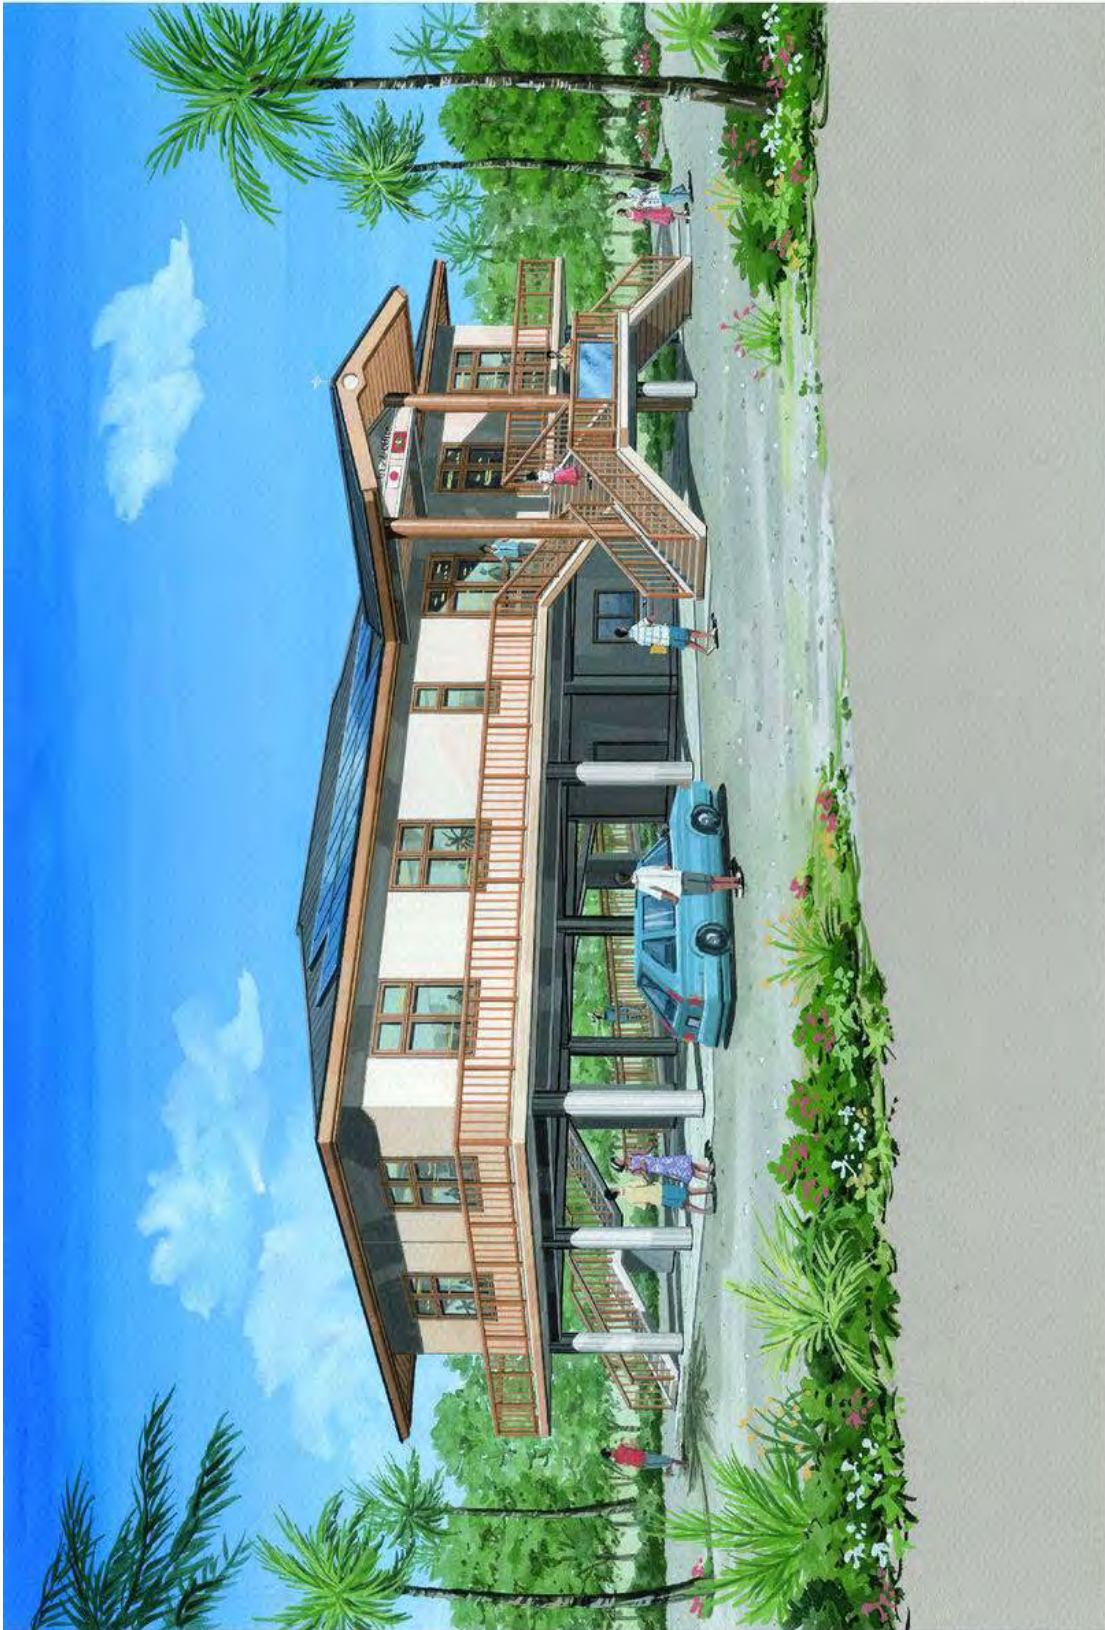
Island Office : Fonadhoo, Laamu Atoll

Figure 5.4 Perspective Drawing of Island Office

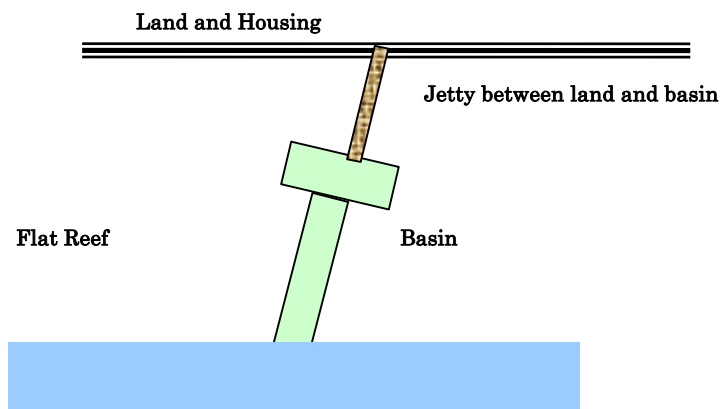
higher transport cost of materials. If the flat reef is wider than 500 m, it is recommended to make alternative study to see if provision of a jetty could be an economical solution.

Figure 6.3 Typical Plan of Small Island Harbour of Longer Approach Channel

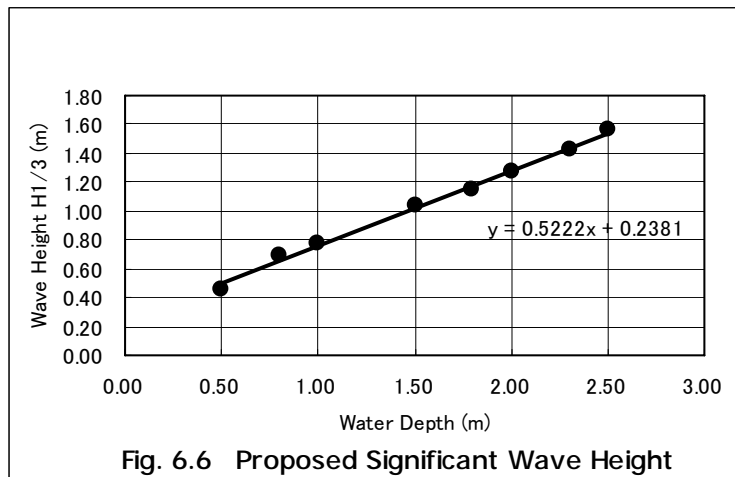
Water Depth h (m)	H_o'/L_o	h/H_o'	K_s	$H_{1/3}$ (m)
0.50	0.05	0.22	0.20	0.46
0.80	0.05	0.35	0.30	0.69
1.00	0.05	0.43	0.34	0.78
1.50	0.05	0.65	0.45	1.04
1.80	0.05	0.78	0.50	1.15
2.00	0.05	0.87	0.55	1.27
2.30	0.05	1.00	0.62	1.43
2.50	0.05	1.09	0.68	1.56

Fig. 6.6 Proposed Significant Wave Height

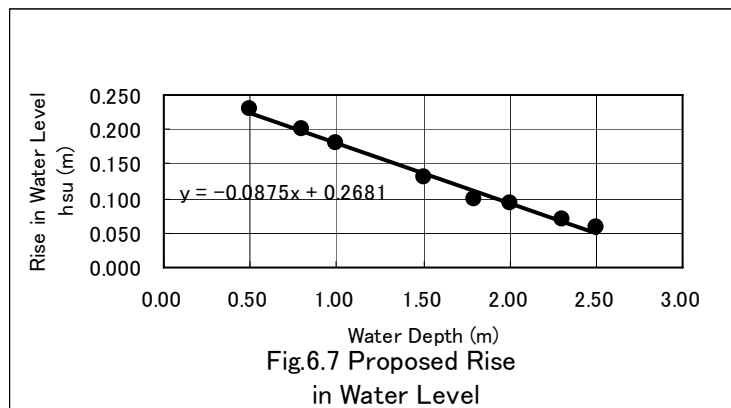
It is assumed that the wave set-up height on the reef flat is as follows:

$$h_{su} = 0.27 - 0.09 \times h_{rf}$$

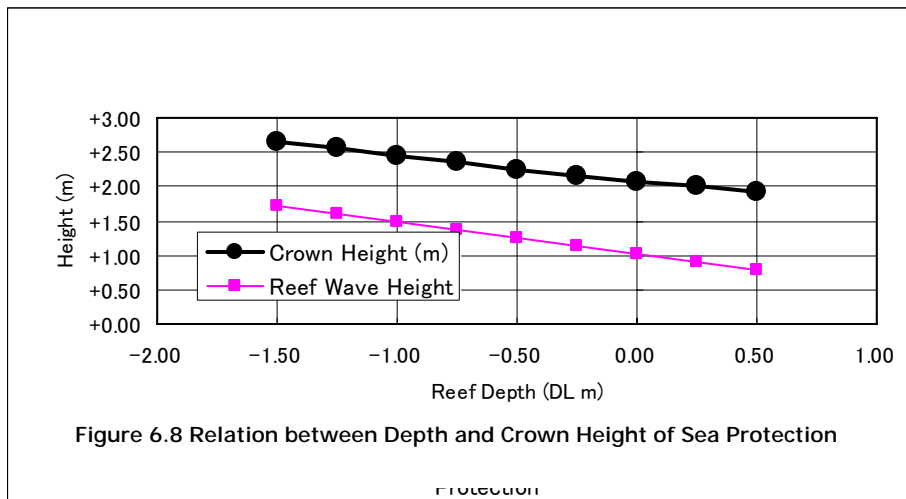
Estimation was carried out for the crown height by the wave intensity on the flat reef. Calculation results indicate moderate height as follows:

Required Crown Height DL+1.92 ~ +2.25 m

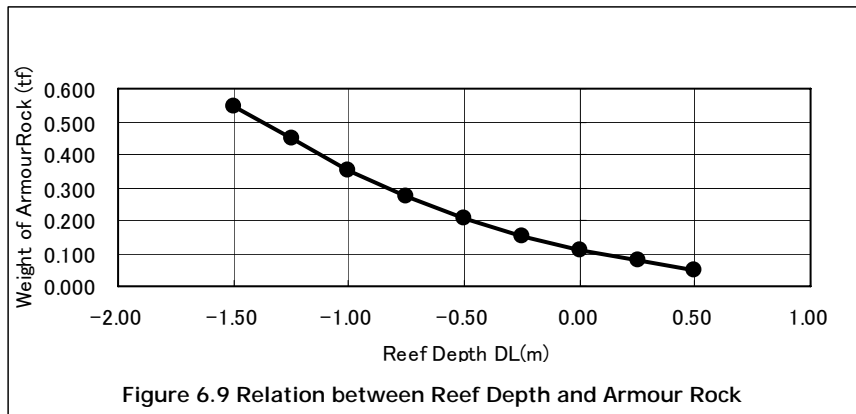
Required size of armour rock is estimated as follows:

Minimum Weight of armour rock: W > 51 kgf ~ 250 kgf

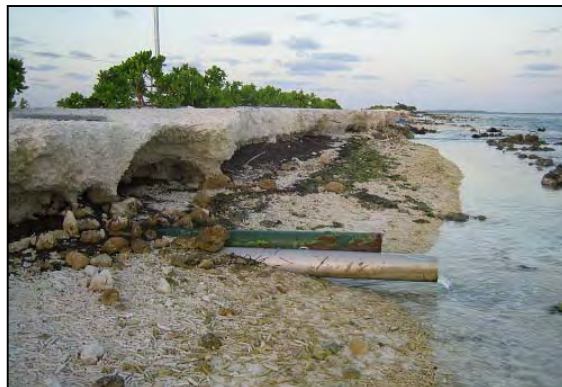
Damaged Causeway No.2
Before repair in the end of May.
West side

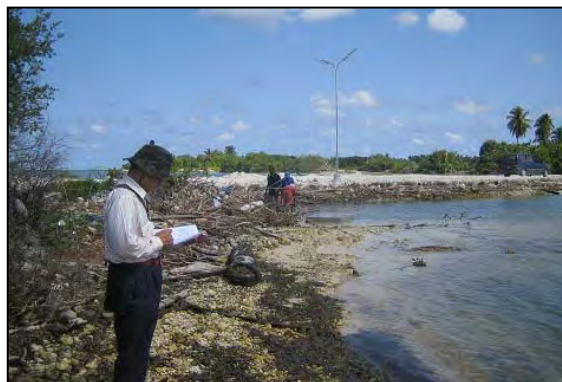
Damaged Causeway No.1
West side

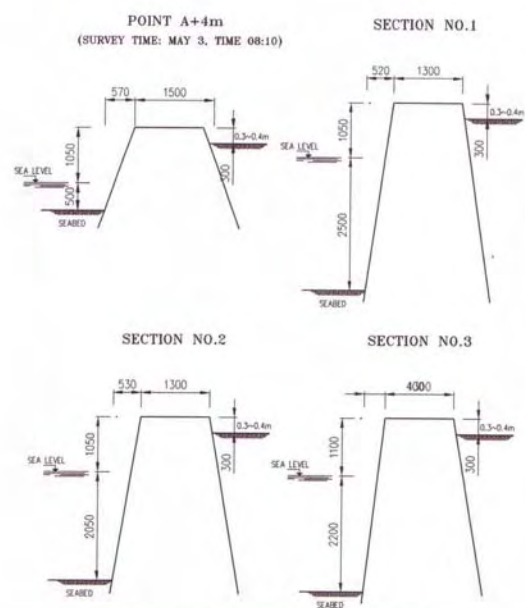
Fig. 6.6.26 Existing Quaywall Sections (L-4 Fonadho)

Figure 6.19 Design Drawings of the Fonadho Island Harbour

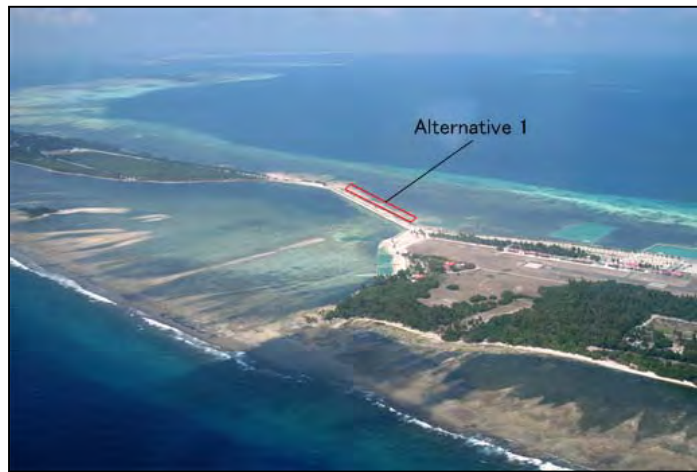
Figure 6.26 Proposed Sand Procurement Sites for Causeway No.2 (Alternative 1)

Location	Amount	Method
Alternative 1	Approximately 10 m from the west side of causeway See Figure 6.7.3	580m x 15m x 1m = 8,700m ³	Dredging with grab or backhoe
Alternative 2	Sandy area west coast of southern part of Fonadhoo Island, which is approximately 3 km from the causeway.* See Figure 6.7.4	580m x 15m x 1m = 8,700m ³	Dredging with grab or backhoe. Dredged sand will then be transported to the causeway with pick-up truck.
Alternative 3	New Thundi Port in Gan Island, which is approximately 10 km from the causeway.	8,700m ³	Utilization of dredged material from the new Thundi Port. Dredged sand will then be transported to the causeway with pick-up truck.

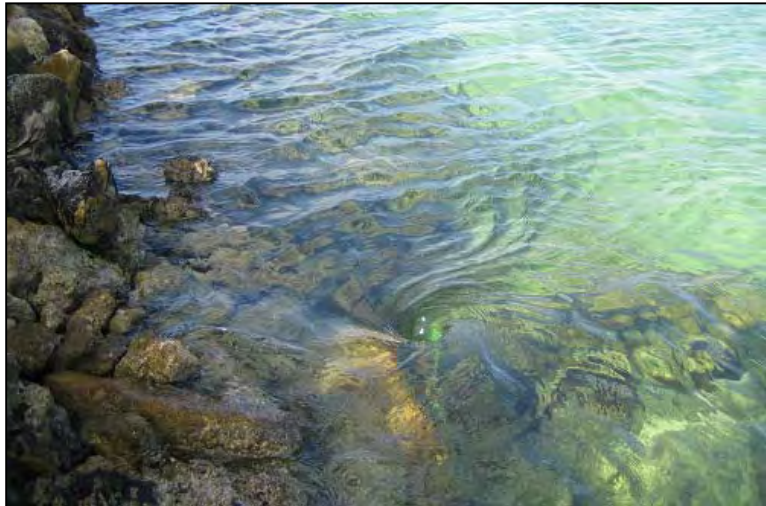
Whirlpool by head difference
between the east and west.

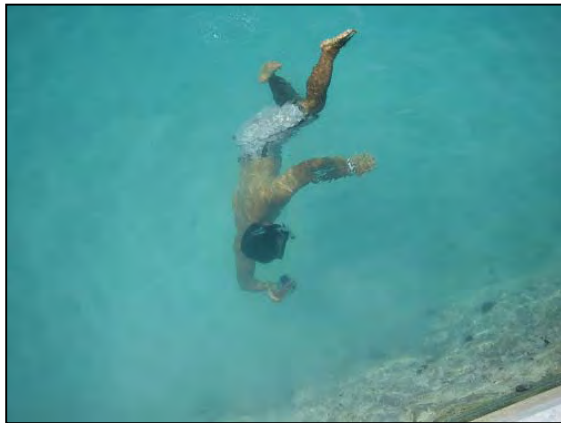
Diving for quay wall damage observation at Hirilandhoo by the Study Team, May 14, 2005.

The Team carried out an underwater investigation of every island harbour and causeway. Results of this study indicates the general summary of facilities under the Low Water Level, as follows:

- Almost no proper protection underwater was provided to the core of gravity wall, rocks and coral debris.
- Collapsed and tumbled conditions were observed in the serious damage areas.
- Some structures in air are sound; however, there are serious damages underwater.
