Final Report

*for the Detailed Design Study
on the Urgent Rehabilitation Project
of*

Tanjung

Pririk Port

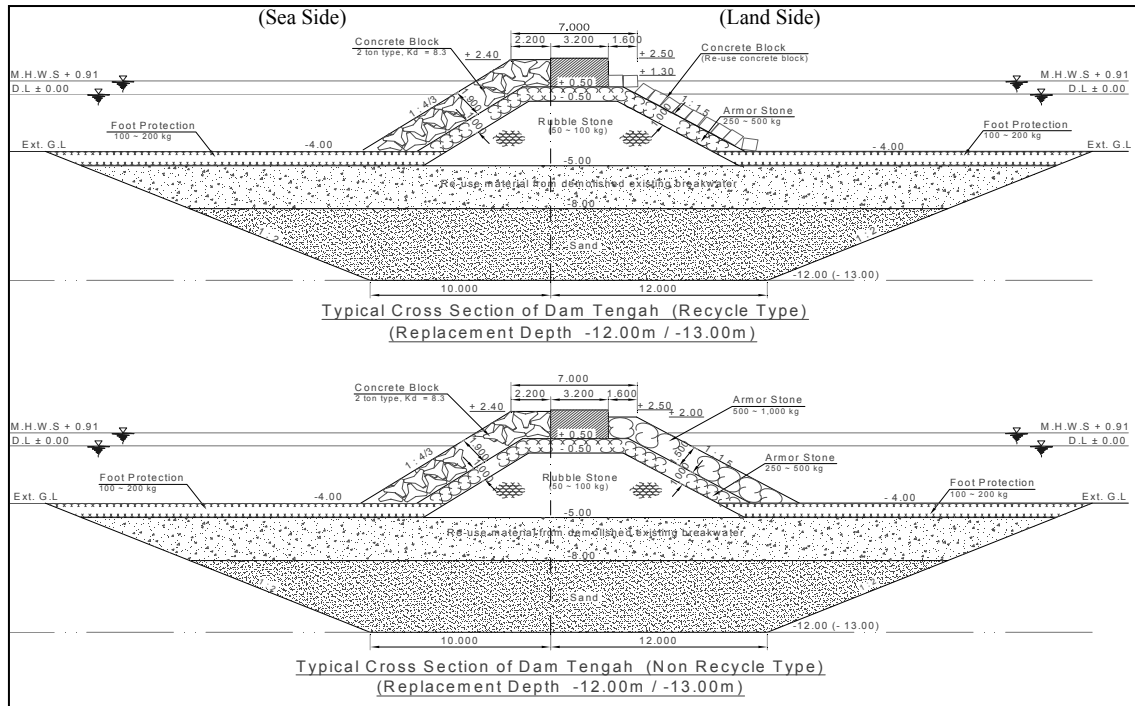
Cross Section of New Dam Tengah-1

- (10) For New Dam Tengah, a rubble-mound structure with sand replacement has been selected because of its advantage in reusability of the demolished breakwater materials (environment-friendly) and less settlement in the future (low-maintenance cost). For New Dam Barat, a combined foundation structure, consisting of shallow sand-replacement and bamboo-piling with bamboo-mattress, has been selected, because of its advantage over the high cost of full-scale sand replacement. For the temporary breakwater-Dam Tengah-2, only bamboo mattress has been considered as foundation, allowing settlement in the future. (See following Figures)

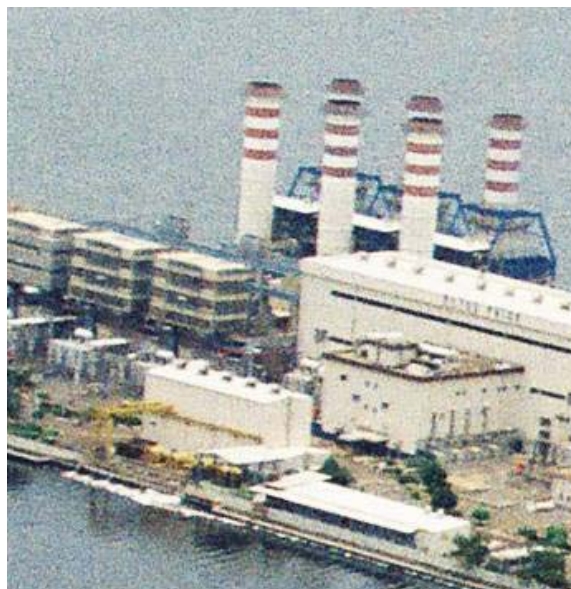
Currents inside Tanjung Port are in a number of stations surprisingly high. Currents measured at the outlet of the Kali Japat show nearly constant currents of 0.75 to 1.0 m/s and running in directions 200 to 250, nearly constant into the outlet (rather then out of the outlet). This current is even higher than the current at the Kali Sunter Baru outlet, where currents are measured to vary between 0.10 and 0.60 m/s. Since this high current was not expected, an explanation was sought for and (likely) found by the presence of a powerplant located at close distance inside the Kali Japat outlet. This powerplant takes water from inside the Kali Japat and discharges this on open sea (see Photo 2.5.1).

Photo 2.5.1 Cooling Water Inlet of Tanjung Priok Power Plant, Located Approx. 500 m West of the Measurement Point
