### 2.2.3 QIP for Emergency Repair Works of Aceh River and Floodway

#### (1) Design Condition

The Project aims at repairing the damaged dykes to their original situation urgently in order to protect the city area from flooding and high tide. With implementation of the Project the present inundation areas will be secured and contribute to return of affected people and other development activities.

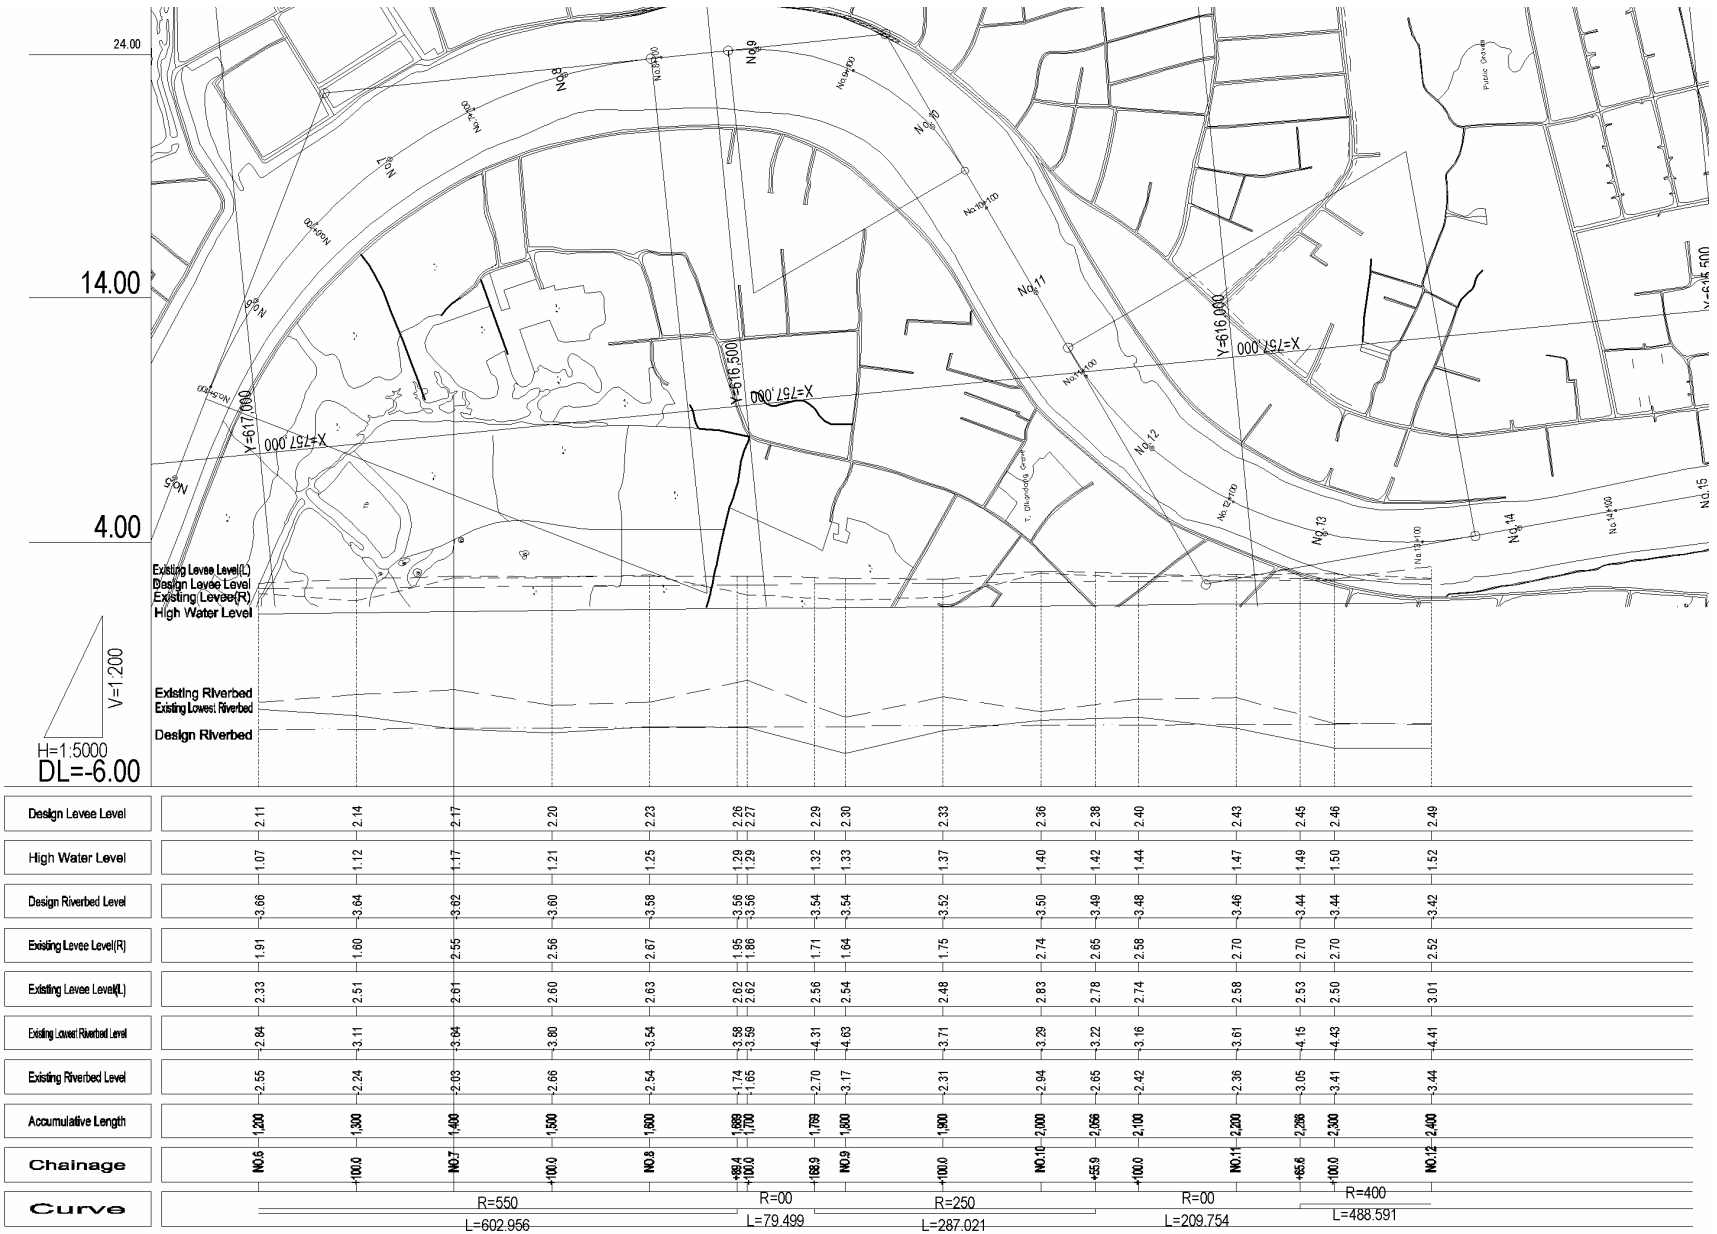
Figure 2.2.6 Plan and Profile of Aceh River under Case 2 (2/3)

Plan and profile of proposed improvement work is as given in Figure 2.2.6.

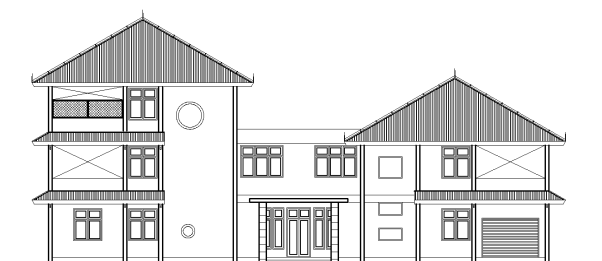
Figure 2.2.15 View of Nirmala Orphanage Administration Building and Education Building

Existing facility		New construction plan		Plan overview
Floor Space (m <sup>2</sup> )	438.0(m <sup>2</sup> )		602.4(m <sup>2</sup> )		
Cumulative Floor Space (m <sup>2</sup> )	438.0(m <sup>2</sup> )		1459.0(m <sup>2</sup> )		
Eave Height (m)	3.80(m)		9.80(m)		
Floors	One-story		Three-story		
Construction	Reinforced steel concrete frame Block construction		Reinforced steel concrete construction		
Room Name	1 <sup>st</sup> floor	<ul style="list-style-type: none"> <li>• Office</li> <li>• Storage</li> <li>• Classroom</li> <li>• Hostel</li> <li>• Other common space</li> </ul>	1 <sup>st</sup> floor	<ul style="list-style-type: none"> <li>• Office</li> <li>• Storage</li> <li>• Classroom</li> <li>• Hostel</li> <li>• Other common space</li> </ul>	
	2 <sup>nd</sup> floor	N/A	2 <sup>nd</sup> floor	<ul style="list-style-type: none"> <li>• Hostel</li> </ul>	
	3 <sup>rd</sup> floor		3 <sup>rd</sup> floor	<ul style="list-style-type: none"> <li>• Multi-purpose room (meetings, evacuation area)</li> </ul>

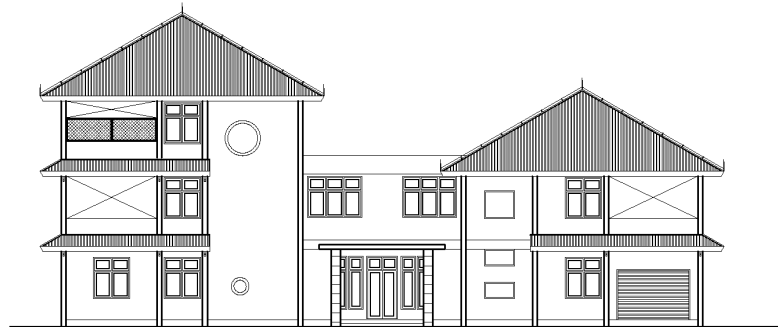
Figure 2.2.16 View of Jroh Naguna Orphanage Vocational Training Building

Existing facility		New construction plan		Plan overview
Floor Space (m <sup>2</sup> )	169.0(m <sup>2</sup> )		217.4(m <sup>2</sup> )		
Cumulative Floor Space (m <sup>2</sup> )	169.0(m <sup>2</sup> )		434.8(m <sup>2</sup> )		
Eave Height (m)	3.80(m)		7.70(m)		
Floors	One-story		Two-story		
Construction	Reinforced steel concrete frame Block construction		Reinforced steel concrete construction		
Room Name	1 <sup>st</sup> floor	<ul style="list-style-type: none"> <li>• Training room</li> <li>• Storage</li> <li>• Other space</li> </ul> common	1 <sup>st</sup> floor	<ul style="list-style-type: none"> <li>• Training room</li> <li>• Storage</li> <li>• Hostel</li> <li>• Other space</li> </ul> common	
	2 <sup>nd</sup> floor	N/A	2 <sup>nd</sup> floor	<ul style="list-style-type: none"> <li>• Hostel</li> </ul>

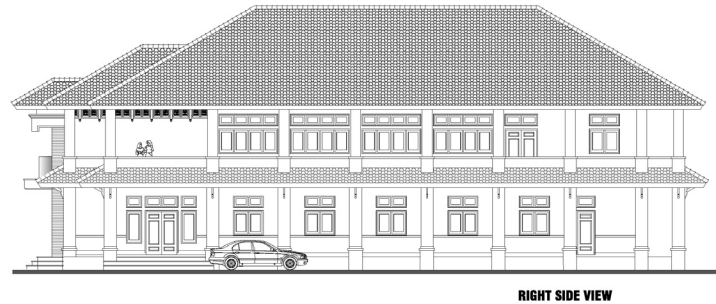
Figure 2.2.17 View of Jroh Naguna Orphanage Auditorium

Existing facility		New construction plan		Plan overview
Floor space (m <sup>2</sup> )	388.0(m <sup>2</sup> )		398.0(m <sup>2</sup> )		
Cumulative Floor Space (m <sup>2</sup> )	388.0(m <sup>2</sup> )		796.0(m <sup>2</sup> )		
Eave Height (m)	4.40(m)		8.50(m)		
Floors	One-story		Two-story		
Construction	Reinforced steel concrete frame Block construction		Reinforced steel concrete construction		
Room Name	1 <sup>st</sup> floor	<ul style="list-style-type: none"> <li>• Auditorium</li> <li>• Storage</li> <li>• Other common space</li> </ul>	1 <sup>st</sup> floor	<ul style="list-style-type: none"> <li>• Hostel</li> <li>• Other common space</li> </ul>	
	2 <sup>nd</sup> floor	N/A	2 <sup>nd</sup> floor	<ul style="list-style-type: none"> <li>• Auditorium</li> <li>• Other common space</li> </ul>
