**THE STUDY
ON
THE URGENT REHABILITATION AND RECONSTRUCTION
SUPPORT PROGRAM
FOR
ACEH PROVINCE AND AFFECTED AREAS
IN NORTH SUMATRA**

**(URGENT REHABILITATION AND RECONSTRUCTION PLAN
FOR BANDA ACEH CITY)**

**FINAL REPORT (2)
VOLUME III : APPENDICIES**

**APPENDIX-1 QUICK IMPACT PROJECT (QIP) BY JICA FUND
(SEPTAGE TREATMENT PLANT)**

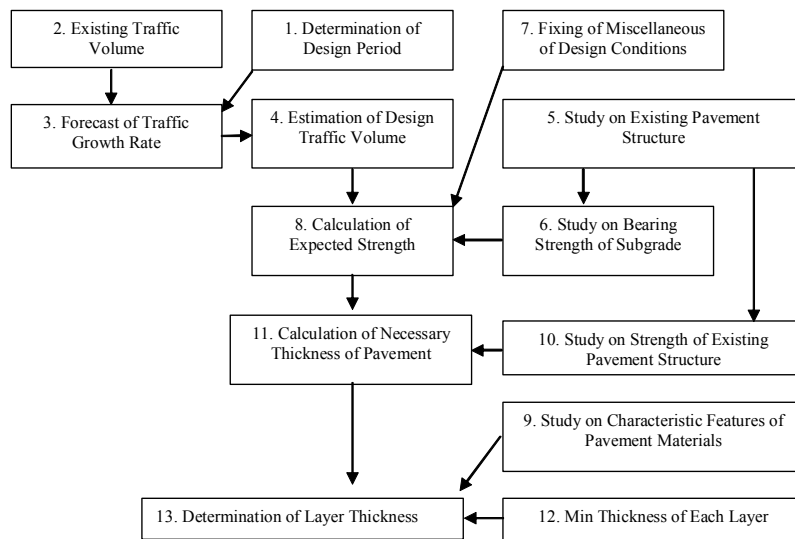
Figure 1.2.1 Asphalt Pavement Design Procedure by AASHTO

The following procedures are adopted for the design as described in Figure. 1.2.1:

Necessary strength of the pavement, termed as Structural Number (SN), is calculated by the following formula:

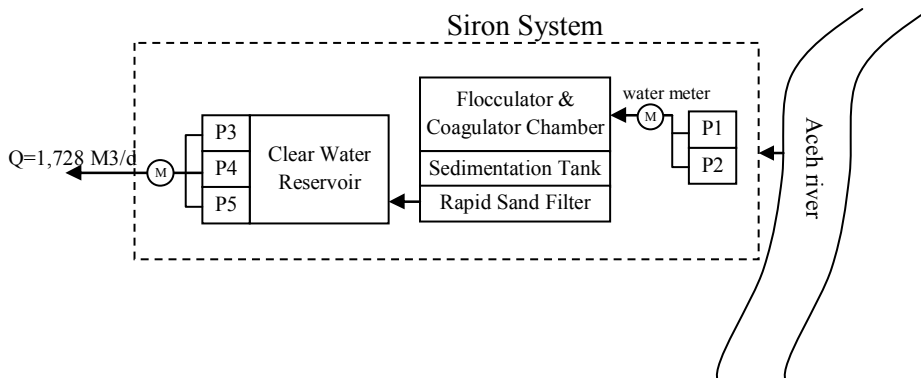
Figure 1.1.3 Schematic Layout of Siron WTP

A schematic layout of Lambaro and Siron WTPs are as shown in Figures 1.1.2 and 1.1.3 respectively. Both the plants depend on unregulated surface runoff of the Aceh River for raw water intake.

The Siron WTP is located on the right bank of the Aceh River and had a daily production capacity of 3,460m³.

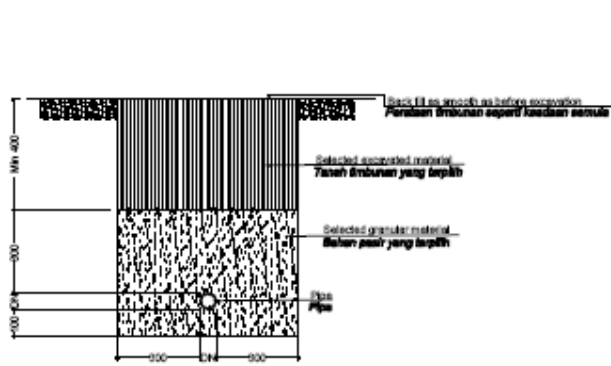
Fig. 1.2.4

Type I (Beneath Road Shoulder)
Tipe I (Dibawah Bahu Jalan)

Type II (Beneath Asphalt Pavement)
Tipe II (Dibawah Jalan Aspal)

Type III (Beneath Macadam Pavement)
Tipe III (Dibawah Jalan Kerikil)

Type IV (Road Crossing)
Tipe IV (Penyeberangan Jalan)
