EMERGENCY REPAIR WORKS OF ACEH RIVER AND FLOODWAY UNDER JAPAN'S NON-PROJECT TYPE GRANT AID

APPENDIX-3: EMERGENCY REPAIR WORKS OF THE ACEH RIVER AND FLOODWAY UNDER JAPAN’S NON-PROJECT TYPE GRAND AID

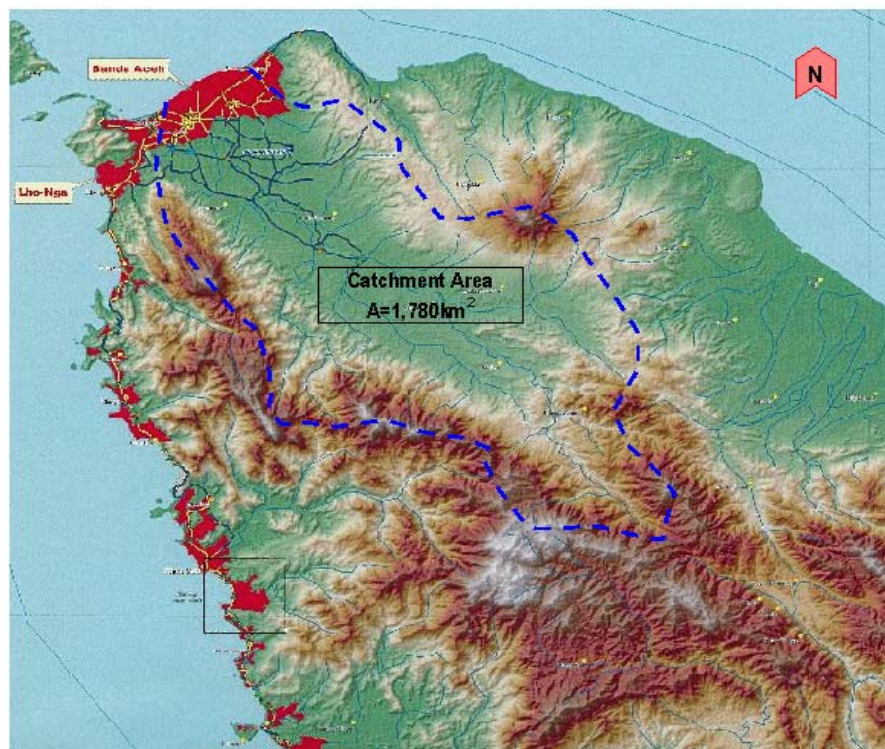
Figure 1.1.1 Aceh River River Basin

The Aceh River River has a catchments area of 1,780 km² with a length of 145 km. It takes its origin at Seulawah Mountains and runs to the north into the Strait of Malacca. Its drainage area includes Banda Aceh City and eleven (11) Kecamatan in the Kabupaten Aceh Besar, namely Masjid Raya Darul Imarah, Ingin Jaya, Kota Baro, Montasik, Sukamakmur, Indrapuri, Darussalam, Seulimum Kampung Jawa, and Kopelma Darussalam.

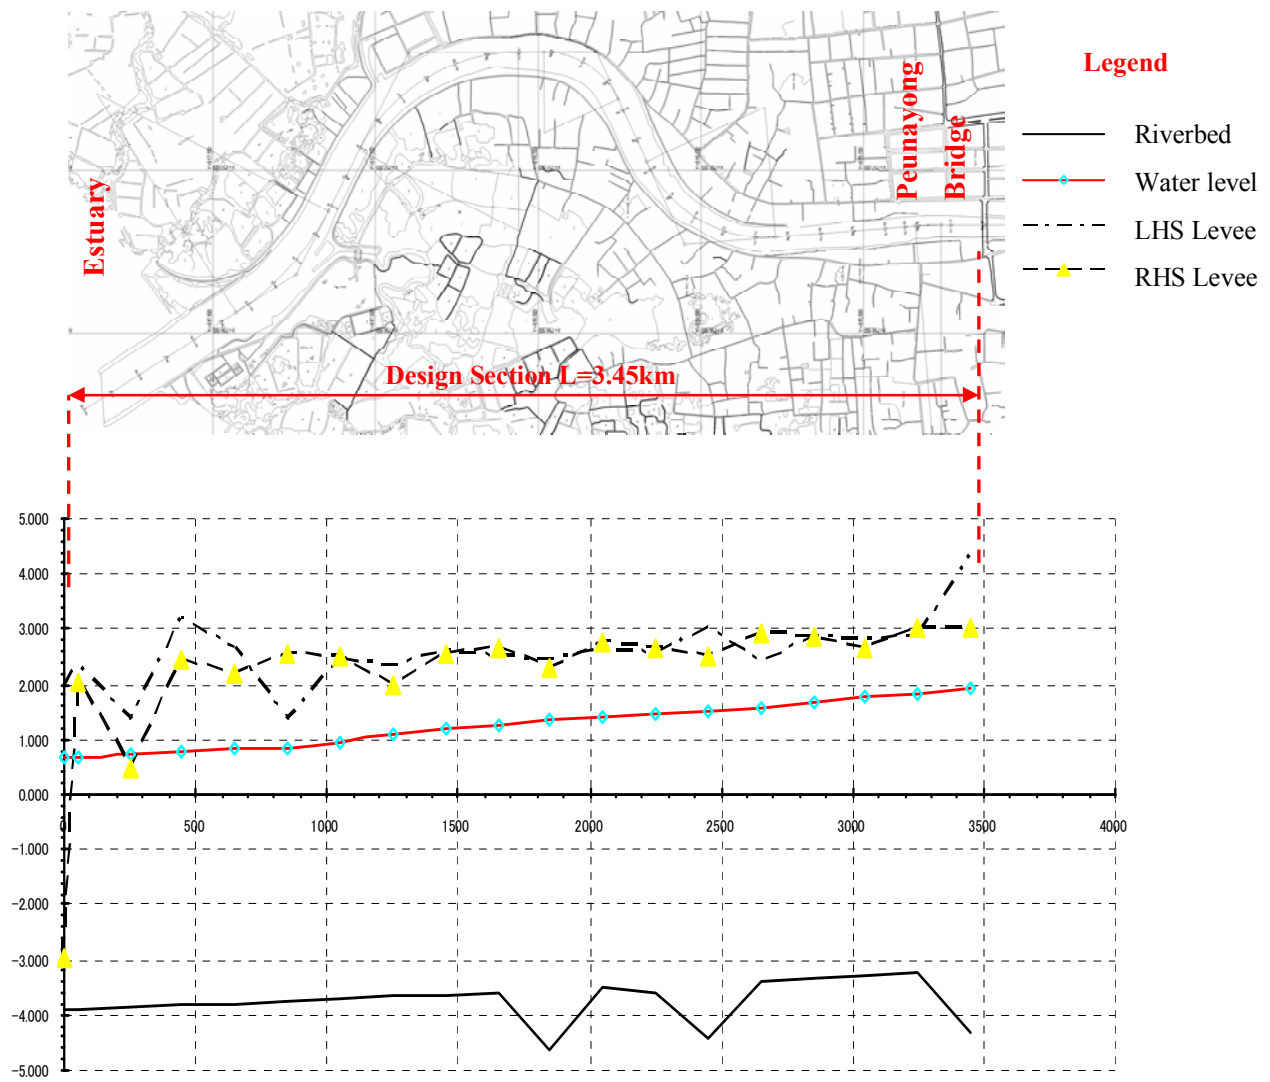
Plan and profile of the river and the result of hydraulic calculation are given in Figure 1.2.6 and Table 1.2.2 respectively.

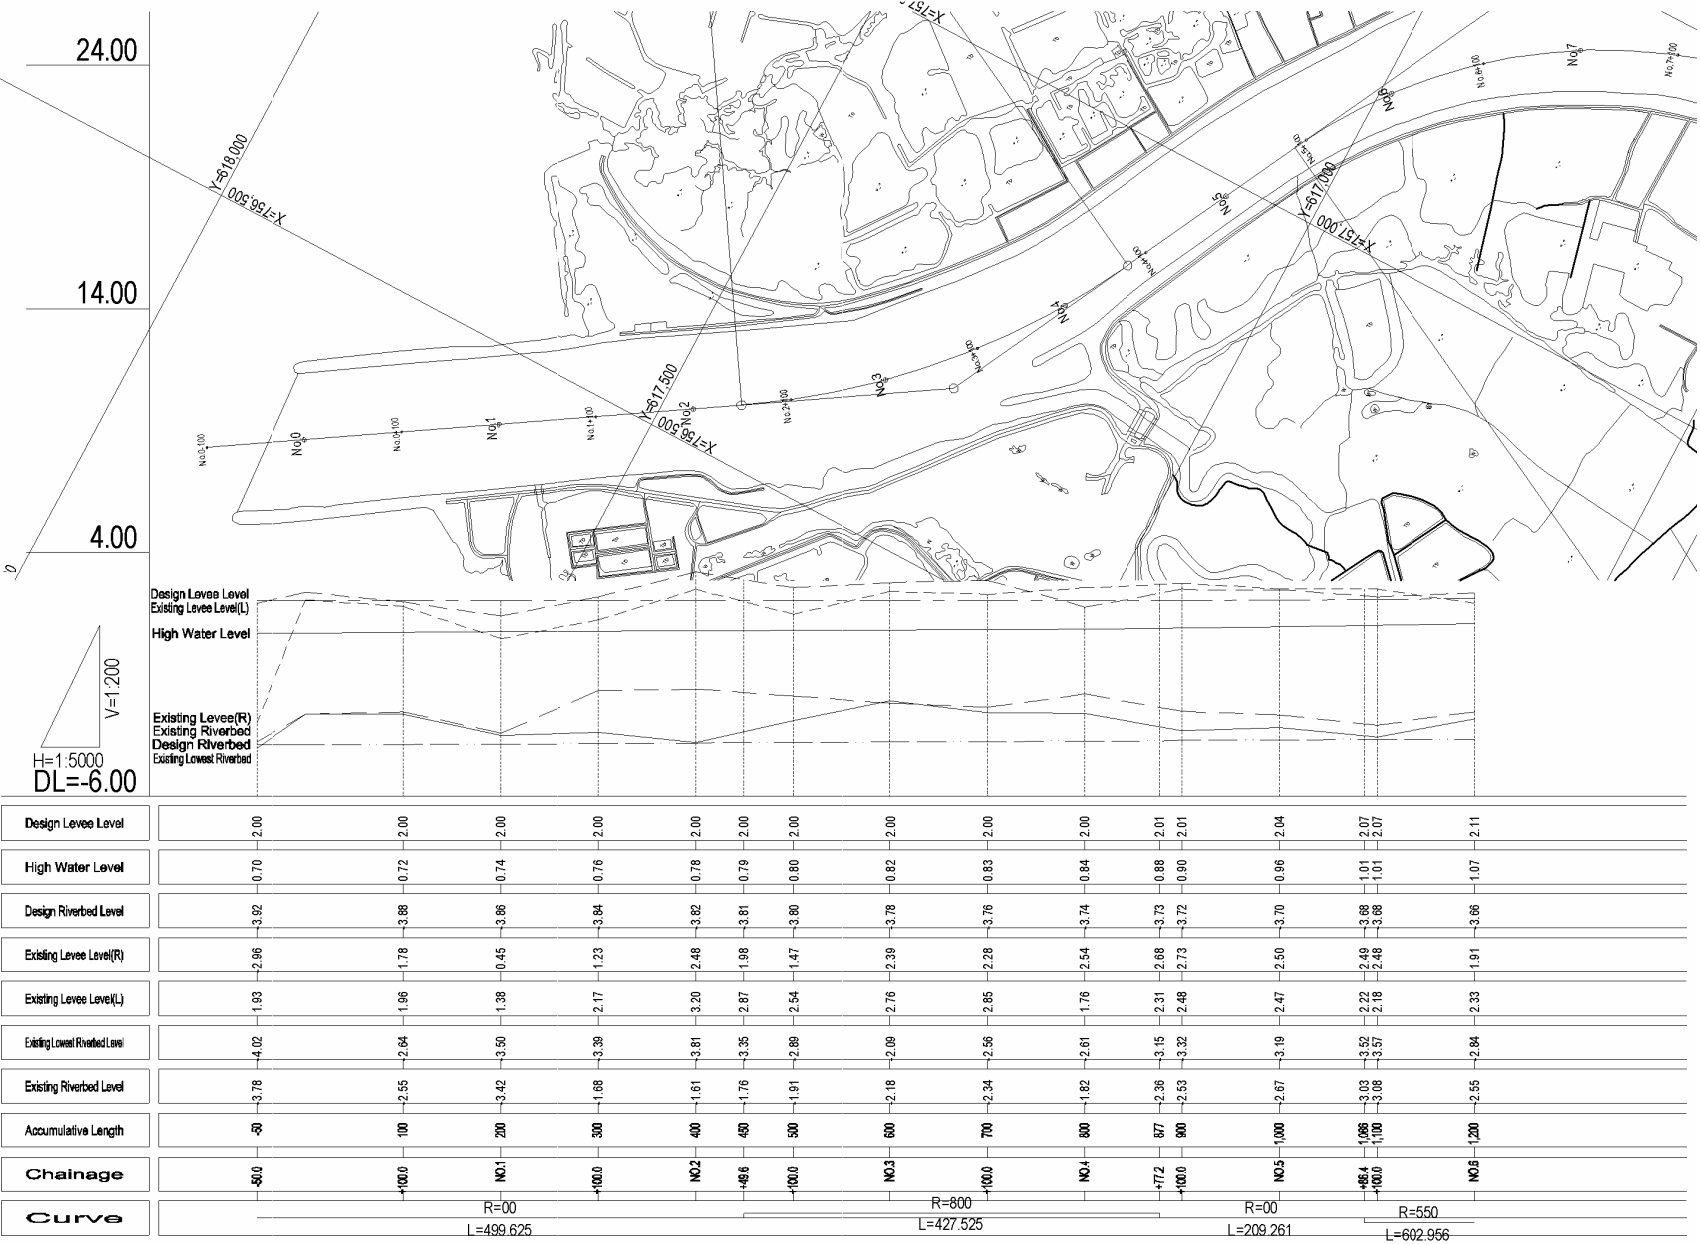
Figure 1.2.8 Plan and Profile of Aceh River under Case 2 (1/3)

Plan and profile of proposed improvement work is as given in Figure 1.2.8.

As a result of case study for river improvement work, it is concluded that Case 2 is technically and economically feasible and is adopted for the Project.

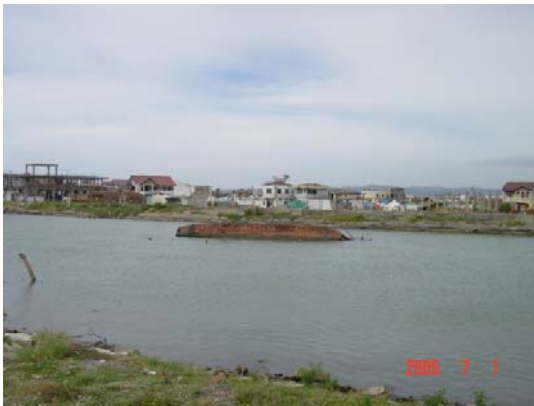
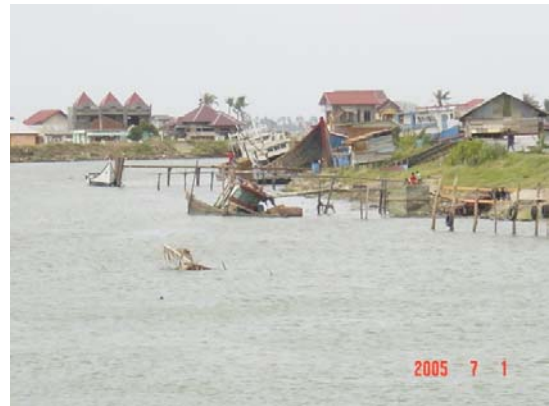
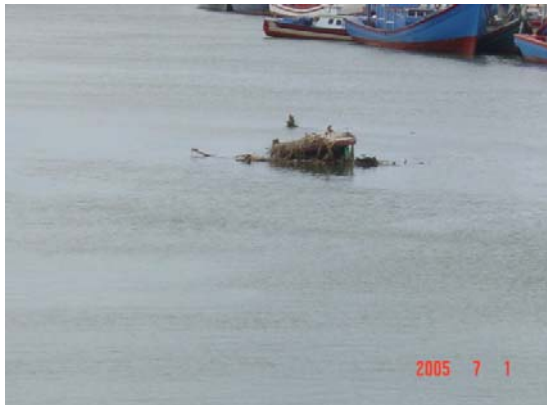
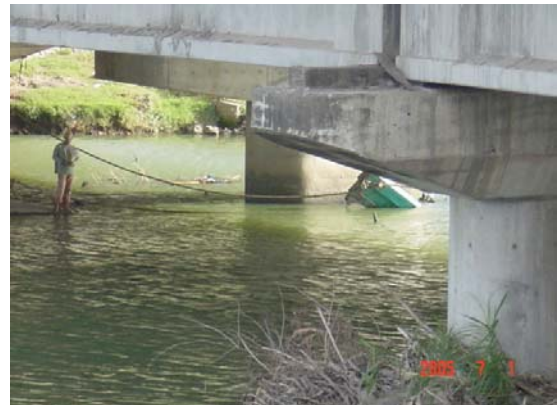
As of July 2005, there are three (3) sunken boats between the estuary and the Peunayong Bridge, and also another three (3) sunken boats in the upstream from Surabaya Bridge. Four out of 6 sunken boats are seen in photographs below:

The biggest sunken ship: overall length, 20 meters

Sunken ship appeared bow and cabin at Lampulo

Sunken Ship near Peunayong Bridge

Sunken small boat under Surabaya Bridge

Those boats are estimated to be 10 to 20 meters in length and necessary to be salvaged in order to secure flow area sufficient to discharge design flood flow and to ensure safe passage of water transport. The salvage work is considered to be executed by either crab dredger or derrick crane.

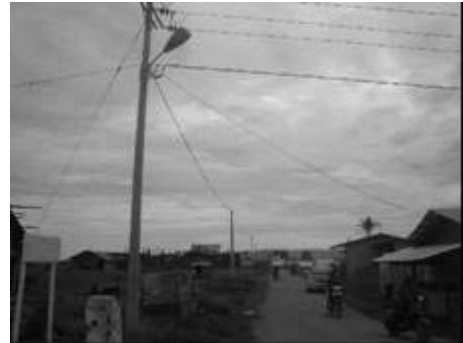
Figure 1.1.6 Telegraph Poles Near the Project Site

The power supply-related equipment of the facility was also destroyed by the tsunami. Currently, PLN is doing the wiring construction for the telegraph poles around the project site, so as in the past, power will be supplied through the poles. As a rule, however, when applications are submitted to PLN (Indonesia's state-run power company), PLN makes the decisions regarding the locations where power is to be supplied.
