PART H ENVIRONMENTAL AND SOCIAL CONSIDERATIONS

H1 EIA Process in Solomon

H2 Environmental Impact of the Projects for Honiara

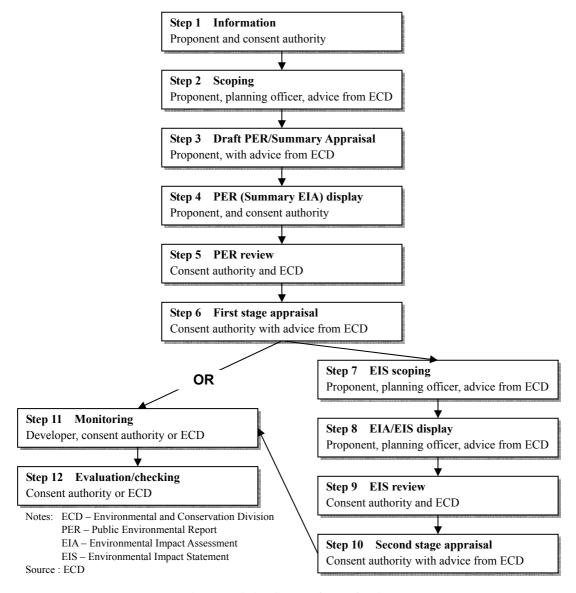
Figure H1-1 Steps of PER/EIA Process

Solomon Islands Environment and Conservation Division (ECD) in the Ministry of Natural Resources provides *Solomon Islands Environmental Impact Assessment Guidelines* (hereinafter referred to as "the Guideline") for planners and developers. Figure H1-1 shows the steps recommended in the Guideline. The proponent of project submits the draft public environmental report (PER) or summary appraisal.

In order to get approval from ECD, proponent of this project has to submit the draft PER or summary appraisal to ECD in line with the Guideline. The following activities are necessary for proposed project.

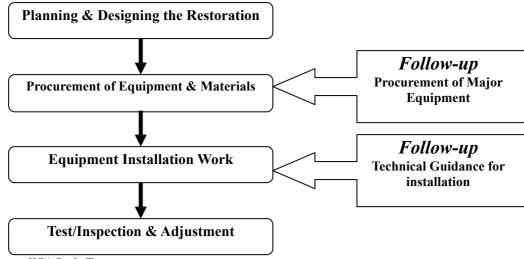
Figure I1-1 Position of Follow-up Cooperation

F/U is positioned as shown in Figure I1-1 in the rehabilitation flow. The works not covered by F/U are under the scope of SIWA.
