(1) Water Sources

(2) Pumping Stations

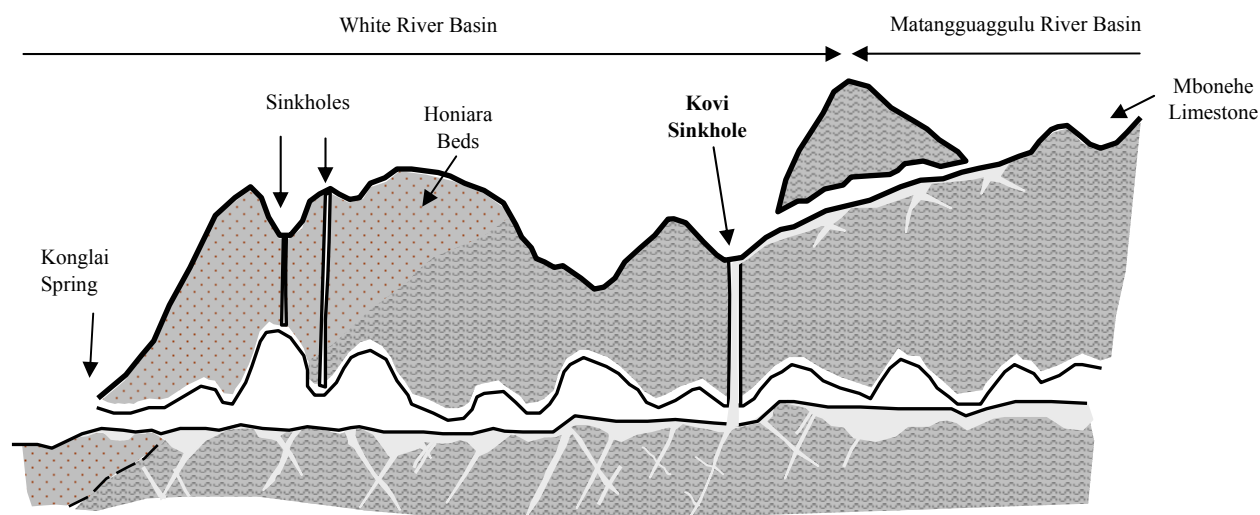
Figure B1.5-2 Image of Cave System of Konglai Spring to Kovi Sinkhole

Water flowing within cave system appears in spring point of Konglai. River water other than White River provides water into this cave system. Mbonehi limestone is widely distributed in White River basin and neighboring river basins. There are many sinkholes in the area, which are vertical holes developed by erosion of limestone due to rainfall. Sinkholes reach cave system of underground, and much surface water falls into the cave system though sinkholes (see Figure B1.5-2). It is said that water falling into Kovi sinkhole, which is located in the middle- area of White River, is main water source of Konglai Spring (see Figure B1.5-1). Kovi sinkhole is located in White River basin. It is assumed that water from Matanguaggulu River appears at immediate up part of Kovi sinkhole crossing water-shed. There are several faults crossing above two river basins, which cause connection of river water of the two basins though undergrad case system.

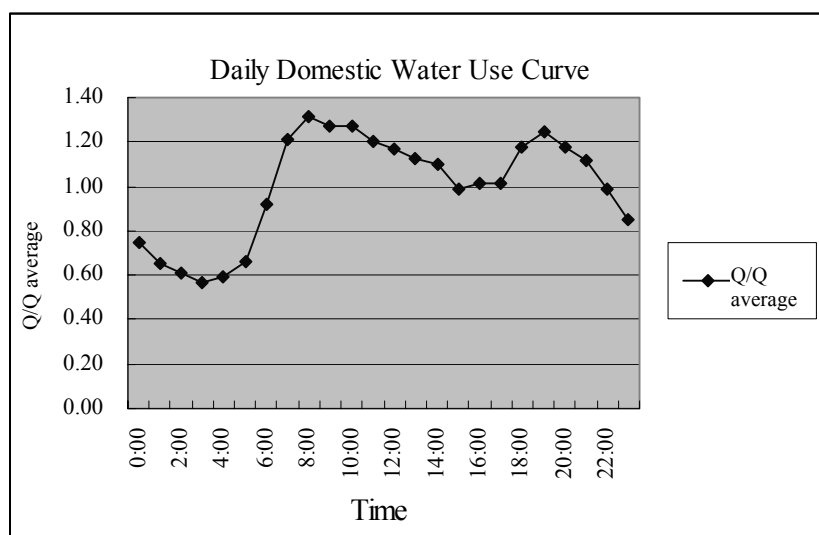
Figure B2.1-1 Domestic Daily Water Usage Curve

The domestic demand daily variations were observed to obtain the hourly peak factor through the flow measurement in the leakage survey at the model areas. The daily domestic water use curve compiled as a basis for planning is as shown in Figure B2.1-1.

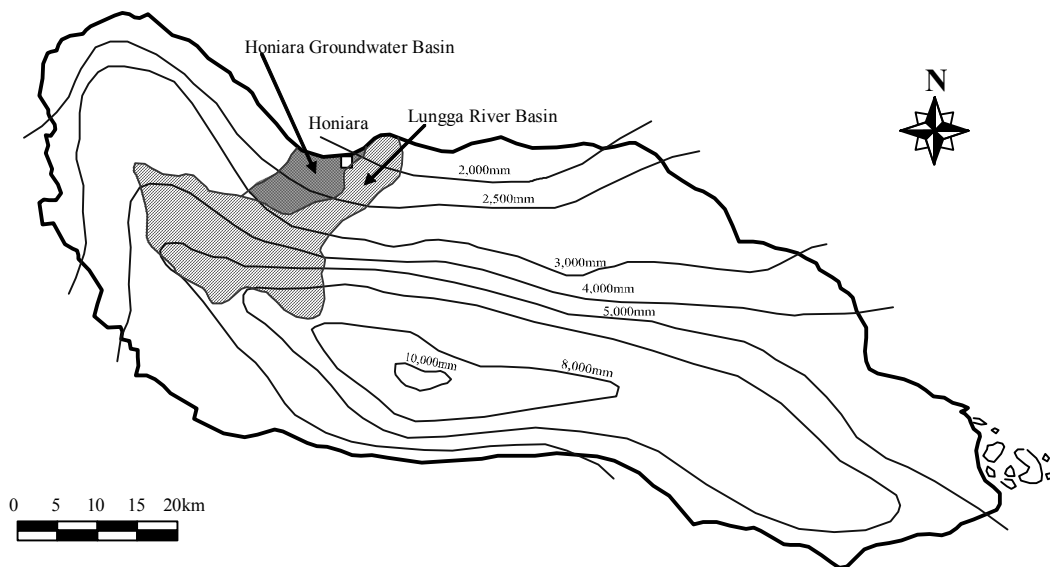
Figure B2.2-1 Lungga River Basin and Honiara Groundwater Basin

Honiara Groundwater Basin is divided into 4 river basins, namely, White River, Rove Creek, Mataniko River and Kombito Creek. Mataniko River Basin has the biggest area of above 4 river basins. However, there was no long-term discharge observation for water balance analysis for Mataniko River. Situation of data accumulation is the same in case of the other rivers. On the other hand, there is long-term discharge data for Lungga River, which flows in the south of Honiara Groundwater Basin. This data has been accumulated in MNR, and it has enough accuracy for water balance analysis. Therefore, water balance on Honiara Groundwater Basin should be analyzed based on water balance of Lungga River Basin.
