**BASIC DESIGN STUDY REPORT
ON
THE PROJECT
FOR
REHABILITATION AND IMPROVEMENT
OF
MALIANA I IRRIGATION SYSTEM
IN
THE DEMOCRATIC REPUBLIC OF TIMOR-LESTE**

**JAPAN INTERNATIONAL COOPERATION AGENCY
GRANT AID MANAGEMENT DEPARTMENT**

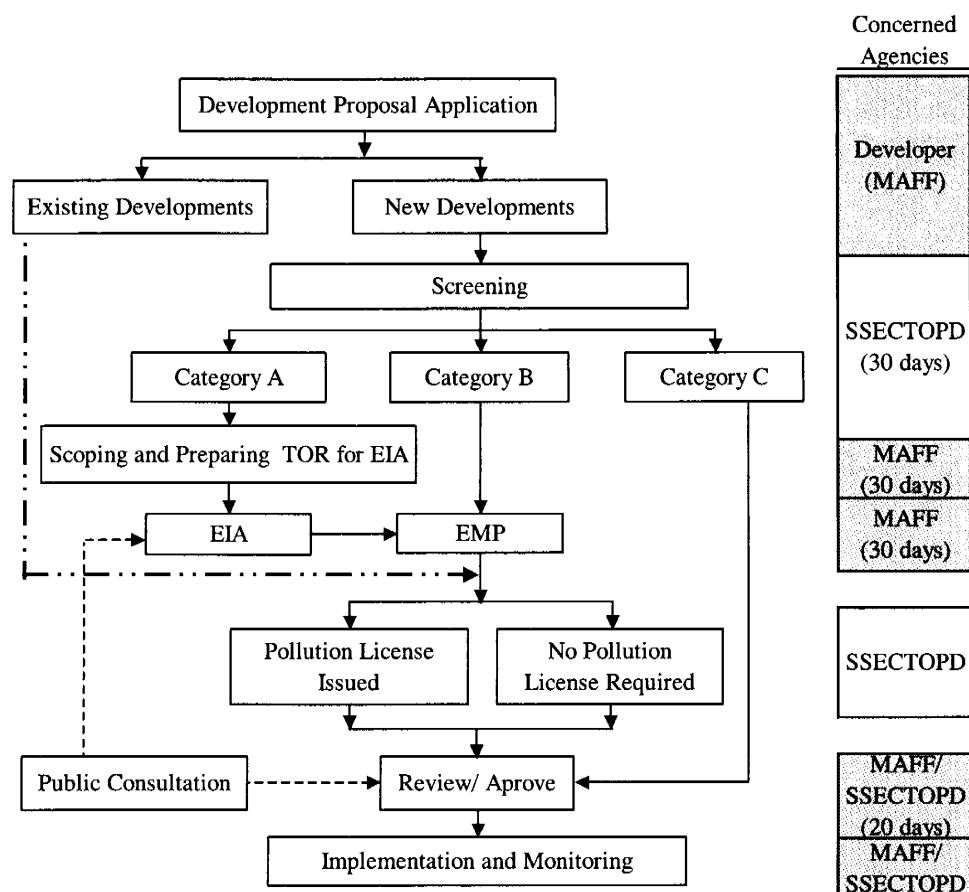
According to "Guideline #1: Environmental Requirements for Development Proposal" stated in the proposed "Environment Guideline (draft)" that is currently being implemented in Timor-Leste, developer (The developer of Maliana I Project is MAFF) of new and improvement projects is required to submit an application to the Secretary of State for Environmental Coordination Technical Ordering and Physical Development (SSECTOPD) and to secure approval on the contents of the development plan as indicated in the flowchart of Figure 2-2. Accordingly, prior to the project implementation, MAFF shall provide an Environmental Management Plan (EMP) and obtain permission from SSECTOPD as a prerequisite procedure to implement the Project.

EIA:Environmental Impact Assessment

EMP:Environmental Management Plan Source: Environmental Guideline # 1, SSECTOPD
