Chapter 3

Existing Water Supply System

3 Existing Water Supply System

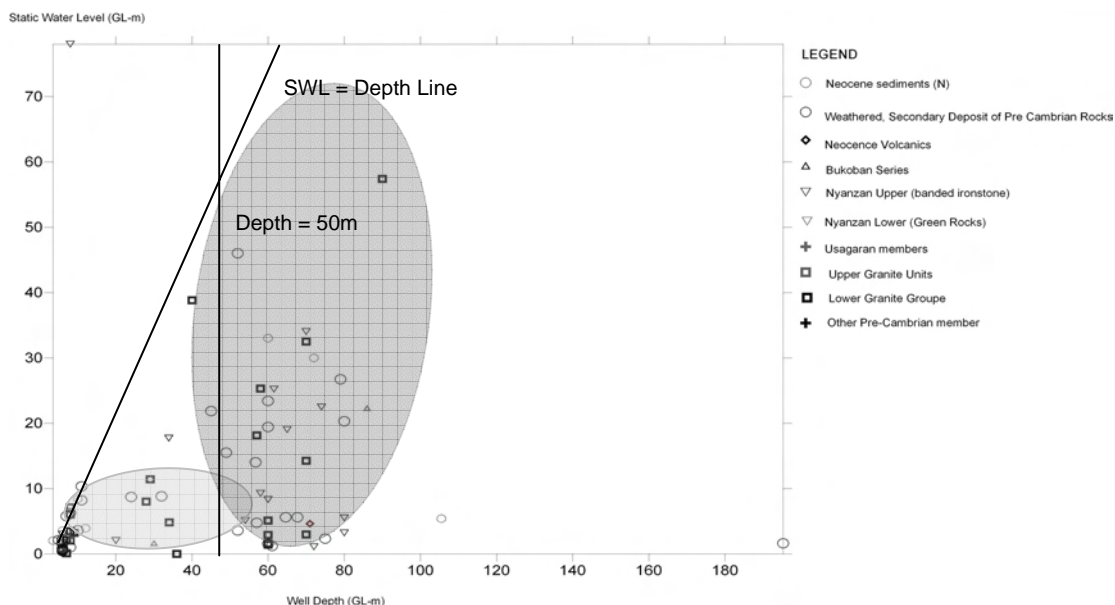
Figure 4.3-3: Well Depth and Static Water Level

The relationship between well depth and water level is examined in Figure 4.3-3.

There is a tendency for the static water level to be less than 10 meters until a depth of between 40 to 50 meters. The aquifer unit in this range is weathered Precambrian and granite members. This may indicate that unconfined – semi confined aquifers are present until a depth of around more or less 50 meters, and as the depth increases, the variation of yield increases.

It should be noted that the difference of massive rocks and the decomposed zone can hardly be identified from the surface. Therefore, from the depth of 30m to 80m bgs, the two rock units interfuse.
