APPENDICES

Table A2-1 Inventory Survey (Aganan RIS in Region-VI)

INVENTORY SURVEY
FOR
NATIONAL IRRIGATION SYSTEMS (NIS)

NIS Name : Aganan RIS (Region-VI)
Survey Year : CY 2004 – 2005

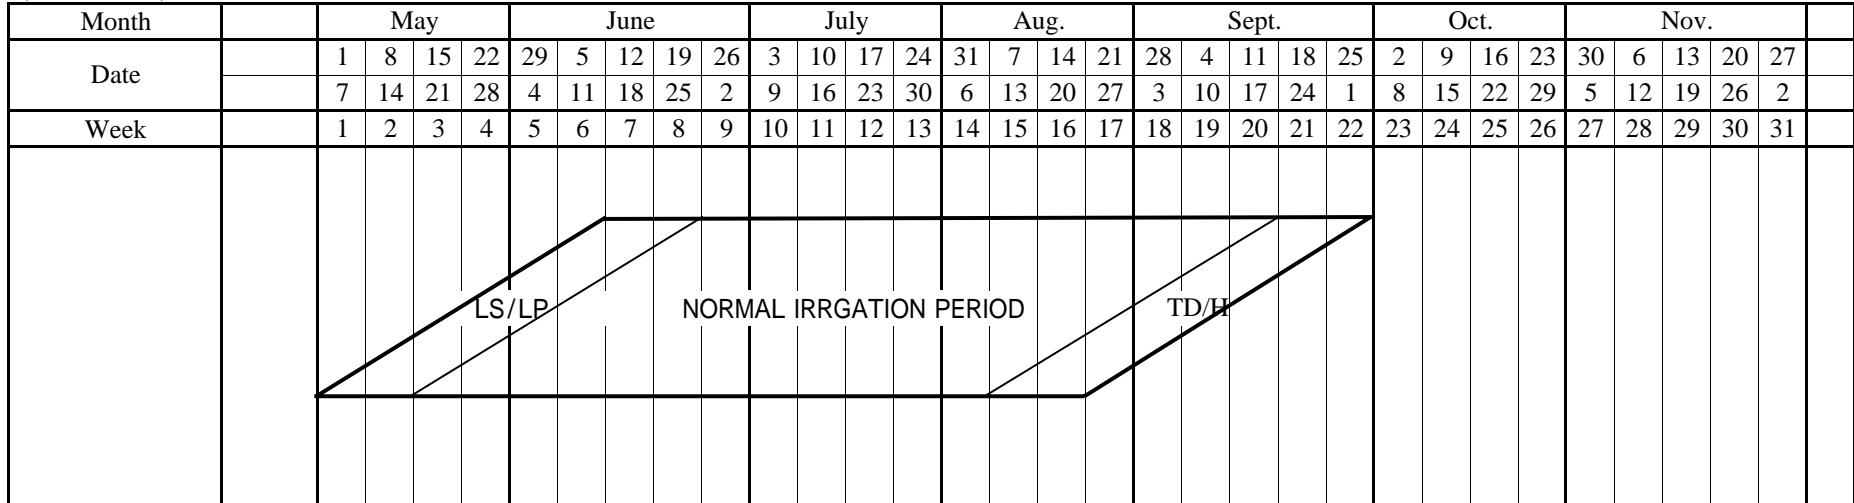
Figure 2-1 Typical Cropping Pattern of Paddy

(Wet Season)

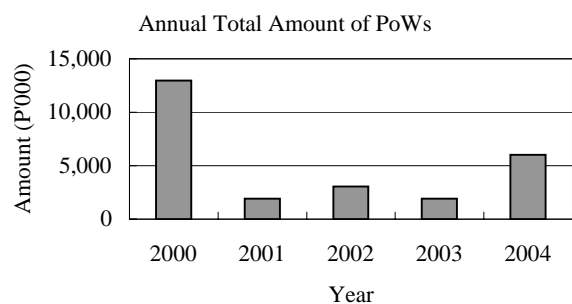
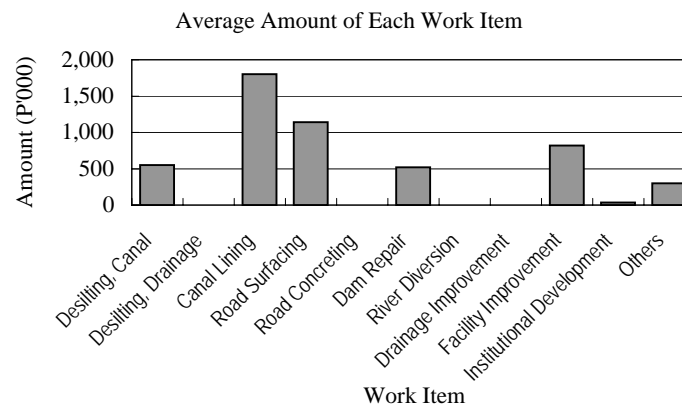
Work Item ('000 Pesos)	2000	2001	2002	2003	2004	Total	Average	Share (%)	Rank	
1 Desilting, Canal	672	286	0	1,806	0	2,764	553	11	4	Total Share
2 Desilting, Drainage	0	0	0	0	0	0	0	0	8	of Rank 1-3
3 Canal Lining	9,002	0	0	0	0	9,002	1,800	35	1	73%
4 Road Surfacing	2,150	859	1,947	0	756	5,712	1,142	22	2	Total Share
5 Road Concreting	0	0	0	0	0	0	0	0	8	of Rank 1-5
6 Dam Repair	0	0	0	0	2,590	2,590	518	10	5	93%
7 River Diversion	0	0	0	0	0	0	0	0	8	
8 Drainage Improvement	0	0	0	0	0	0	0	0	8	
9 Facility Improvement	1,142	773	0	0	2,192	4,107	821	16	3	
10 Institutional Development	0	0	90	96	0	186	37	1	7	
11 Others	0	0	1,025	0	471	1,496	299	6	6	
Total	12,967	1,918	3,062	1,901	6,009	25,857	5,171	100
