CHAPTER 5 TARGET SETTING FOR EARTHQUAKE RESISTANT PLAN

5.1 General

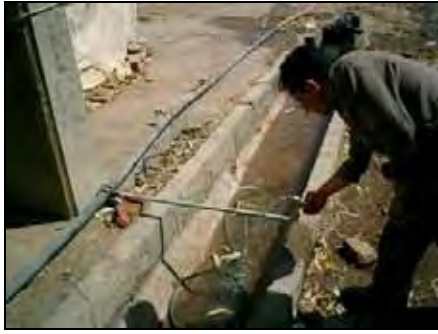
Ground-surface piping and temporary water taps in Bam City

In Bam city, the damage of distribution pipe network was very serious and it was extremely hard to repair these pipes. Temporary public water taps were installed in various locations in the city after separating seriously damaged network from the distribution main which were relatively less damaged. After the separation of damaged pipes conducted by closing gate valves, polyethylene pipes (PEP) were branched from the upstream points of the closed valves for temporary water supply.

The PEP were mainly supplied with the help of other provinces (the aid from foreign countries were relatively small). As seen in the pictures above, temporary ground-surface pipes (running on the ground surface for emergent water supply) were installed by the local water supply authority itself.

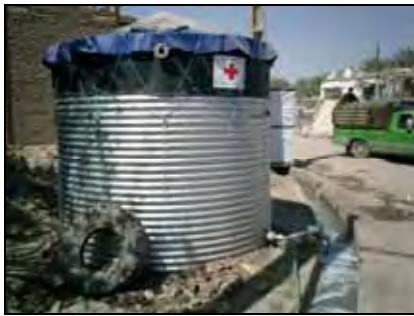
Temporary water supply tanks in Bam City

In addition to these temporary pipes, temporary water supply tanks with taps were installed in various locations in the city with help of other Iranian provinces (partially from international organizations as well). Approximately three months after the earthquake, 18 tankers were operated to supply water to these tanks.

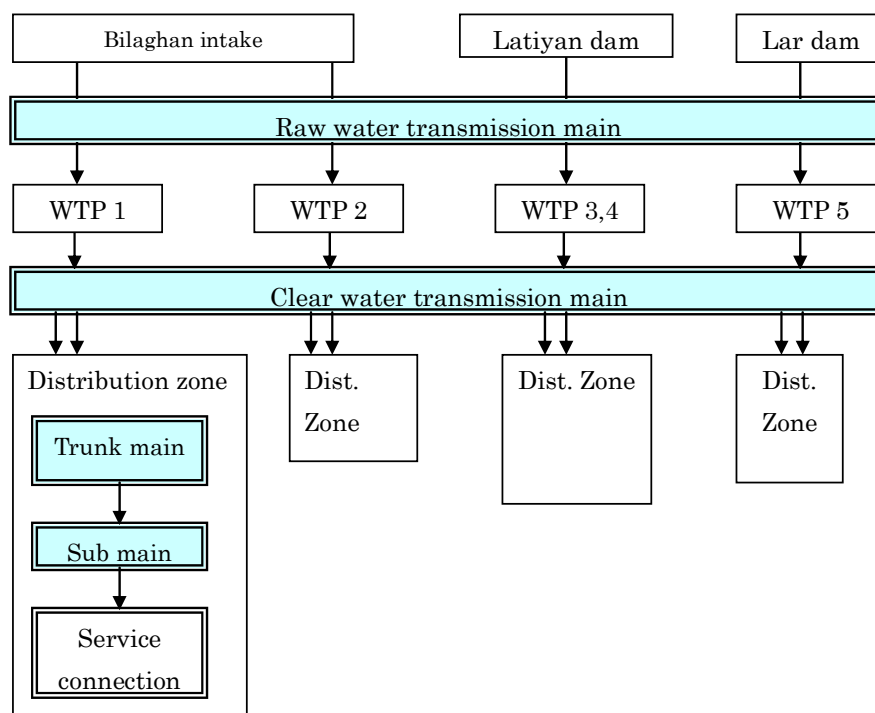
Figure 6.2.1 Water Supply Cascade Structure

Existing pipeline system has class structure, i.e., shape of cascade. Water transferred from intake to final users through the system. *Figure 6.2.1* shows schematic layout of the system.

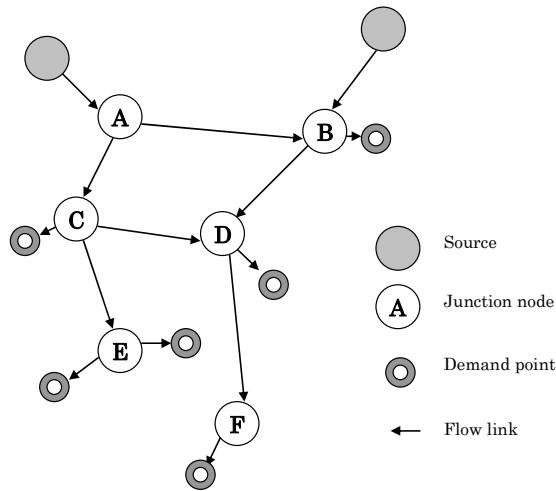
Figure 6.2.14 Reliability Analysis

Hereinafter analysis method is briefly described. Water starts from water treatment plant and reaches to reservoirs or junctions connected to distribution mains through transmission main system.

Water in the reservoirs is distributed to corresponding reservoir zones together with direct injected water to distribution mains. Therefore transported water is allocated to specified reservoir zones. These quantities are given as demand quantities. Considering these

conditions, each demand has corresponding reservoir zone. If any damage occurs in pipeline and demand quantities become less than required or even zero, such influences can be considered as effects to certain reservoir zone. Magnitude of effects is summarized for every reservoir zone. Worst case for the zone is the case of water supply stops completely. Possibility of such water stoppage situation is calculated in the analysis. Sometimes term “reliability” is used instead of damage possibility. This reliability indicates possible rate of “any” water to the zone. 100% reliability means any water arrives to the zone even though quantity is quite small. This doesn’t mean percentage of water shortage area nor water
