6-3-3 Airports

6-3-4 Water Supply

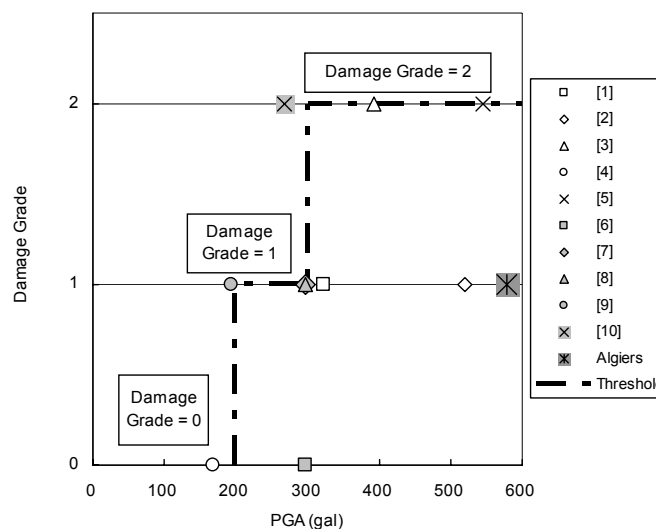
Figure 6-34 Relationship between Damage Grade of Airport and PGA

For the relationship between the damage grade and the PGA refer to Table 6-21. The Algiers airport damaged experience from the Boumerdes Earthquake is shown in Figure 6-34.

(The number in the legend of the above figure corresponds with the airport name in Table 6-20.)

Damage condition (grade) of the Algiers airport from the Boumerdes Earthquake deviates from the threshold line. However, the structure of the Algiers port is based on the international code, this implies that there is possibility that similar damage could occur due to a huge earthquake. Hence, the above relationship is applied for the airport damage estimation to be on the safe side.

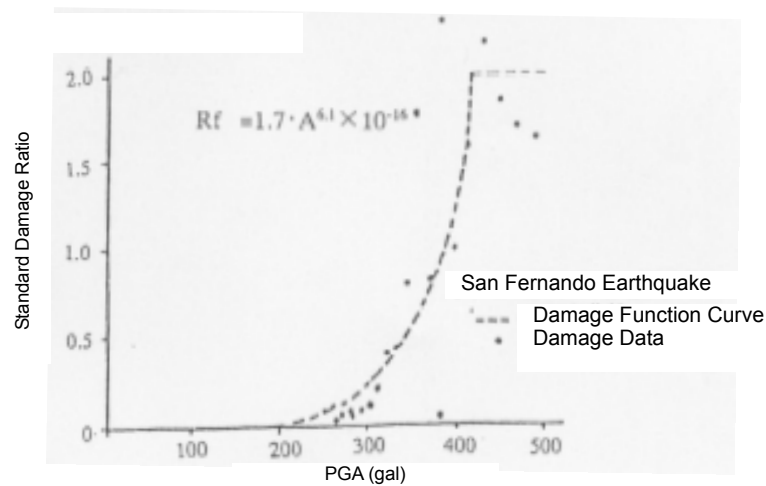
Figure 6-36 Relationship between Peak Ground Acceleration and Standard Damage Ratio for buried Pipeline based on the San Fernando Earthquake (1971)

The basic concept of the damage function for pipelines buried underground was established by Kubo and Katayama (1975) based on the damage condition of the pipelines due to the San Fernando Earthquake in 1971 as shown in Figure 6-36.
