**BASIC DESIGN STUDY REPORT
ON
THE PROJECT FOR
IMPROVEMENT OF FISHERIES TRANSPORTATION
IN SOUTH TARAWA
IN
THE REPUBLIC OF KIRIBATI**

JANUARY 2007

JAPAN INTERNATIONAL COOPERATION AGENCY

CONSTRUCTION PROJECT CONSULTANTS, INC.

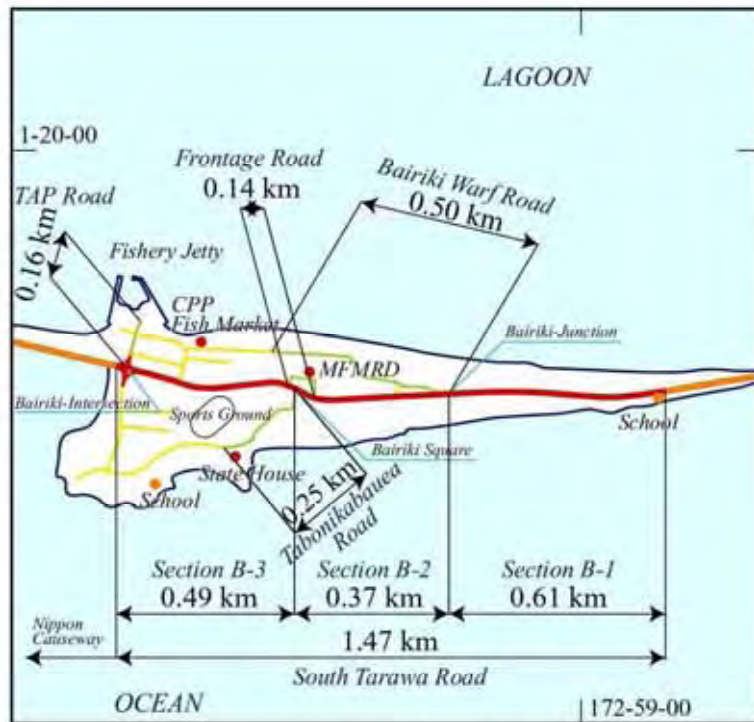
South Tarawa Road
 $L=0.49+0.37+0.61=1.47$ km
 Frontage Road
 $L=0.14$ km
 Tabonikabauea Road
 $L=0.25$ km
 TAP Road
 $L=0.16$ km
 Bairiki Warf Road
 $L=0.50$ km

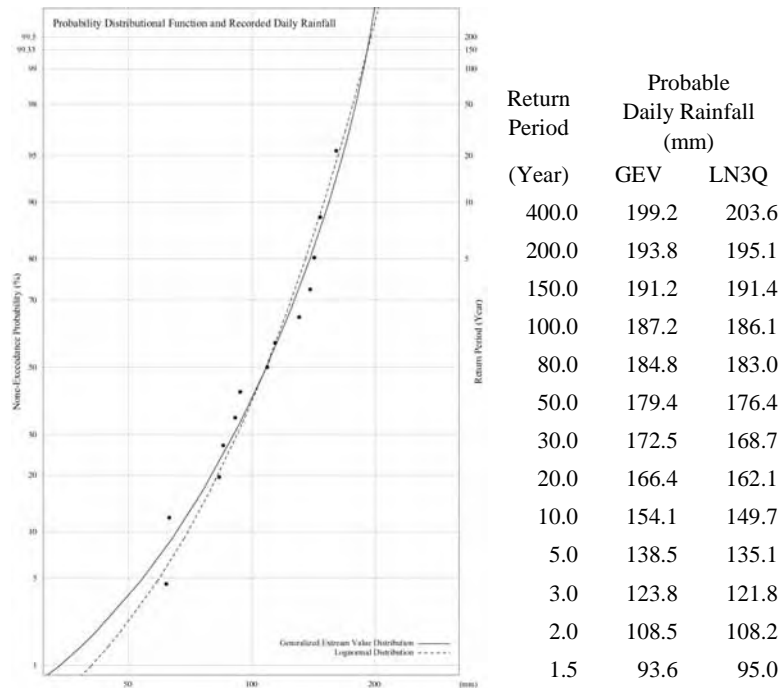
Fig. 2-4 Results of Probable Daily Rainfall Analysis

Fig. 2-4 shows the rainfall intensity probability curve based on the maximum daily rainfall records of the Meteorological Agency for the period from 1993 to 2005. Based on the data for 13 years, the rainfall intensity return period (daily rainfall) can be estimated as shown in Table 2-1.

Return Period	3 Years	5 Years	10 Years	20 Years	30 Years	50 Years	100 Years
Rainfall Intensity (Daily Rainfall)	124 mm	139 mm	155 mm	167 mm	173 mm	180 mm	188 mm

The standard type of rain in Kiribati is short downpours caused by well-developed cumulonimbus. As it is the standard practice to use the rainfall intensity with a return period of three years for the design of side ditches with an extremely short reaching time, such as roadside drainage ditches, as recommended by the Guidelines for Drainage Works (by the Japan Road Association, June, 1987) or used by actual designs in various countries, this standard practice is adopted for the design of the drainage ditches described later. The lower estimate and the higher estimate for the hourly rainfall intensity with a return period of three years is 62 mm and 124 mm respectively.

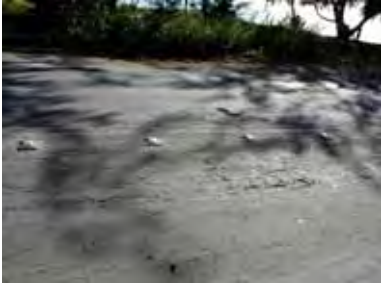
No.	Road Surface Condition	Cause of Road Surface Deterioration	Type of Repair Work	Sample Photograph
a	Crisscrossing crack	Insufficient base course strength Deterioration of the paving Poor groundwater drainage	D or E

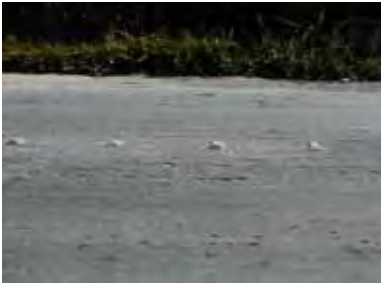
b	Linear crack	Deterioration of the asphalt paving Poor work	B, C or D

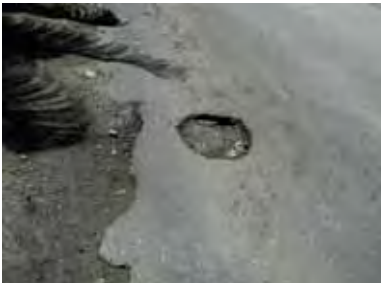
c	Pot hole	Localised insufficient base course strength Deterioration of the asphalt paving Poor work	B, C or D

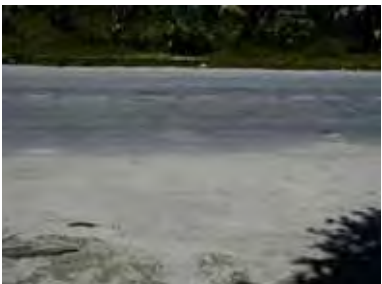
d	Rutting	Insufficient base course strength Inappropriate mixture design Poor quality of the aggregates used	D or E

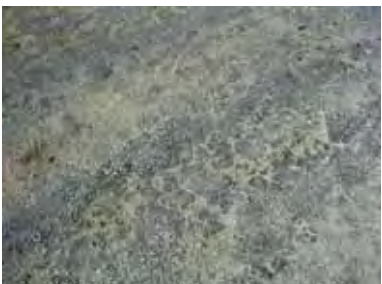
e	Ravelling	Inappropriate mixture design Poor quality of the aggregates used Poor work	C or D
