ネパール国
ネパール電力公社

ネパール国
アッパーセティ水力発電計画調査
環境社会配慮レポート

平成 19 年 6 月
(2007)

委託先
電源開発株式会社
日本工営株式会社

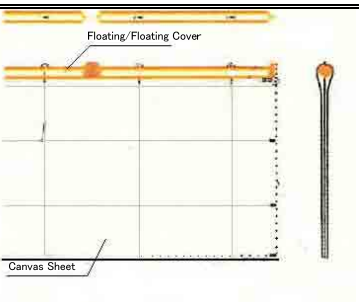
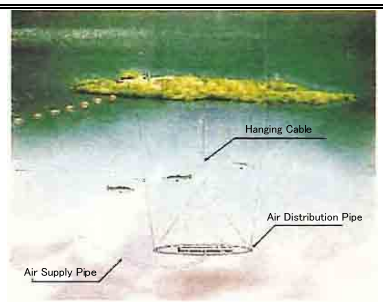
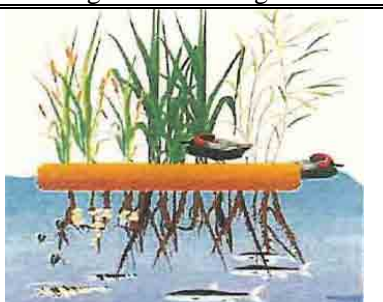
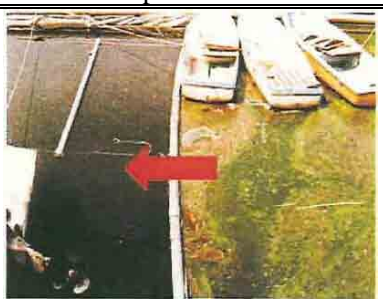
Table 1.3-2 Comparison of the Measures for the Eutrophication in the Reservoir

Purpose	Restrict the photosynthesis of phytoplankton by nutrient salt flowing downward	Make circulation flow in the reservoir by supplying the air bubble. In addition to prevention of algae bloom, it is expected that DO in the reservoir will be improved.	Plants absorb the nutrient salt from the reservoir water. Furthermore, algae bloom is controlled since the floating inland shade the sun light on the surface of the reservoir.	Change the reservoir water into weak alkali condition by input the mineral. In the alkali condition, microbes actively resolve the organic material.
Specification	Float: Foam Polystyrene covered with rubber sheet Curtain: High strength polyester	Deep aeration system Shallow aeration system Total aeration system	Inside: Palm fiber Outside: Synthetic resin foundation with protection net	Main Ingredient: Magnesium Hydroxide

Features	<ul style="list-style-type: none"> • The effects appear soon • To removal easily • No maintenance • Durability 5 to 8 years 	<ul style="list-style-type: none"> • To improve DO • Large system is required. 	<ul style="list-style-type: none"> • More than 10% of reservoir surface should be covered. • No maintenance • Impossible to provide in the fast flow area 	<ul style="list-style-type: none"> • Deodorizing effect is expected. • To prevent elution of the phosphorus from the bottom of the reservoir • In the case that the reservoir volume and river discharge is large, large quantity of the minerals is required
Initial Cost	Low	Medium	High	High
Running Cost	No	Operation and maintenance costs are required.	No	Depend on the reservoir water condition
Total Estimation	Recommendable	Difficult	Impossible	Difficult

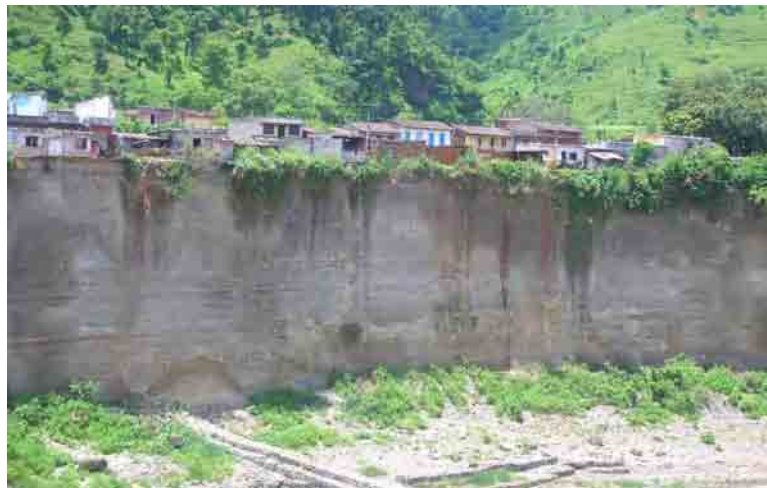
Plate 1: Soil slide on the river terrace at Bhimad Bazaar

Bhimad Bazaar is situated on the river terrace deposits (Plate 1). The vertical elevated Tar is about 30 m high. It is composed of gravel containing pebbles to cobbles of limestone and calcareous shale with light brown silt, fine sand and a little clay matrix. The terrace deposit is loose and soft.

The terrace deposit of Bhimad Bazaar extends between the Jyagdi Khola and Seti River and forms a vertical soil cliff. In the past, there used to be a moderately gentle slope, but due to toe cutting by the Seti River, the terrace became vertical and is very prone to collapses.

The deposit has three distinct sequences. The top 2 m of it is composed of rounded to subrounded boulders and pebbles of limestone, gneiss, quartzite and other metamorphic and sedimentary rocks. At the bottom of this sequence there is an erosional surface. This sequence consists of fine light brown sand and clay matrix. It is a fining-upward sequence with boulders up to 70 cm in diameter. The second sequence is light grey to dark grey gravel containing dominantly fine pebble with some cobbles of calcareous shale and limestone. The lowermost sequence is light brown in colour. It is rather loose with dominantly subrounded fine pebbles of grey calcareous shale and limestone with light brown sand and silt.

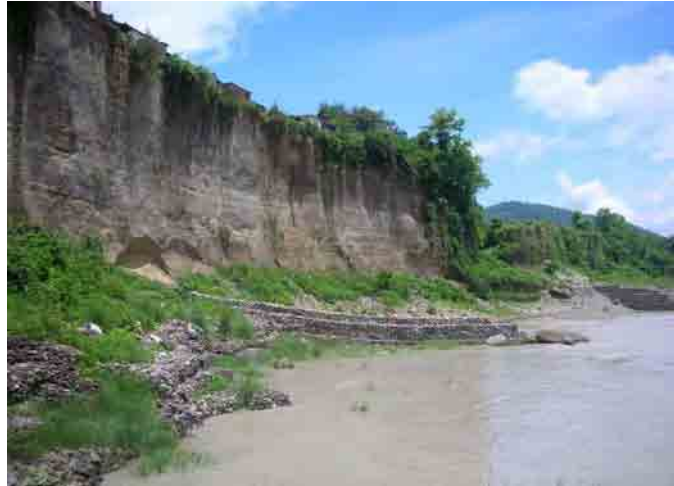
Plate 2: Terrace cliff east of Bhimad Bazaar

Since 2003, the Seti River Control and Bhimad Bazaar Management Committee is working for the management of Bhimad Bazaar and carrying out river training works to protect the Bhimad Bazaar from bank erosion and undercutting. The Committee has constructed about 150 m long gabion embankment, 3 spurs (about 40 m long, 2 m high and 2 m wide) to protect the steep cliff from toe cutting (Plates 2 and 3). As a result, presently the cliff is protected and the Seti River is undercutting its left bank.

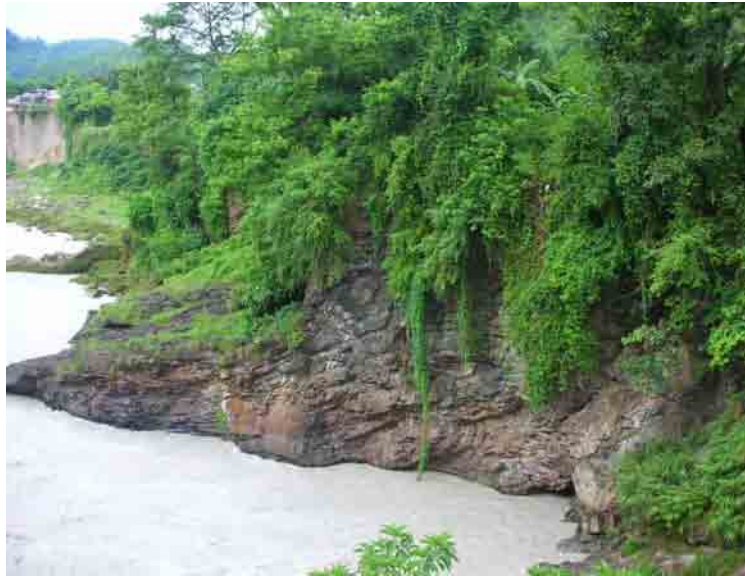
Plate 4: Rock exposure (black slate) on the right bank of The Seti River at the bridge

Dark grey to black coloured thin- to medium-bedded slate (Plate 4) is exposed on both banks of the Seti River, over which there is a truss bridge (span = 55 m) and an antique suspension bridge made by local people using local resources during the ruling period of Juddha Shamsheer. The black slate is dipping towards the south with dip amount less than 45° . Very gently dipping synclinal fold is observed just below the truss bridge. A narrow gorge is formed at this place.

The rock exposure is about 20 m in high and 35 m in wide. There are two prominent joint sets, which are filled with silt and clay. The exposure is damp but no water is seeping through it.

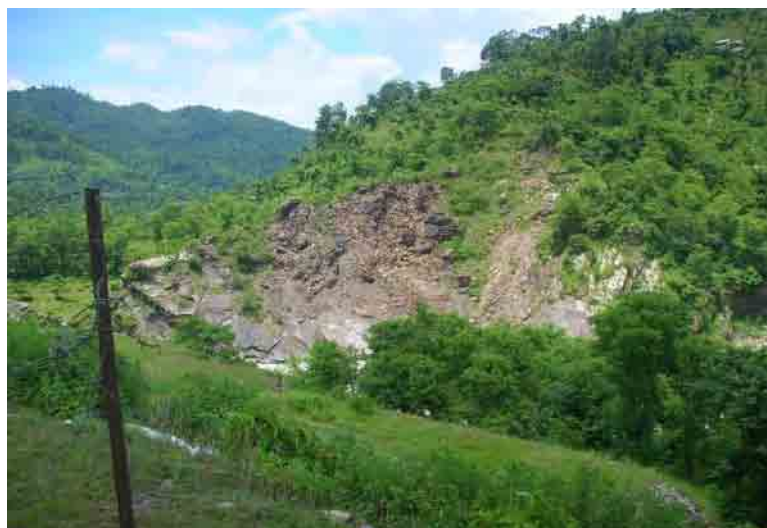
Plate 5: Rockslide on the left bank of The Seti River near Bhimad Bazaar

About 300 m downstream from Bhimad bazaar, on the left bank, there is about 20 m high and 15 m wide plane rockslide (Plate 5). It is a dip slope and there are two perpendicular joint sets intersecting the cleavage plane. On the right bank, opposite the rockslide, a soil slide is seen on the terrace. Rills and gully are well developed in it and intense erosion is taking place.

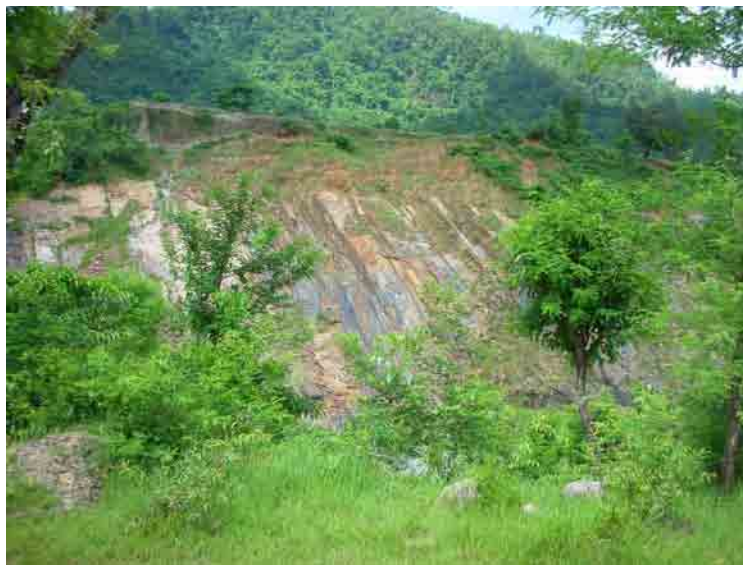
Plate 6: Plane failure at Chhang Patan

A plane rockslide is seen about 350 m downstream from the suspension bridge on the left bank of the river (Plate 6). The exposure height is about 35 m and width is about 120 m.

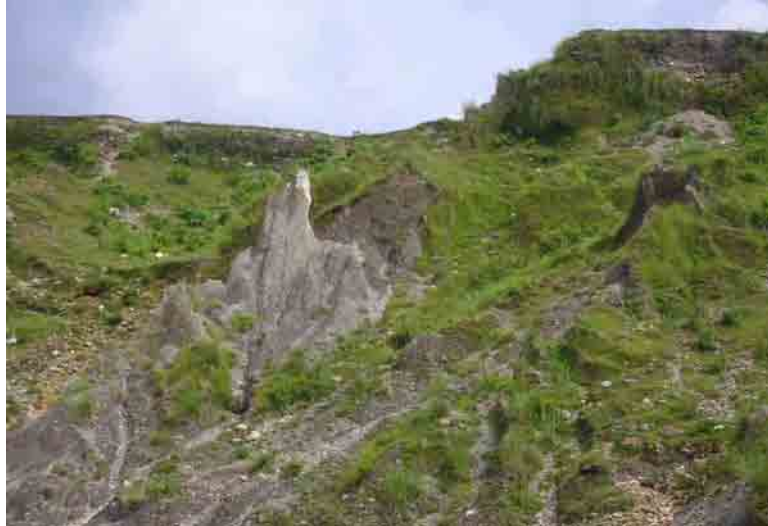
Plate 7: Intense gully erosion on the soil slide and river terrace on the right bank of Jyagdi Khola

The Jyagdi Khola is flowing between Khanaltar and Male Bagar. Its both banks are severely eroded with badland topographic features such as pinnacles (Plate 7). The river terrace is also seen on the right abutment of the bridge. Gravel to boulder size clasts are loosely cemented and flat to subrounded in shape. They are composed of limestone, gneiss, quartzite, and phyllite with reddish brown matrix. The pebble imbrication indicates SE flow direction.

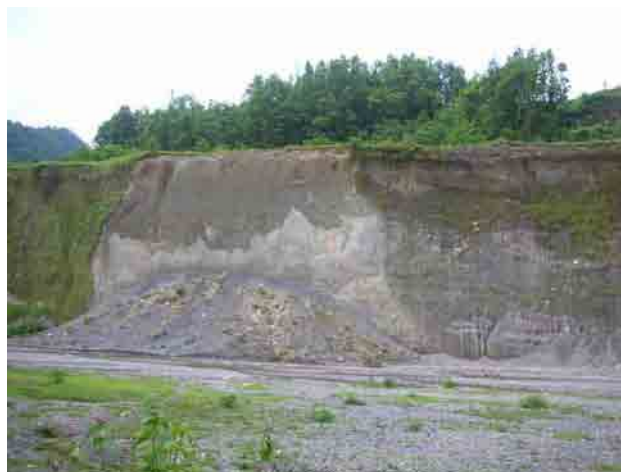
Plate 8: A small soil slide in the Wantang Khola

At this location, vertical cliffs are observed on both banks of the Wantang Khola, near an earthen road. The cliffs are composed of loose fine sand and pebbles. A small soil failure is seen (Plate 8) and it is about 15 m high. The upper part of the terrace is composed gneiss, quartzite, limestone and granite boulders, which are spread at the lower reaches. An outlet of an irrigation drain is also seen (Plate 9).

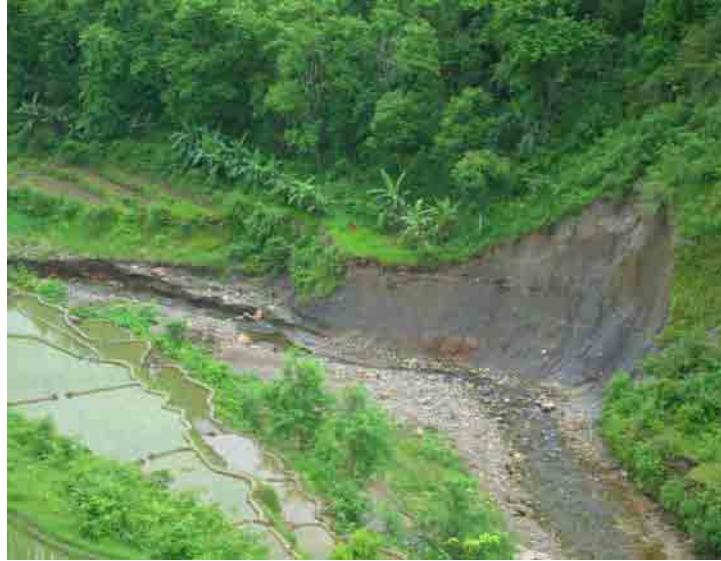
Plate 11: A small soil slides on Phedi Khola

At the confluence of the Chyobri Khola and Phedi Khola, a few small soil slides are observed on the cut bank of the tributary (Plates 11). Many small soil slides and rockslides are observed along the Phedi Khola, downstream from the confluence with the Chyobri Khola. Sporadically, recent alluvial deposits are seen in the riverbed whereas mostly the riverbed is covered by steep old river terraces and at the lower part of the terrace slate is exposed.

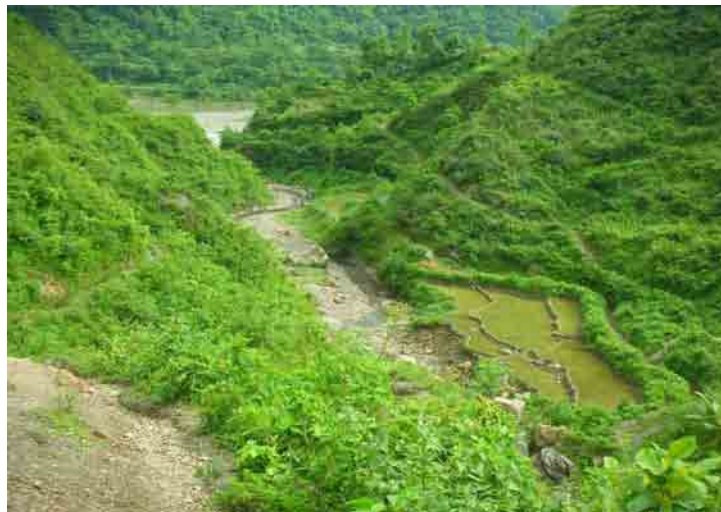
Plate 12: Irrigation canals to Bandarkuna

A terrace deposit composed of small pebbles with a few cobbles in fine matrix is observed along the foot trail towards Bandarkuna from Jalbire. At the river bend, some small landslides are observed. There are small irrigation canals on both banks of the Phedi Khola, and they irrigate the agriculture land of Bandarkuna (Plate 12).

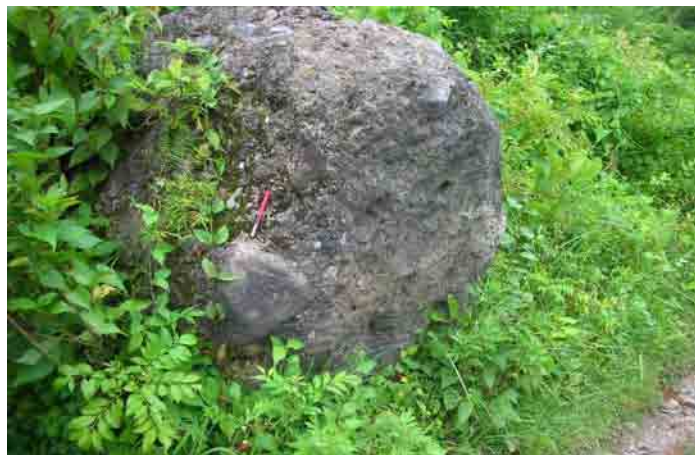
Plate 13: Conglomerate

Along the riverbank, at Bandarkuna, big conglomerate boulders (up to 2.5 m in diameter) are observed. They are composed of boulders of subangular to subrounded, laminated, grey limestone, marble, laminated sandstone, and shale (Plate 13). The boulders contain a small quantity of gneiss, granite and schist gravel. Their grain size varies from 40 cm to a few cm. They have a calcareous matrix, which has cemented the clasts (Plate 14).

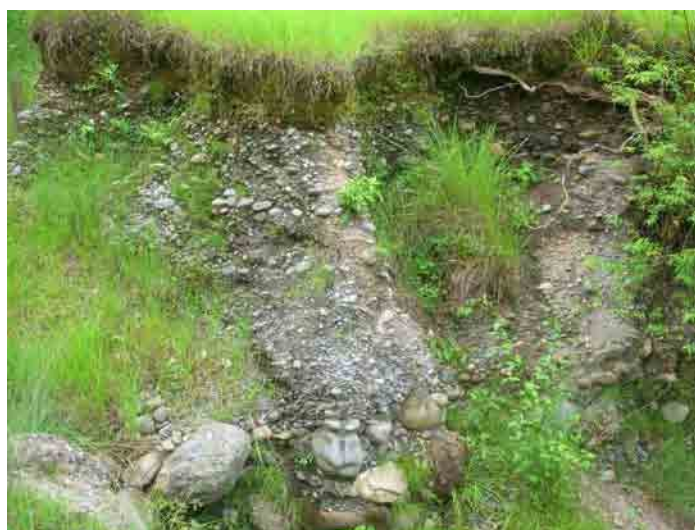
Terrace deposits are observed on the way to Geruwatar. They are composed of gneiss, quartzite, limestone, and granite with a fine matrix of sand and clay (Plate 14).

Plate 14: Terrace near Geruwatar

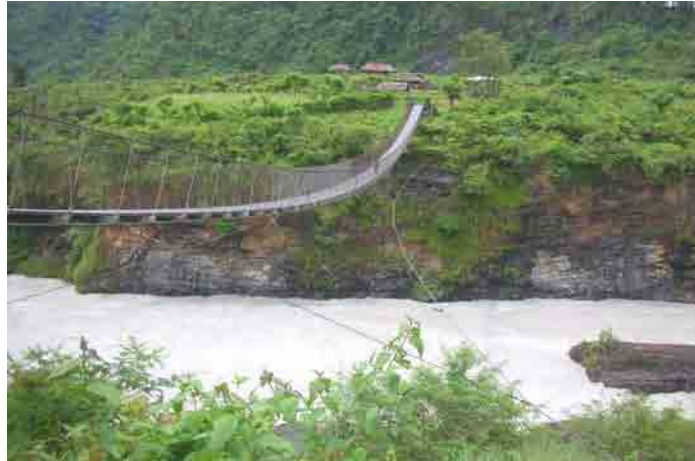
Below the suspension bridge of Geruwatar, on the right bank, a rock cliff of thickly laminated to medium bedded black slate is observed. A gently plunging syncline with small anticline in its core is observed (Plate 15).

Plunge direction: 180. Plunge amount: 10-15

Height of exposure: 20 m, width: 65 m

Plate 15 Rock exposure at Geruwa Tar village

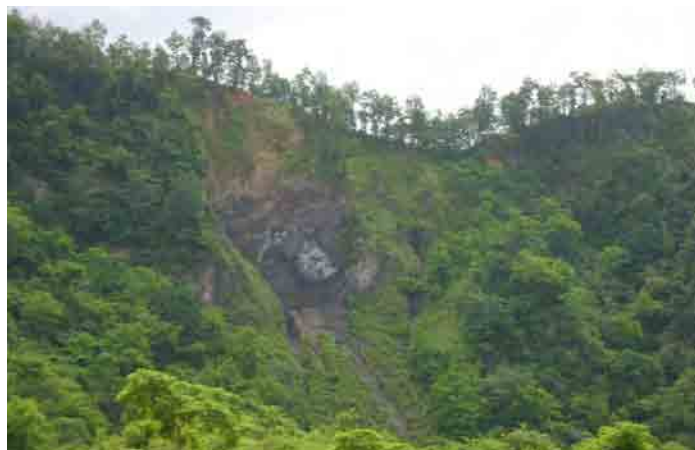
Highly folded and fractured slate is seen on the left bank of the Seti River, opposite the Geruwatar village (Plate 16). Its crown is about 25 m above the riverbed.

Plate 16: Shear zone

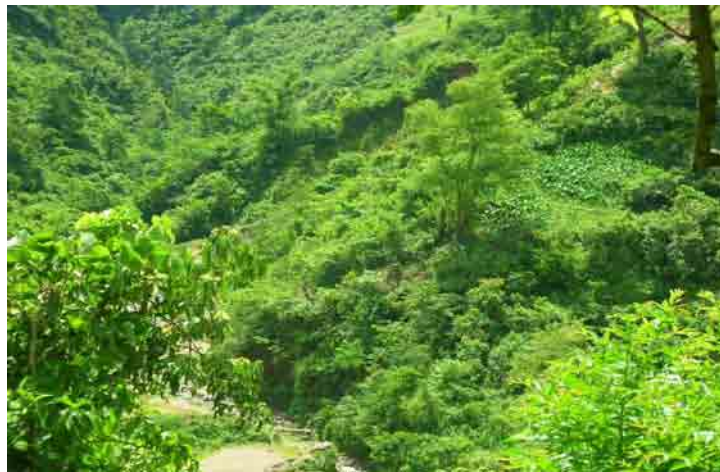
Old soil slide is observed at the Dying Khola near the right bank of the suspension bridge, which is covered by vegetation (Plate 17).

Plate 17: An old soil slide covered by shrubs at the Dying Khola near the right abutment of suspension bridge

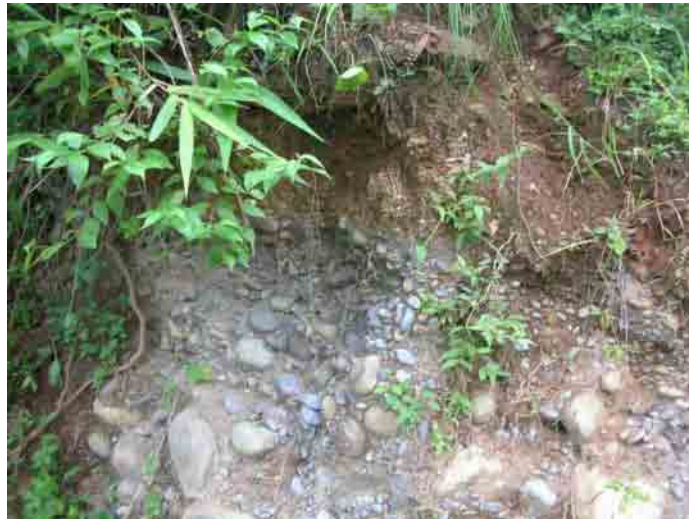
On the left bank of the Seti River, about 1.5 km towards Beteni at a spring of Deurali, about 5 m thick alluvial deposit with fining-upward sequence is observed consisting of boulders up to 1 m size (Plate 18). The boulders are basically of quartzite, dolomite, gneiss and shale with sand and silty clayey fine matrix. Altitude = 330 m.

Plate 18: River terrace overlain by colluvial soil

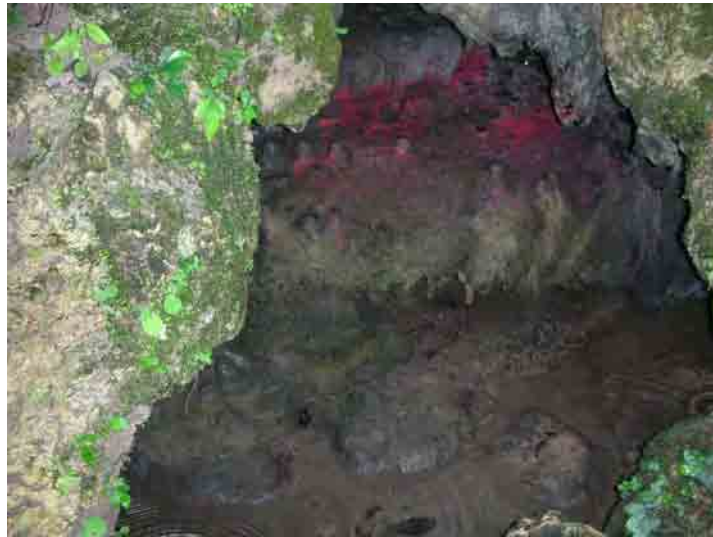
On the left bank, small caverns are present with 1 m x 2 m openings and beautiful stalactites and stalagmites (Plate 19). From the small caverns water is flowing out. Besides that on the right bank cliff also up to 20 height from riverbed small holes are present, which are tufa, and are most vulnerable to dam site seepage. Some geophysical survey is required to map out the seepage area

Plate 19: Leakage through the cavern near proposed dam axis on the left bank of the Seti River

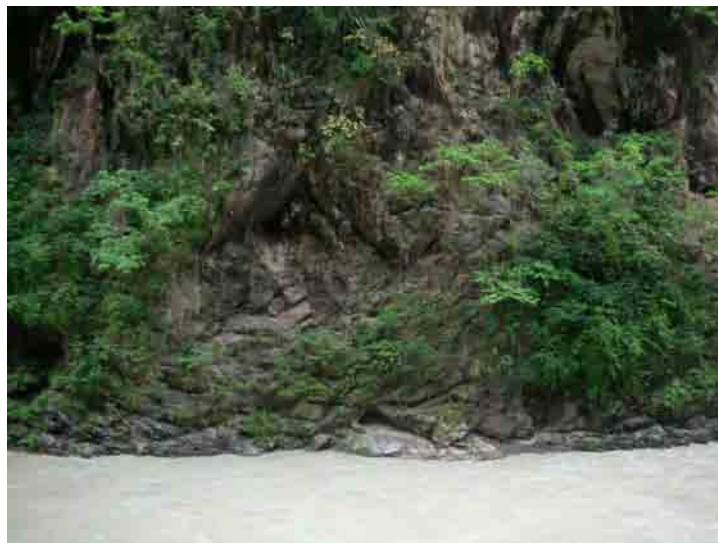
(Plate 20). The dolomite is thickly laminated to very thickly bedded (>2m). Due to the unfavourable jointing pattern, there is a possibility of rock fall.

Plate 20: Proposed dam axis on the right bank of the Seti River
