**THE STUDY ON  
NATURAL DISASTER PREVENTION  
IN PYANJ RIVER**

**FINAL REPORT**

**VOLUME 2      SUPPORTING REPORT**

**CTI ENGINEERING INTERNATIONAL CO., LTD.**

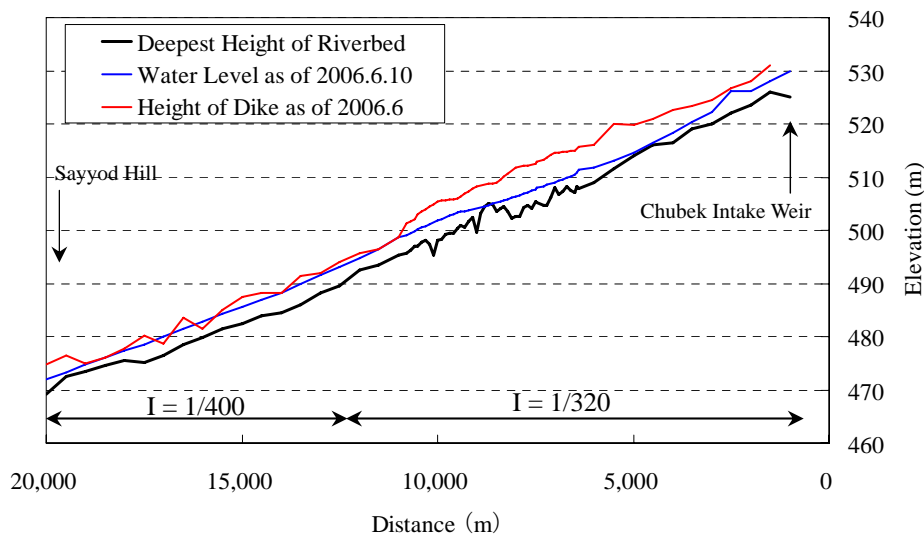
Fig. R 1.1.2 Slope of Pyanj River

At the Hamadoni alluvial fan, the Pyanj River has the gradient of between 1/300 and 1/400 along the 20 km stretch between Chubek Weir and Sayyod Hill, as shown by the riverbed profiles in Fig. R 1.1.2. According to the topographic map with the scale of 100,000, the slope upstream from the head of the fan is about 1/200.

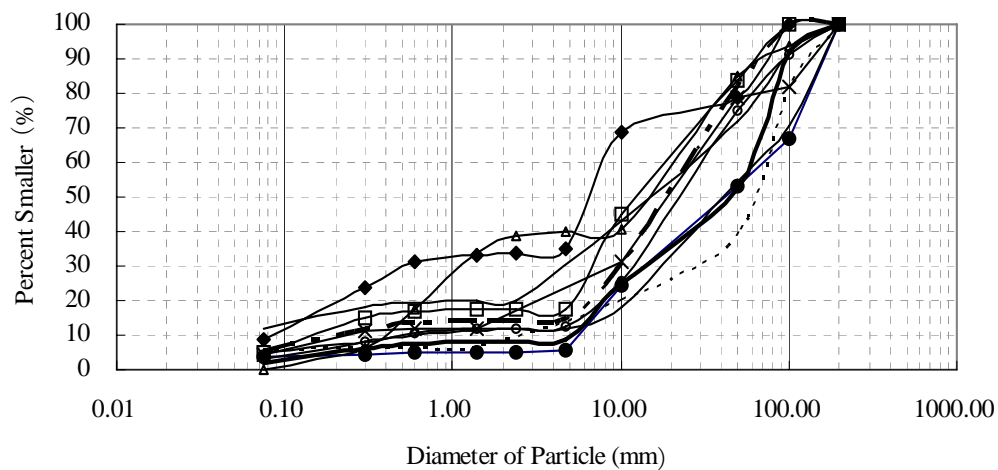
Fig. R 1.1.4 Graduation Curve of Riverbed Material

A riverbed material survey was carried out in the channel of Pyanj River and the alluvial fan in the study area. The particle size distribution of each sample is summarized as gradation curve in Fig. R 1.1.4. Based on the analysis (refer to Chapter 2 of the supporting report), the average grain diameter of sand and gravel varies between 20 mm and 70 mm, which fit the standard characteristics.

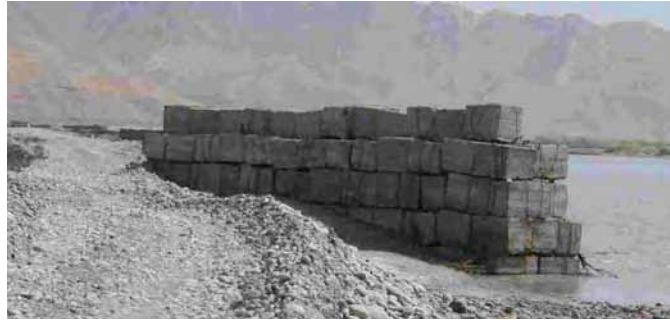
Fig. R 1.6.3 Photograph and Typical Design of Concrete Block Spur Dike

Spur dikes that reduce flow velocity and encourage sedimentation around the main dikes are quite commonly used in rivers where the river course is wide and meandering and eroding the banks. The existing dike of Pyanj River is protected by a total of 38 spur dikes as of December 2005, and 18 of them are constructed along the main dike. The spur dikes are generally classified into two types; namely, Concrete Block Spur Dike and Round Head Spur Dike (made of soil embankment), as shown in Fig. R 1.6.3 and Fig. R 1.6.4.

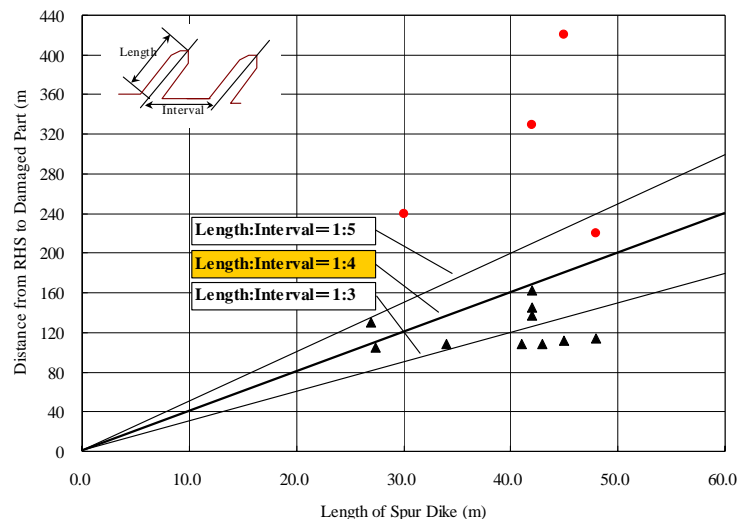
Fig. R 1.6.8 Result of Site Survey on Spur Dike Effect

Some parts of main dike were damaged in the flood season of 2006 although the spur dikes protected the main dike in the groin field where hydraulic barrier generated by spur dikes protect the main dike. Generally, the range of hydraulic barrier is deeply bound up with the length of spur dike. Thus, to confirm the range of hydraulic barrier, the relationship between the length of RHS and the distance from damaged portion of main dike to RHS is surveyed and presented as shown in Fig. R 1.6.9.

The figure indicates that the present RHS can protect the downstream main dike in the range of four (4) times span of the RHS length at least. The red points show damaged portions and black triangle points show the distance from damaged portion to spur dike immediately upstream. The damaged portion in the main dike and the position of spur dike as of January 2007 is illustrated in Fig. 1.6.2 in the Appendix. In addition, the distance from

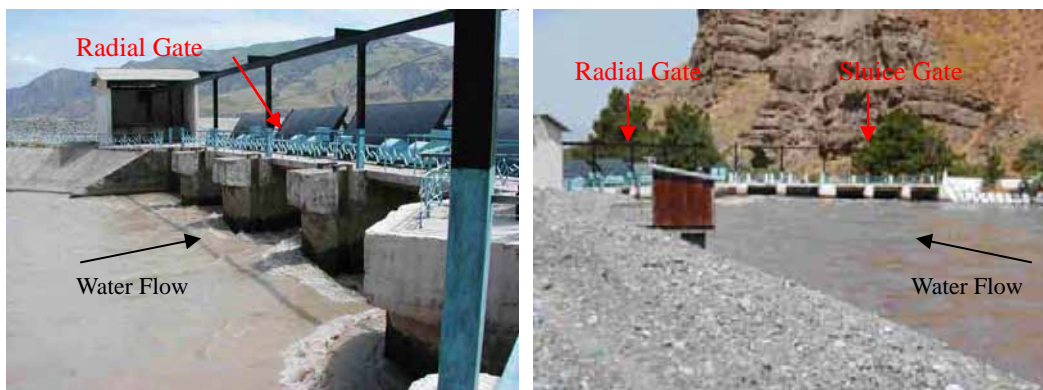
Fig. R 1.6.10 Photograph of Chubek Weir

The Chubek Weir has five (5) sluice gates that limit the quantity of water to the Chubek main canal, and the redundant water pass through four (4) radial gates to the spillway. The location of Chubek Weir are shown in Fig. R 1.6.12. The size of sluice gate is 4 m by 6 m in width and height and the radial gate is 6 m by 6m. According to the estimation by MMRW, the maximum flow capacities through the sluice gates and the radial gates are 120 m<sup>3</sup>/s and 700 m<sup>3</sup>/s respectively. Next figure show gates of Chubek Weir.

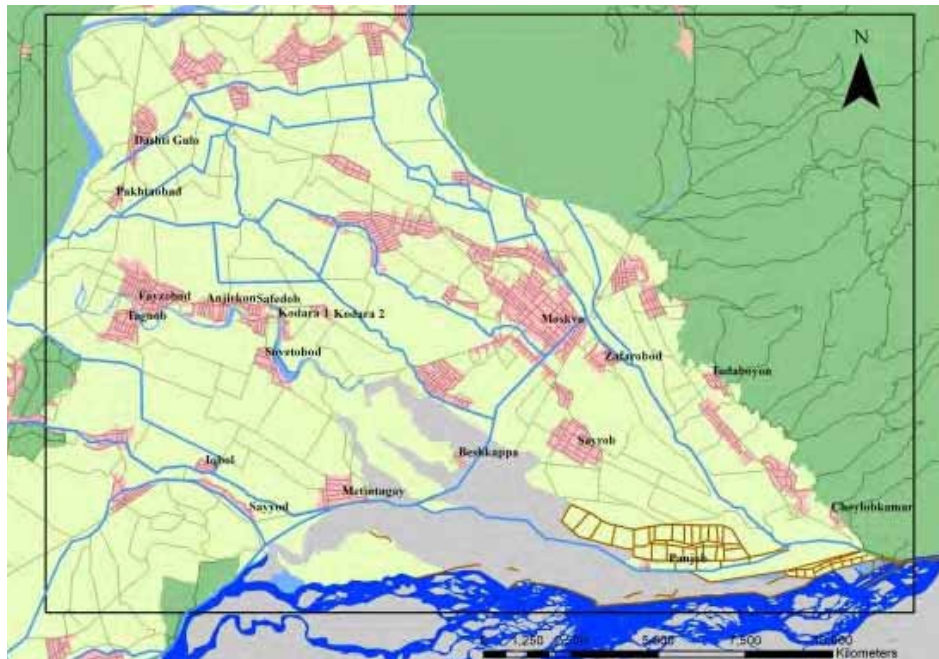
Fig. R 1.8.1 Boundary of Flood Inundation Simulations

Flood Inundation Analysis is carried out at the flood plain of Hamadoni Rayon, which is delineated and squared off in Fig. R. 1.8.1.

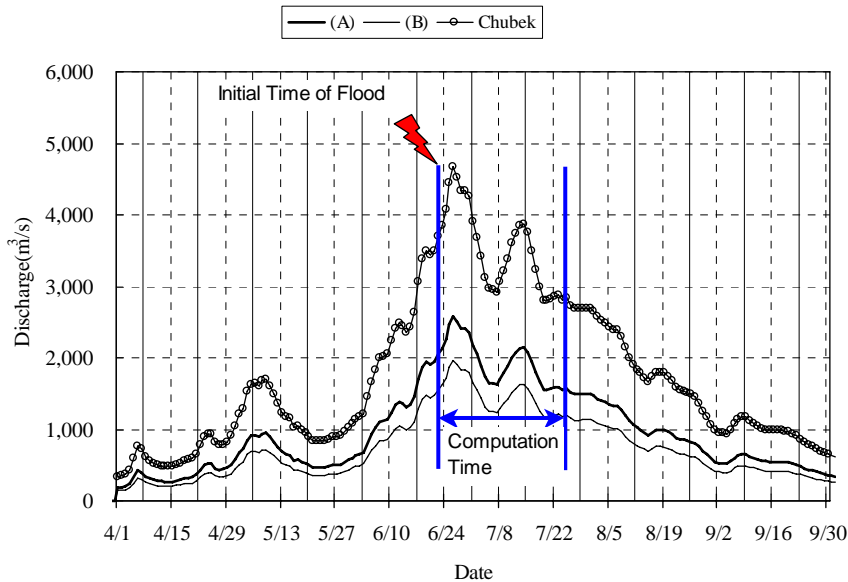
Fig. R 1.8.4 Discharge Hydrograph for Simulation

Incidentally, the distribution rate to Tajikistan side at A and B portions of the main dike are 0.555 and 0.421 respectively.

The water route discharge at the Tajikistan side was calculated by two dimensional flow distribution analysis as explained in Chapter 2 of the supporting report. The discharge hydrographs for water route at the dike broken parts (A portion and B portion in Fig. R 1.8.3) are calculated in accordance with the distribution rate at the same portions.

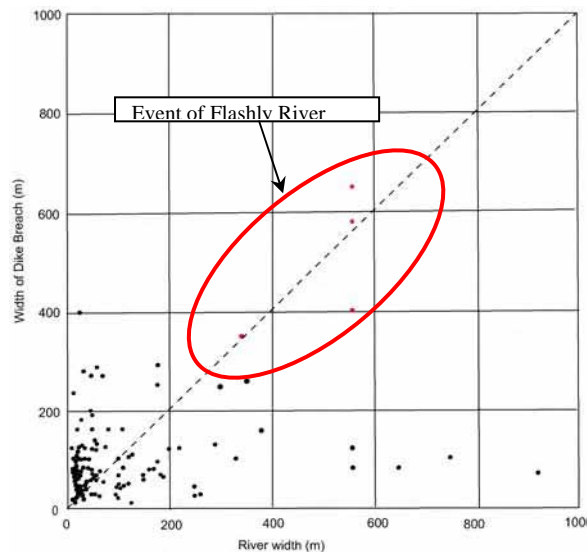
The total length of dike breach is set as 2.0 km for the simulation. In Japanese flashy streams similar to Pyanj River, there is an empirical adequacy in the relationship between river width and dike breach length, as shown in Fig. R.1.8.10. The length was figured out using this relationship and, incidentally, the main dike of Pyanj River was broken for around 2.0 km and the river width was also about 2 km in the 2005 flood, which conforms to the empirical rule mentioned above.

Fig. R 1.8.8 Empirical Adequacy between River Width and Dike Breach Length
