SECTOR 3 SEDIMENT AND EROSION

INTERIM REPORT

THE STUDY ON NATURAL DISASTER PREVENTION IN PYANJ RIVER

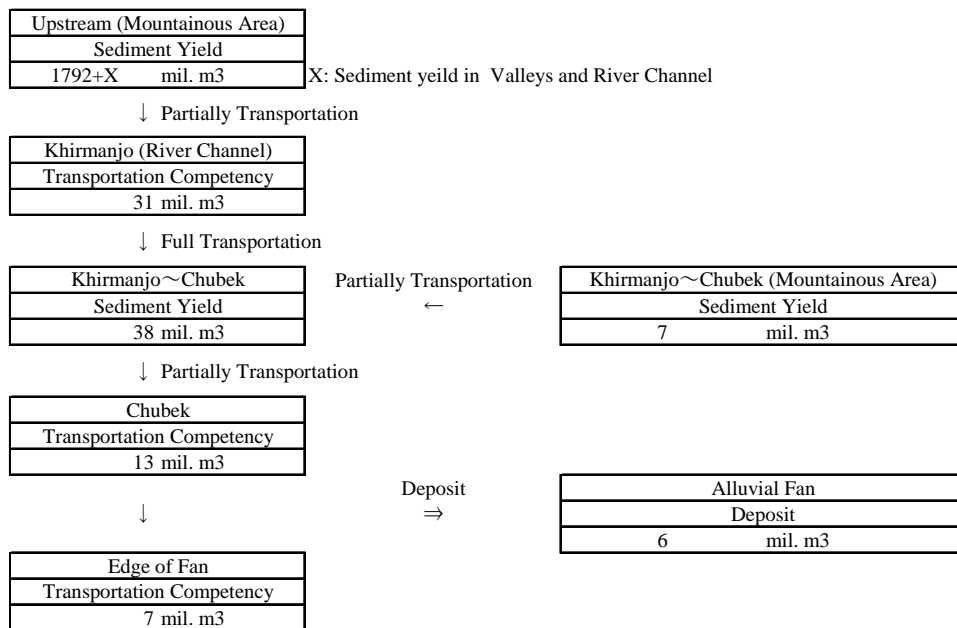
Fig. R 3.5.1 Sediment Balance of Pyanj River Basin

Part of sedimentation conveyed through the narrow valley accumulates on the alluvial fan or flow past further to downstream. To confirm the balance of sedimentation, the competency of transportation of sedimentation was calculated at the top of fan and at the edge of fan. As the result of the calculation, the amount of deposit on alluvial fan can be estimated at about 5 mil. m³ per year, all of which is equivalent to the sedimentation with the depth of two (2) to four (3) cm per year.

The process of conveyance of sedimentation from upstream to alluvial fan is described in Figure below.

From the result achieved up to Subsection, the explanatory diagram for transportation of sediment is described as shown in Fig .3.5.1. According to the figure, the deference of sedimentation between the inflow at Chubek and the outflow at the edge of fan is 6 mil. m³ per year, i.e., the deposit of sedimentation would be accumulated on alluvial fan with 2, 3 cm per year.

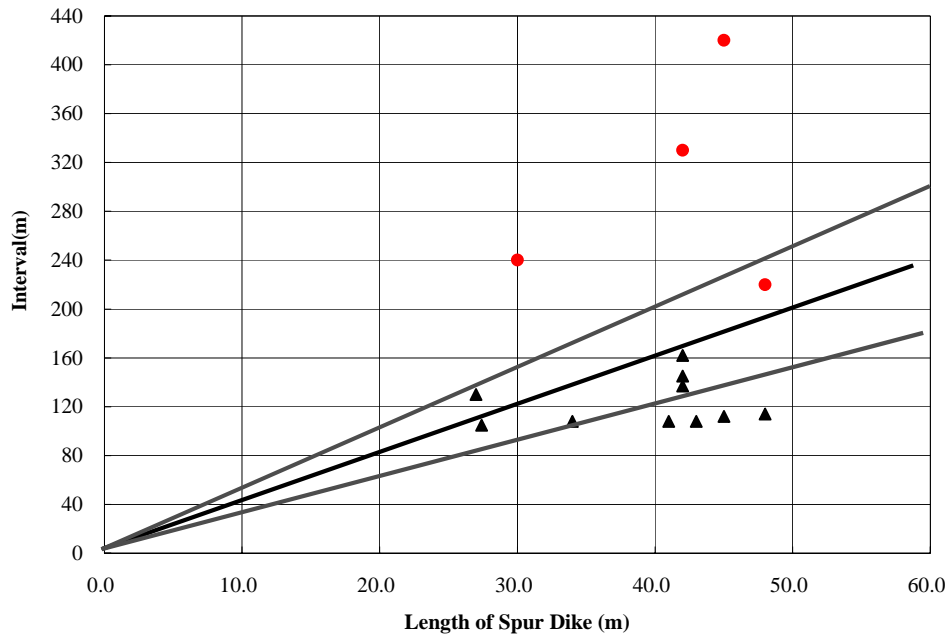
Fig. R 5.4.1 Result of Site Survey on Spur Dike Effect

Site survey on the existing spur dikes has been carried out to find effectiveness of spur dike. One of elements to secure the effectiveness is a ratio of length to interval of spur dikes. Some of portions in the existing dike are heavily eroded while some are well protected by spur dikes. Distances to damaged portions from the immediate upstream spur dikes were scaled along the existing dikes constructed in 2006. Result is shown as follows (Fig R 5.4.1) with red points showing damaged portions and with black triangle points showing intervals of spur dikes, which have been well protecting the embankments with no damages.

note: ● is damaged portion, ▲ is no damaged portion

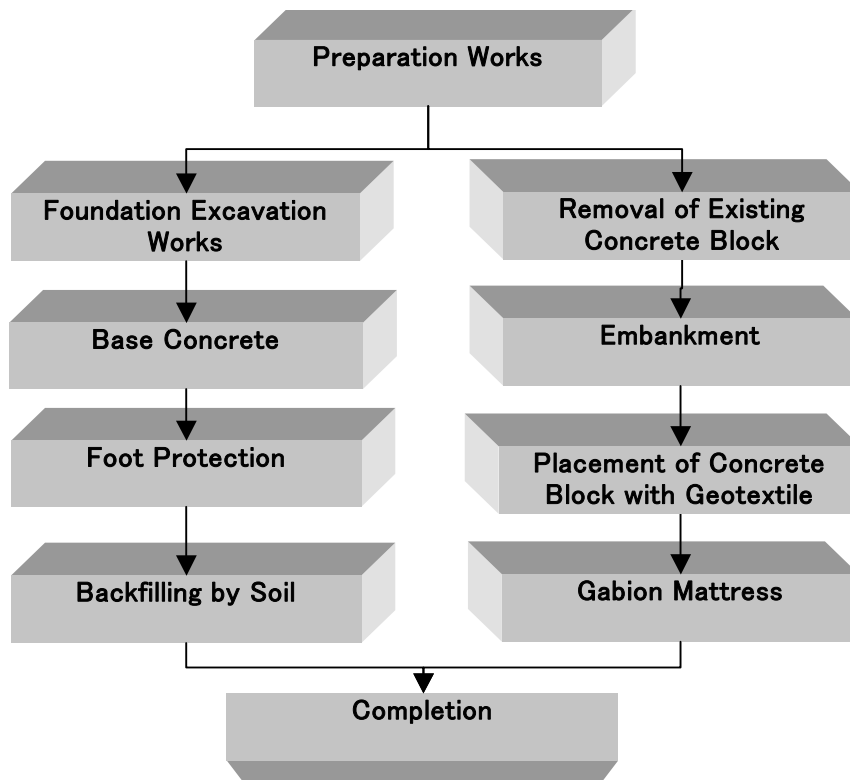
Fig. R.6.3.1 Typical cross-section and construction procedure of Dike

Construction procedure for dike is similar with Spur Dike, starting foundation works and revetment works. Concrete block are placed up until the Design Water Level (DWL). Above of concrete block is applied gabion mattress. Typical cross-section and construction procedure of Dike is shown in Fig. R.6.3.1.

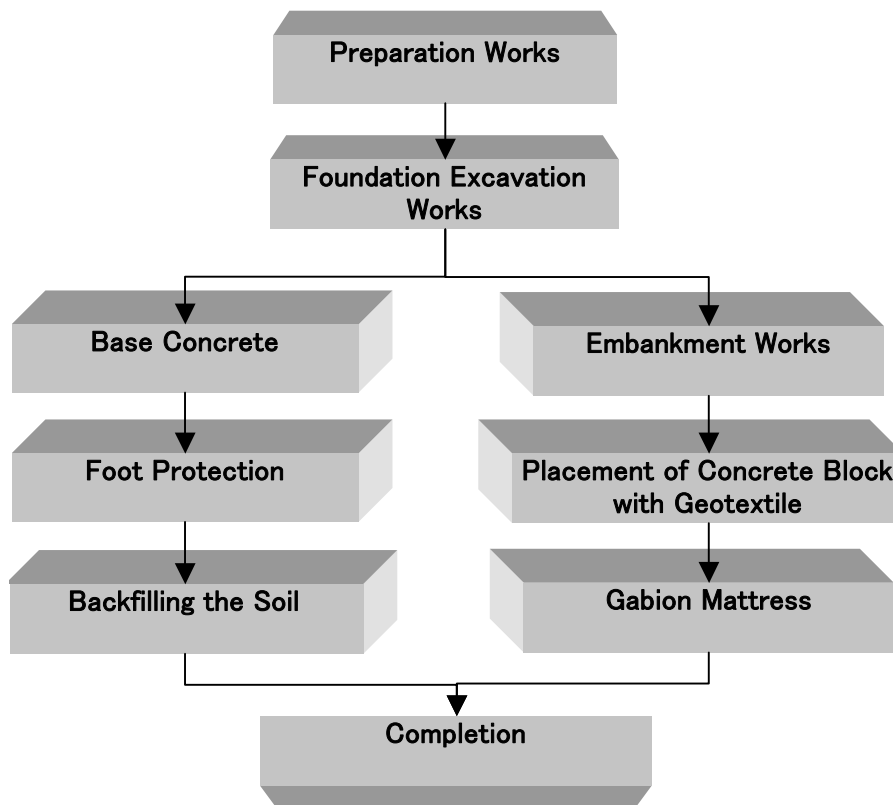
Fig. R.6.3.2 Typical cross-section and construction procedure of Spur Dike

Construction of Spur Dike starts from the excavation works, and base concrete works. Foot protection will be placed by concrete blocks with 12 meter length and each concrete block is connected with four ways by steel shackle. Concrete block will be produced in concrete batching plant and transport to the site. Distance between site and batching plant is 10 km approximately. Typical cross-section and construction procedure of Spur Dike is shown in Fig. R.6.3.2
