資料2 実施機関との打合せに関するテクニカルノート

Technical Note : Design Concept

- ① Reply on the Reconsideration requested by DOR
- ② Geological Condition
- ③ Hydraulic characteristics

Design Concept

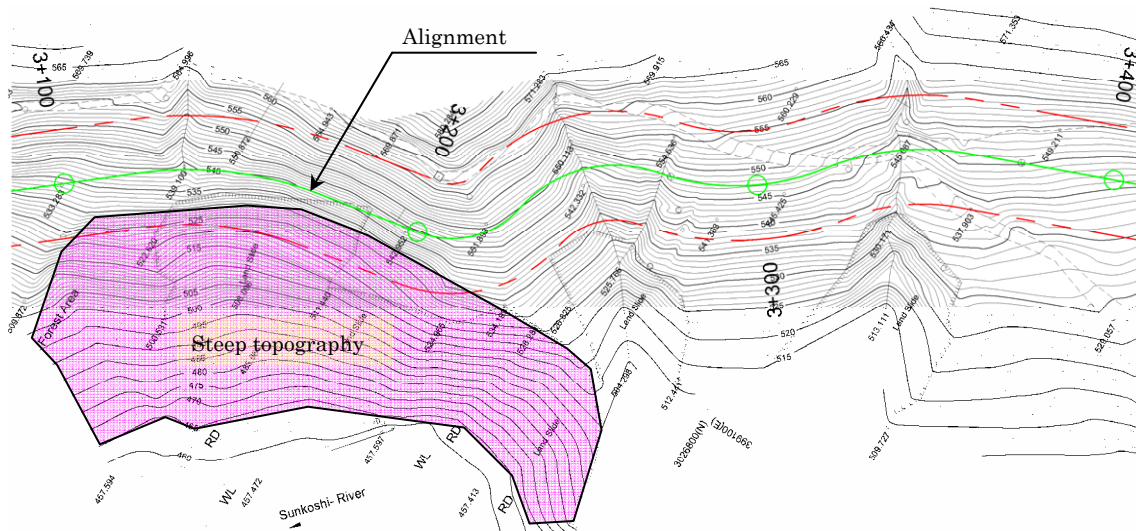
Fig. 1- Center line near station 3+200

As shown in the figure below, the center line passes above the steep topography area. The center line has been determined from the condition of continuity.

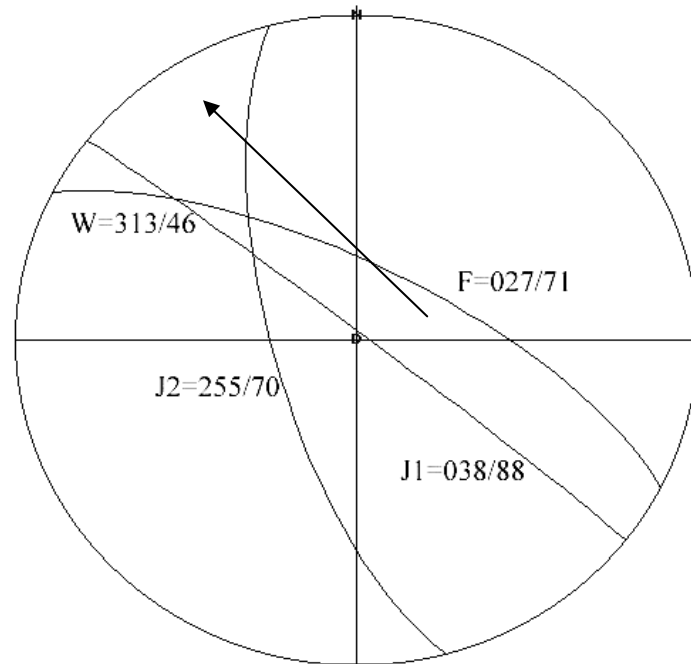
Figure 4: Stereographic projection of discontinuities measured near BM 50 of the EIA (2006). The projection is done on lower hemisphere.

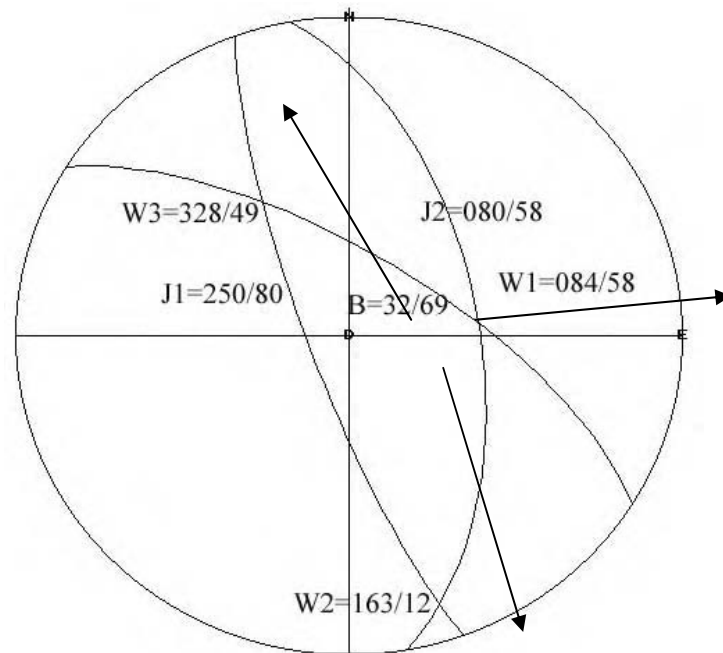
In the beginning, the road alignment passes through the rocky area basically composed of quartzite. The rocks are moderately weathered. The dip direction of the bedrocks and natural hill slope is in same direction (Photo 42). So there is possibility of plane failures (Figure 6). Thick colluvium deposits are found on the rocks. Then the colluvial and residuals soils with thickness of more than 3 m are encountered upto the crossing of the Sadhi Khola. The last sector of the road alignment lies on the colluvium.

Figure 6: Stereographic projection of discontinuities measured near Ch. 23+000. The projection is done on lower hemisphere.

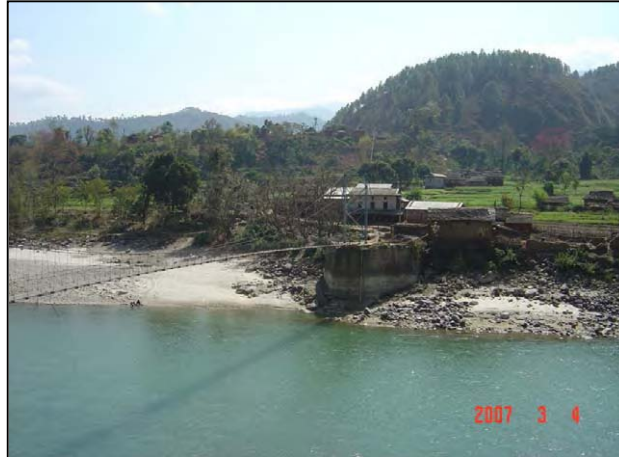
River Channel Control Point: Khurkot Suspension Bridge (Refer to Cover Map)

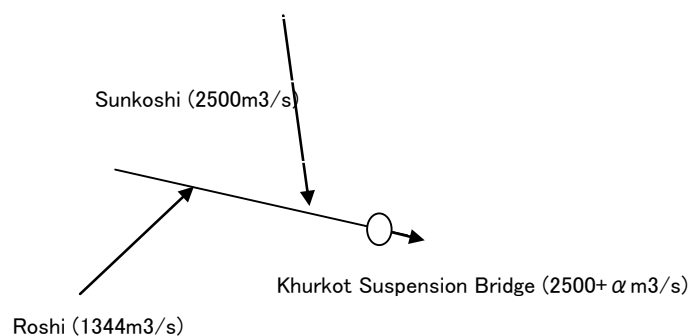
$$\begin{aligned} \text{Section } A &= 80\text{m} \times 7\text{m} = 560 \text{ m}^2 \\ \text{Hydraulic radius } R &= 560 \div 94 = 5.96 \text{ m} \\ \text{Coeff. of roughness } n &= 0.035 \quad (\text{same value as Sec. 4's}) \\ \text{Inclination } I_e = I_b &= 0.0023 \quad (\text{Average Inclination of Sec. 3's Riverbed}) \\ \text{velocity } v &= \frac{1}{n} \times R^{2/3} \times I^{1/2} \\ &= 4.50 \text{ m/sec} \end{aligned}$$

$$Q = A \times v = 2,522 \text{ m}^3/\text{sec} \quad \text{Tamakoshi } (0 + \alpha \text{ m}^3/\text{s})$$

$\therefore Q = 2,500 \text{ m}^3/\text{sec}$, To be the estimated value.

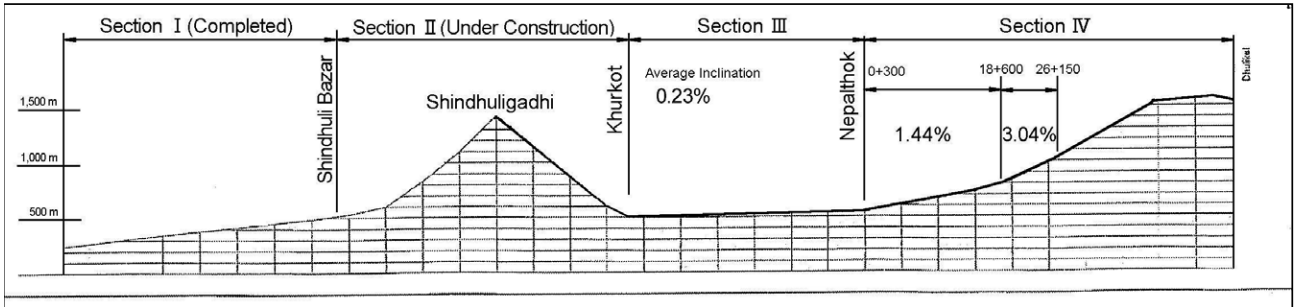
Longitudinal Section of Shindhuli Road

Inclination of riverbed $\hat{=}$ Inclination energy

Steep Inc. River $I_b > 0.6 \sim 2.5\% \rightarrow$ Super-critical Flow

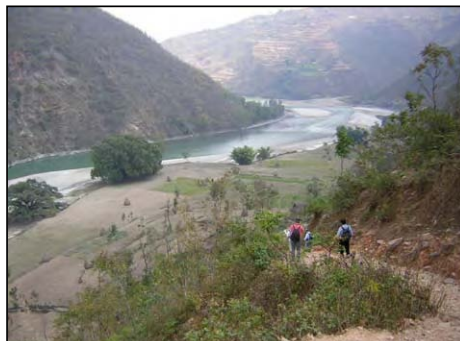
3. 3 Trees in the Flood Plain

Trees in the Flood Plain shows there was no severe flood for long time.
