Appendix 2  
Technical Notes

**Technical Note : Design Concept**

## ② GEOLOGICAL CONDITION OF THE ROAD ALIGNMENT BETWEEN KHURKOT AND NEPALTHOK, SINDHULI DISTRICT

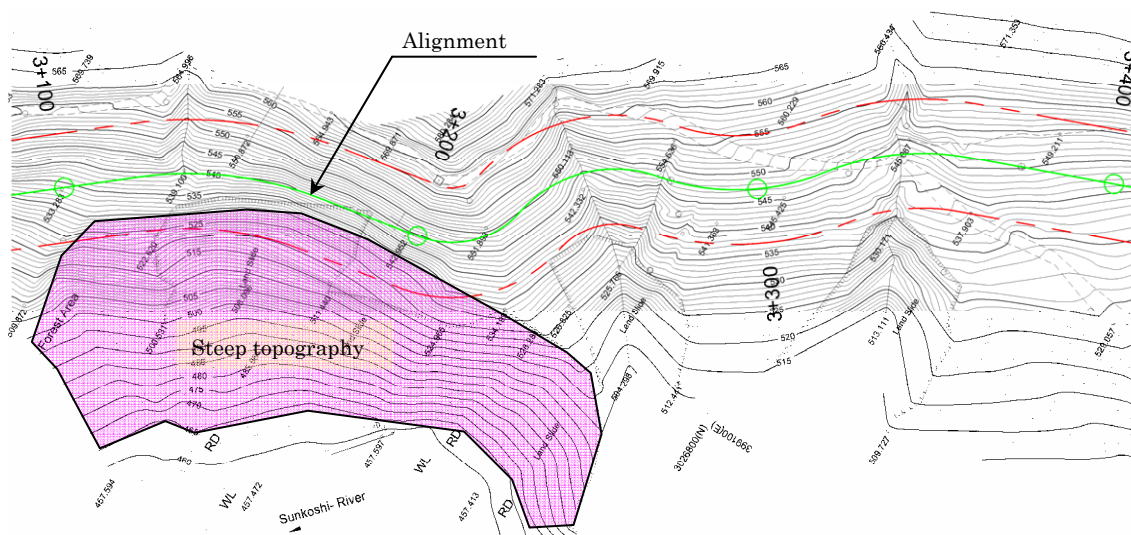
As shown in the figure below, the center line passes above the steep topography area. The center line has been determined from the condition of continuity.

Fig. 1- Center line near station 3+200

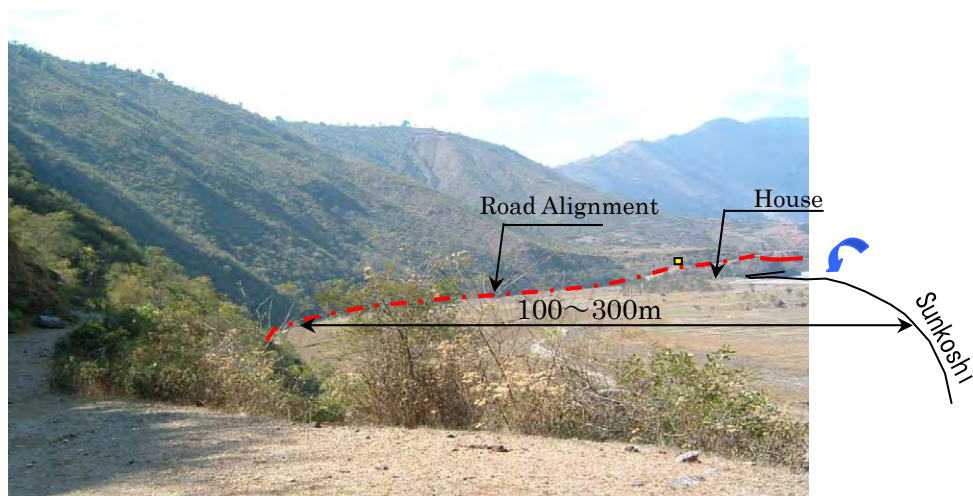
The mountainside of this section is unstable slope covered by a colluvial deposit and occurs slope collapse at the whole stretch of this section. It is recommended to avoid cutting slopes, which may cause to induce the collapse or landslide.

Even if water level rises to the mountain foot level at the time of the flood, flood velocity is small, and a road may not be damaged by the flood (Refer to ③ hydraulic characteristic).

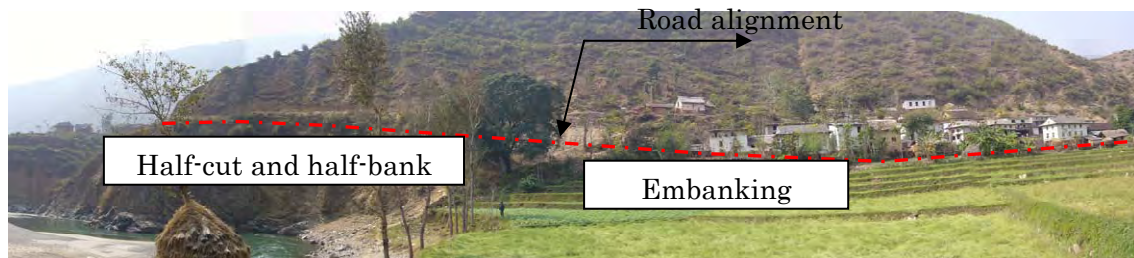
In this section, the alignment rises from the low agricultural land of the Gajulidaha Village to the mountainous area. The vertical gradient of existing road is about 12% on average. And, about ten private houses is located just beside the left side of existing road.

Though it is an rough review, a vertical gradient is set at about 8-10%, and it is planned embanking at the low agricultural land and half-banking and half-cutting at the mountainous area.

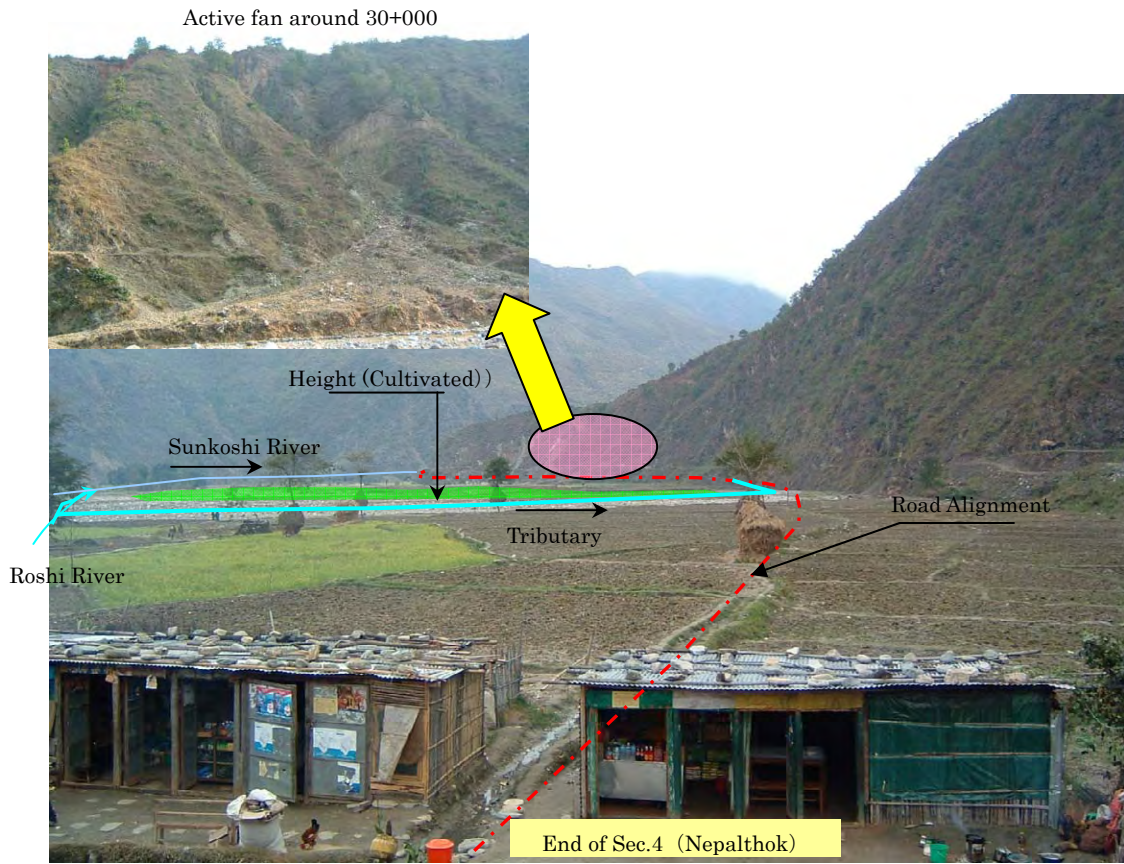
This mountainside section is unstable steep slope area, which is covered by a colluvial deposit, and slope collapse occurs at the whole section. As shown in the photograph, an alluvial fan is active and large-scale slope failure can be seen around STA 30+000. Because of the geological condition of the section, if the alignment is shifted to mountain side, it can be foreseen that large-scale mountainside cutting is required and it may cause a new landslide and slope failure.

During flood, the width of a river of this section is presumed several hundred meters, and velocity and depth of flow are assumed small.

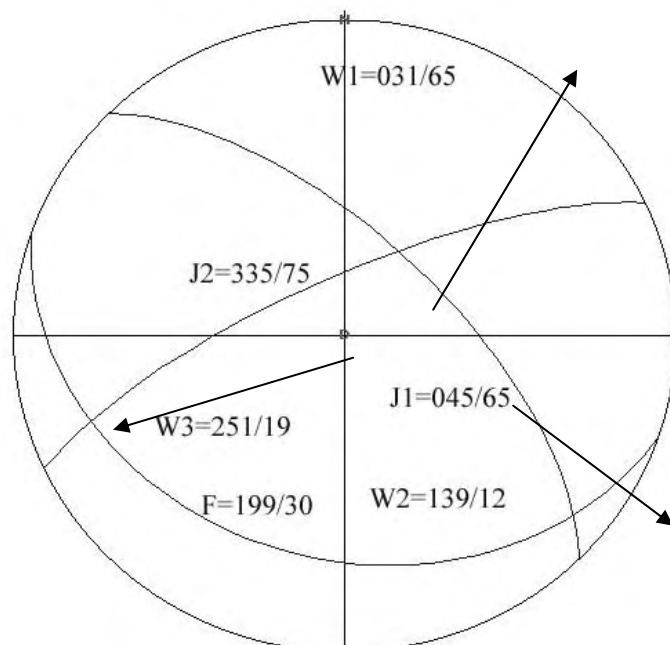
**Figure 3: Stereographic projection of discontinuities measured near the point OS 810 of EIA study (2006). The projection is done on lower hemisphere.**

The first 150 m of the road corridor passes through the alluvial deposit (Photo 1), in which an alluvial fan also lies approximately between chainage 0+070 and 0+080. The fan seems not so active. Therefore, there may not be stability problem. Then the road alignment runs through the moderately thick colluvial material for about 250 m. Here the alignment follows the foot trail. After that it runs on the right bank of the Sunkoshi River, where the exposed rocks are schists and gneisses belonging to the Raduwa Formation of the Kathmandu Complex (Photo 2). The rocks are moderately to highly weathered. Near the Bhalu Khola, the rocks are slightly weathered. The dipping directions of the rocks are opposite to the natural slopes (towards SSW), but wedge failure is possible towards NE due to the intersection of two joints J1 and J2 (Figure 3). However, the wedges in the area are very small in nature.

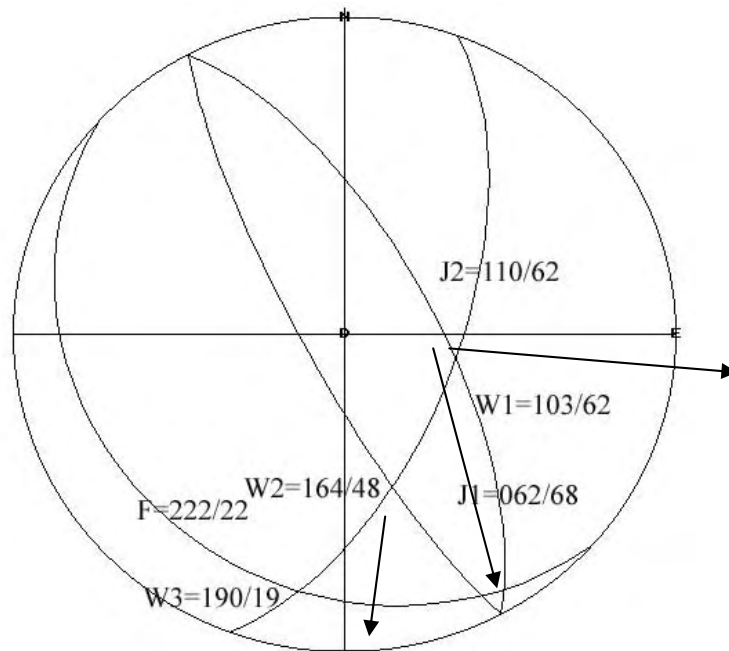
**Figure 5: Stereographic projection of discontinuities measured near Ch. 15+000. The projection is done on lower hemisphere.**

This section lies between Gahate village to Mulkot. The bed rocks are represented by phyllite and quartzite of the Kuncha Formation. These rocks are moderately weathered. Within these chainages thick colluvial deposits are having thickness more than 6 m. The colluvial deposits are composed of boulders and cobbles of the phyllite, schist and quartzite with matrix of silt and sand. Due to the silty portion in the colluvium and steep slope causes the slope failures. Nearby the slope failure (Photo 31 and 32), a lineament (Figure 2) seems to pass through. The fractured rocks on the hill slope are found at chainages between 15+000 and 15+100 (Photo 33). The stereographic projection of the rock mass shows that the area is relatively stable (Figure 5). Only one oblique joint dipping towards NE may cause some problem during the road cutting.

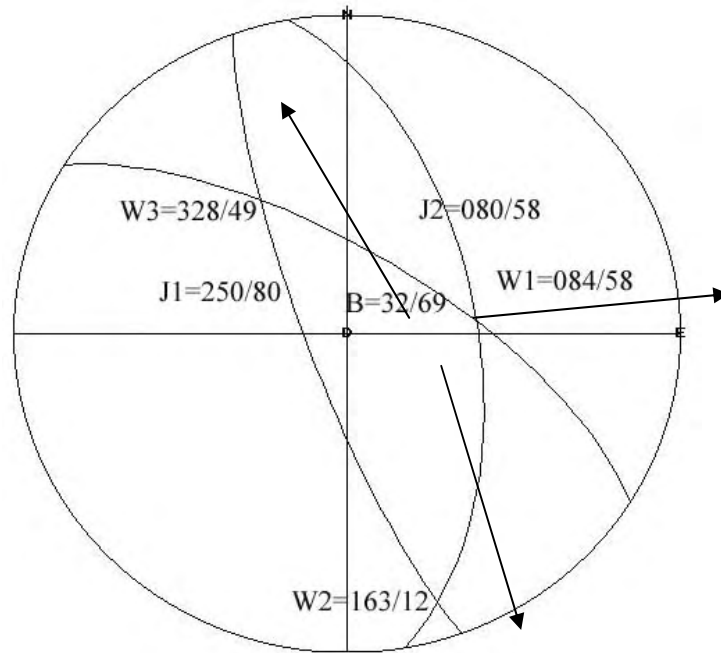
**Figure 6: Stereographic projection of discontinuities measured near Ch. 23+000. The projection is done on lower hemisphere.**

In the beginning, the road alignment passes through the rocky area basically composed of quartzite. The rocks are moderately weathered. The dip direction of the bedrocks and natural hill slope is in same direction (Photo 42). So there is possibility of plane failures (Figure 6). Thick colluvium deposits are found on the rocks. Then the colluvial and residuals soils with thickness of more than 3 m are encountered upto the crossing of the Sadhi Khola. The last sector of the road alignment lies on the colluvium.

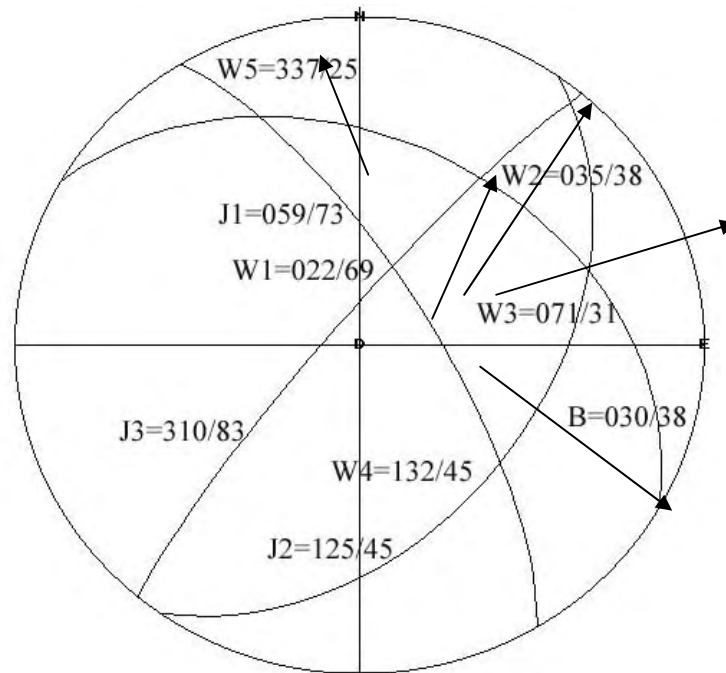
**Figure 7: Stereographic projection of discontinuities measured near 25+050. The projection is done on lower hemisphere.**

This is the steep rock slope mainly composed of the rocks of quartzite and phyllite (Photo 43, 44 and 45). The rocks are moderately to slightly weathered having three sets of the joints. In places, the road corridor has also thin cover of colluvial deposits. The alignment of road and the dipping of the bedrocks are oblique to each other (Figure 7). However, possibility of wedge failure can not be ignored upto 25+100. A faulted anticlinal axis passes at about 25+100. The fault does not seem to be active.

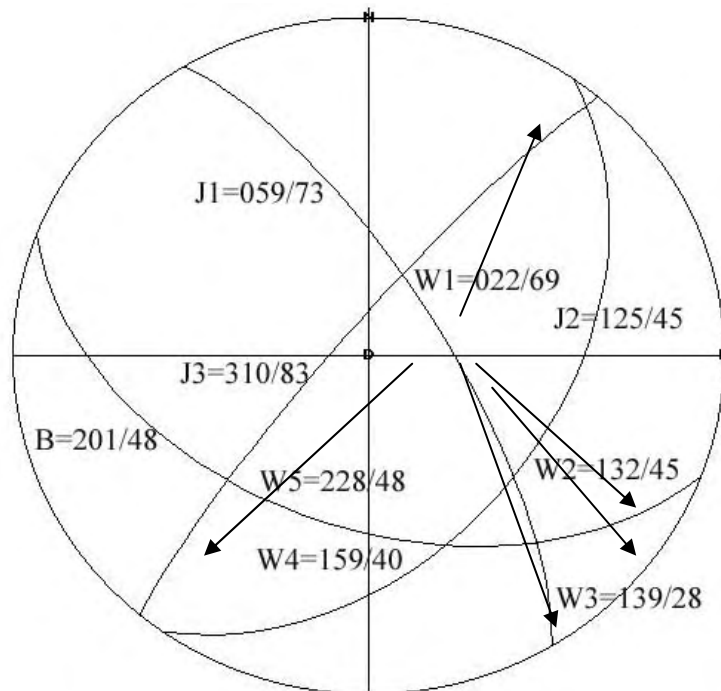
**Figure 8: Stereographic projection of discontinuities measured near 25+125. The projection is done on lower hemisphere.**

The discontinuities measured between 25+100 and 25+150 show that the dipping of the bedrocks are opposite to hill slope however wedge failure is possible (Figure 8).

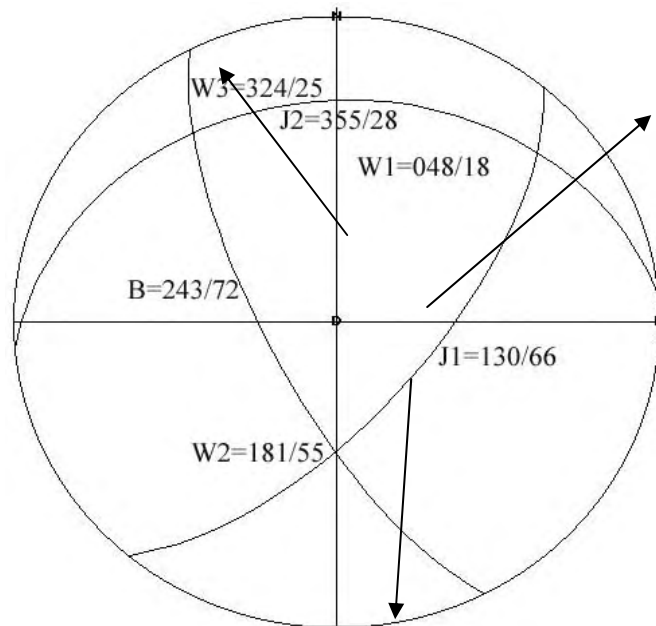
**Figure 9: Stereographic projection of discontinuities measured near 29+800. The projection is done on lower hemisphere.**

Along the road alignment mainly the alluvial deposits are found (Photo 48, 49, 50, 51, 52 and 53). Thin to moderately thick alluvium of the Sunkoshi River are composed of boulders of granite, quartzite. A deep gully is formed at the hill side of the Ch. 29+250 on old alluvium partially changed to residual soil. Only in few places, small rock outcrops are observed along the alignment. The rocks are well observed at the right bank of the Sun Koshi (Photo 49, 50 and 53). The discontinuities at the cliff near 29+800 are projected on a sphere (Figure 9). Though the foliation plane is counter dipping, however there is a possibility of joint plane failure towards N.

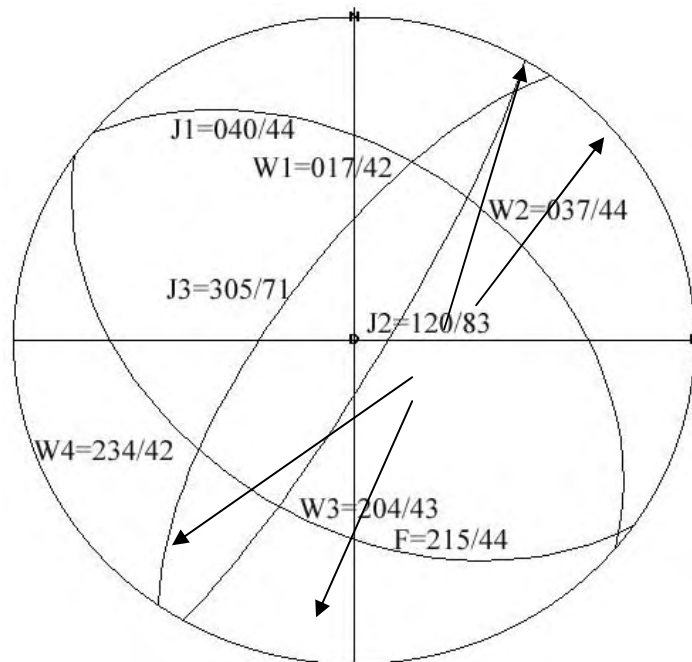
**Figure 10: Stereographic projection of discontinuities measured near 30+900. The projection is done on lower hemisphere.**

The alignment runs mainly on the flood plains of the Roshi Khola (Photo 57). The alluvial deposits are thick boulders of quartzites, granite and gneiss. The bedrocks are exposed on the hill slopes. They belong to Kuncha Formation and the rocks are mainly represented by phyllites, which are fractured and highly to moderately weathered. In places, the rocks are changed into the residual soil. Thin layers of the colluvium (mainly phyllite and schist) and topsoil (0.5 to 1 m thick) are found lying over the bedrocks. At this sector some slope failures are encountered (Photo 54 and 56). An active fan is found at 30+000 (Photo 55). But these will not have effect if the road alignment does not pass through the hill slope. The road alignment and attitude of the bed rock are oblique direction. However, there is possibility of rock failure (Figure 10).

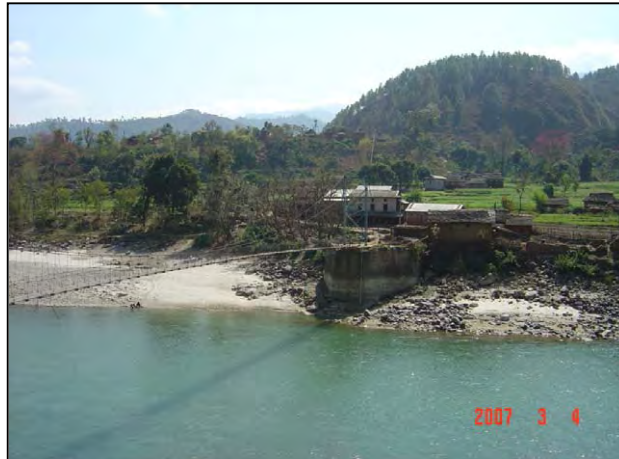
River Channel Control Point: Khurkot Suspension Bridge (Refer to Cover Map)

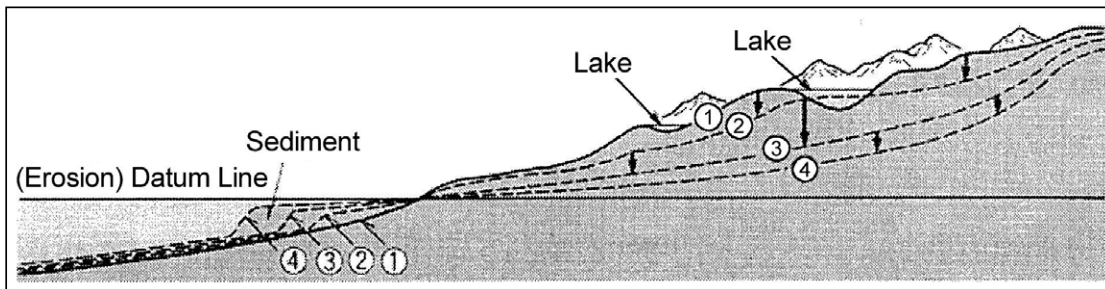
Development of River Profile

River Profile develops with ①②③④.

At first, River Profile is similar to the configuration of the ground, then develops with ③, ④ and reaches to the equilibrium condition.

The River Profile develops as shown on the Illustration due to the erosive and conveyance action of River.

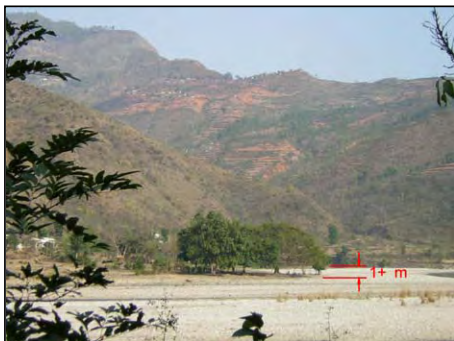
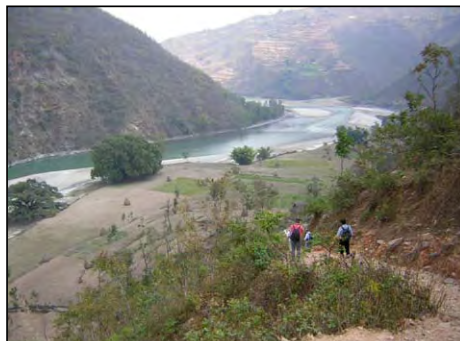
### 3. 3 Trees in the Flood Plain

Trees in the Flood Plain shows there was no sever flood for long time.
