***Chapter 4***  
***Hydrogeology***

## **CHAPTER 4        HYDROGEOLOGY**

Hydrogeological conditions in the Internal Drainage Basin (IDB) were investigated by using the following survey results:

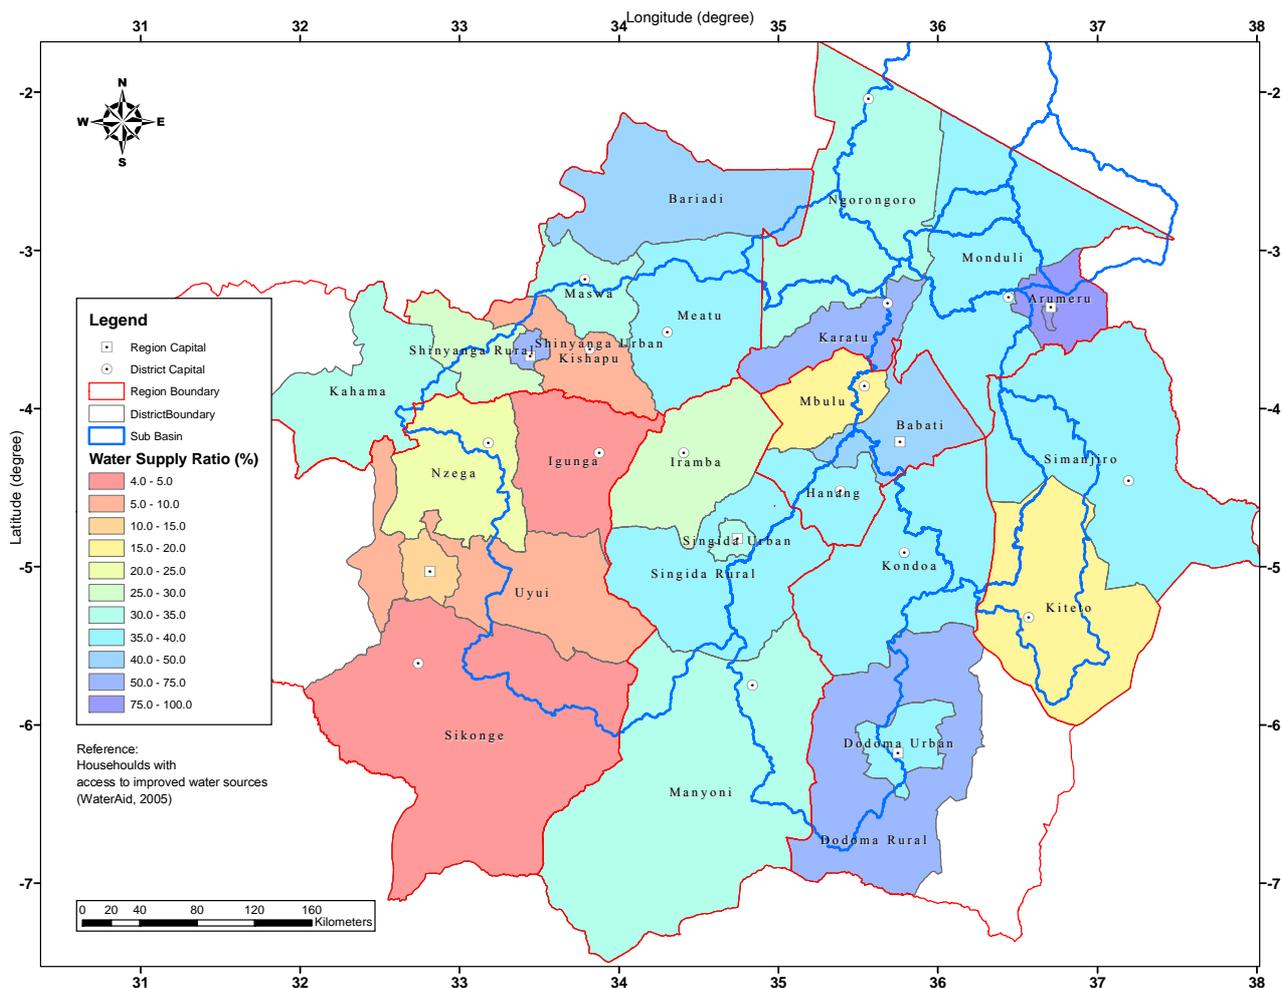
Figure 4-1 Rural Water Supply Ratio by District in IDB

As for water supply ratio, the data shown in Table 4-2, which is published in 2005 by WaterAid (NGO of United Kingdom), was adopted for this study. The distribution of water supply ratio in IDB is shown in Figure 4-1. The water supply ratio is the ratio of population served by improved water sources to the total population in each district.. This ratio is based on the same data as Table 2-4 (Chapter 2). However, Table 4-2 do not include the urban areas such as Singida town, Manyoni town, etc. because this study focuses on the rural areas of IDB.

According to Table 4-2 or Figure 4-1, the water supply ratios of Sikonge and Igunga in Tabora region are very low, but Arumeru in Arusha region is very high.. This result is reflected in the potential evaluation for groundwater development.

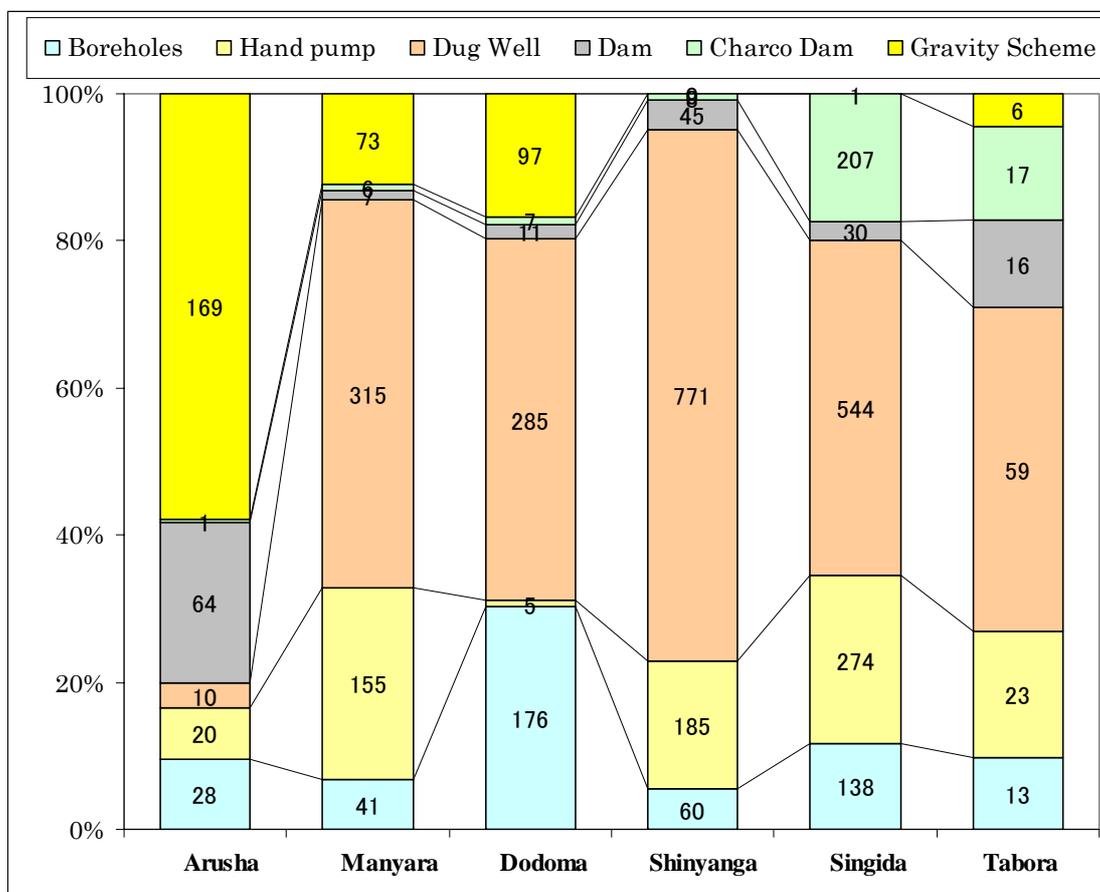
Figure 4-2 Water Source Type of Each Region

The aggregated result of the database is shown in Table 4-3. The ratio of water resource type in each region is shown in Figure 4-2. Piped Borehole, H/P Borehole and Dug well is recognized as using groundwater. Dam, Charco Dam and Gravity scheme (river or spring) is recognized as using surface water. Whereas the dependence rate for surface water in Arusha Region is 80%, other regions are highly depending on groundwater.

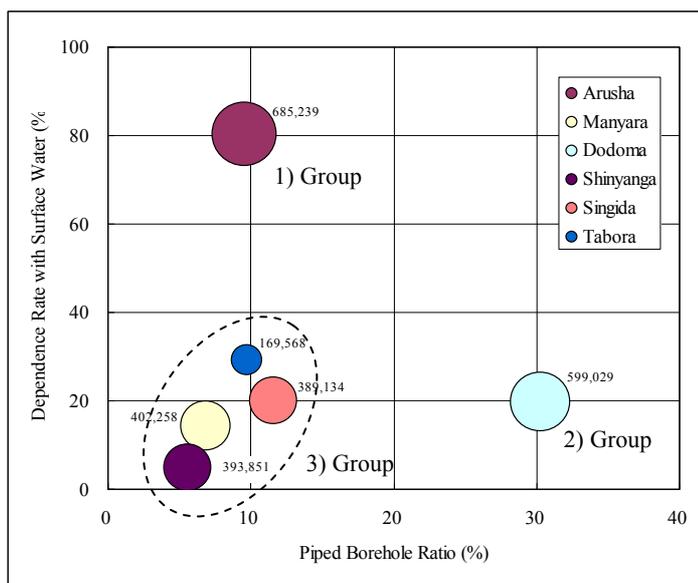
**Figure 4-3 Relationship between Piped Borehole Ratio and Dependence Rate for Surface Water**

To express the relationship mentioned previously, Figure 4-3 was presented. According to this graph, all regions in IDB are classified into three groups: 1) high dependence rate with surface water (Arusha region), 2) low surface water dependence and higher piped borehole ratio region (Dodoma region), and 3) low surface water dependence and low piped borehole water supply ratio. Manyara, Singida, Shinyanga, and Tabora regions can be recognised to be depending on the point water supply facility such as hand pump well or dug well.

(\*Numbers beside circles show the population with water supply services.)

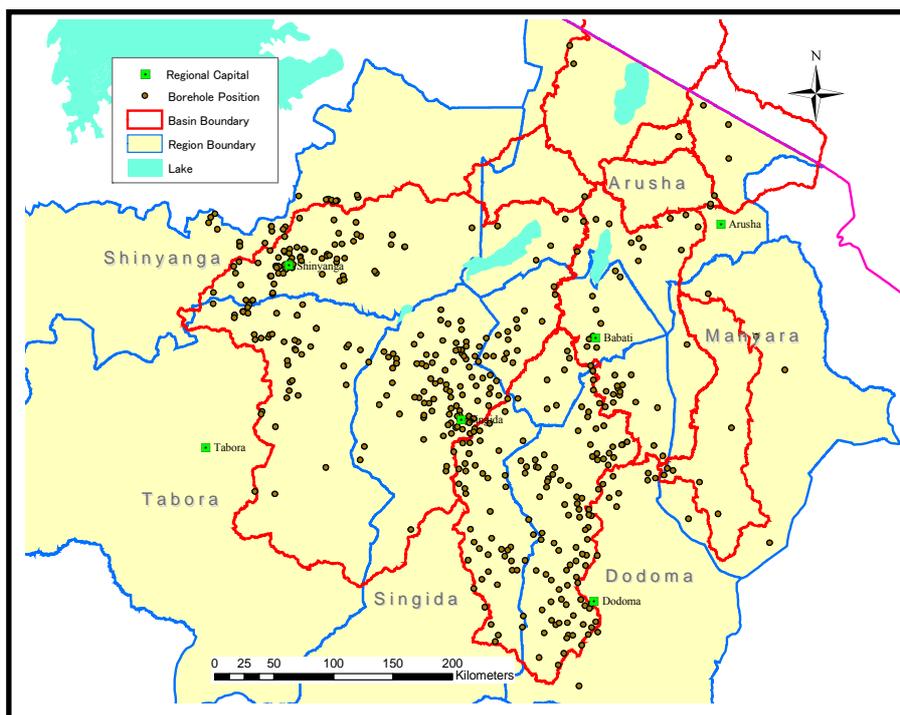
**Figure 4-4 Distribution Map of Surveyed Points for Existing Water Supply Facilities Inventory Survey**

Total number of villages and the distribution of surveyed points are shown in Figure 4-4 and Table 4-4 respectively.

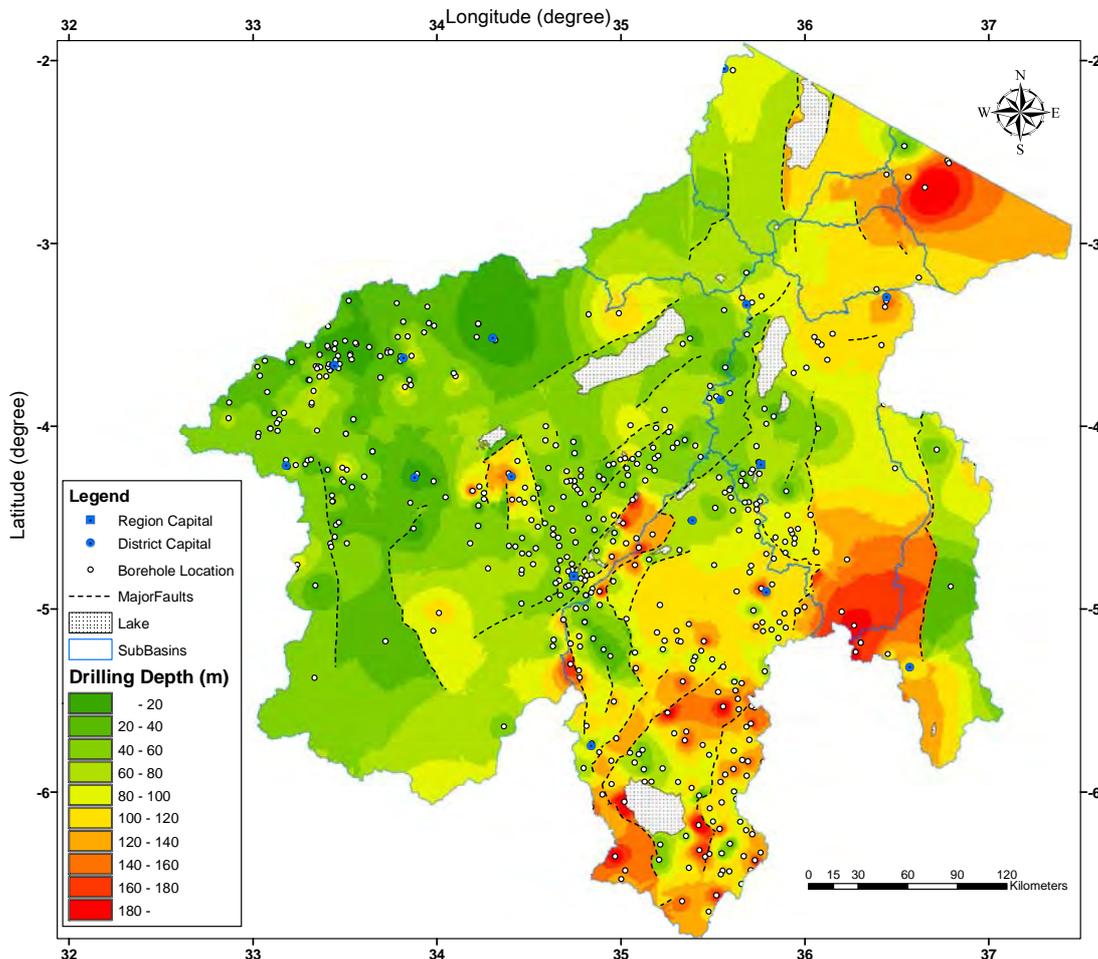
**Figure 4-5 Drilling Depth Distribution Based on Inventory Survey**

Drilling depth distribution of existing borehole is shown in Figure 4-5. Although each borehole has different condition, this distribution indicates the actual depth of the aquifer depth in IDB. The drilling depth is shallower in the western part and central part than the south-eastern and the north-eastern part of IDB.

Areas	Drilling Depth (m)
Arusha region (except Karatu district)	100 - 200
Kiteto and Kondoa district	80 - 200
Karatu, Mbulu, Babati, Simanjiro and Hanang district	40 - 100
Dodoma and Manyoni district	80 - 180
Singida, Iramba district	40 - 140
Igunga, Nzega, Uyui and Sikonge district	20 - 100
Shinyanga, Kishapu, Meatu and Maswa district	20 - 60
Western part of Hanang and Eastern part of Singida	80 - 200

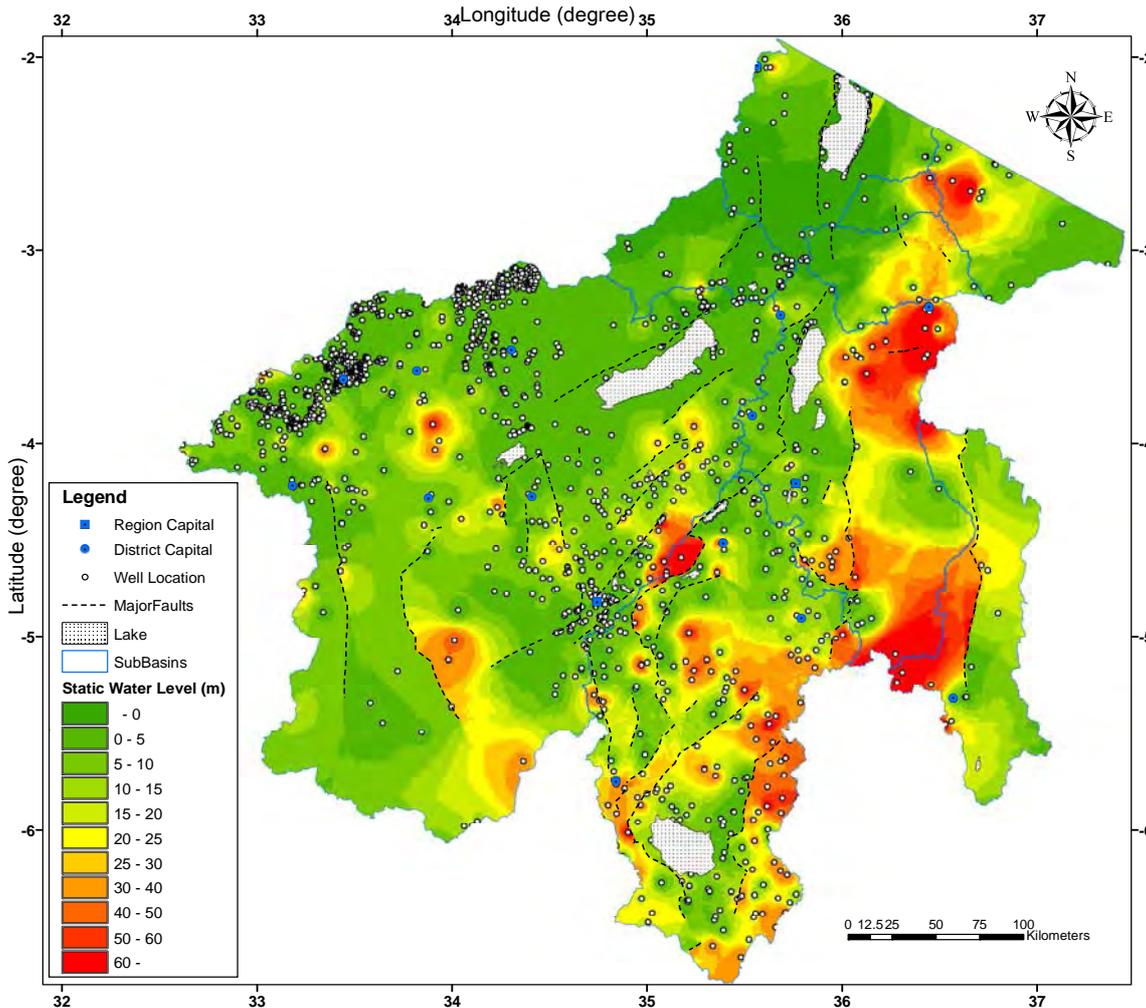
**Figure 4-6 Static Water Level Distribution in IDB**

Static water level distribution of existing boreholes is shown in Figure 4-6. This distribution is including the results of test borehole drilling survey in the study. The features of static water level distribution are shown in Table 4-6.

Areas	Static water level
Arusha region (except Karatu district)	50 – 100
Kiteto and Kondoa district	40 - 100
Simanjiro, Karatu, Mbulu, Babati district	15 - 30
Western part of Dodoma region and North-eastern part of Manyara region	100 - 140
South-western part of Manyara	25 - 40
Singida, Iramba, Igunga, Nzega, Uyui and Sikonge district	5 - 20
Shinyanga, Meatu, Kishapu and Maswa district	5 - 15
Hanang, eastern part of Singida, western part of Kondoa and eastern part of Dodoma district	30 - 50

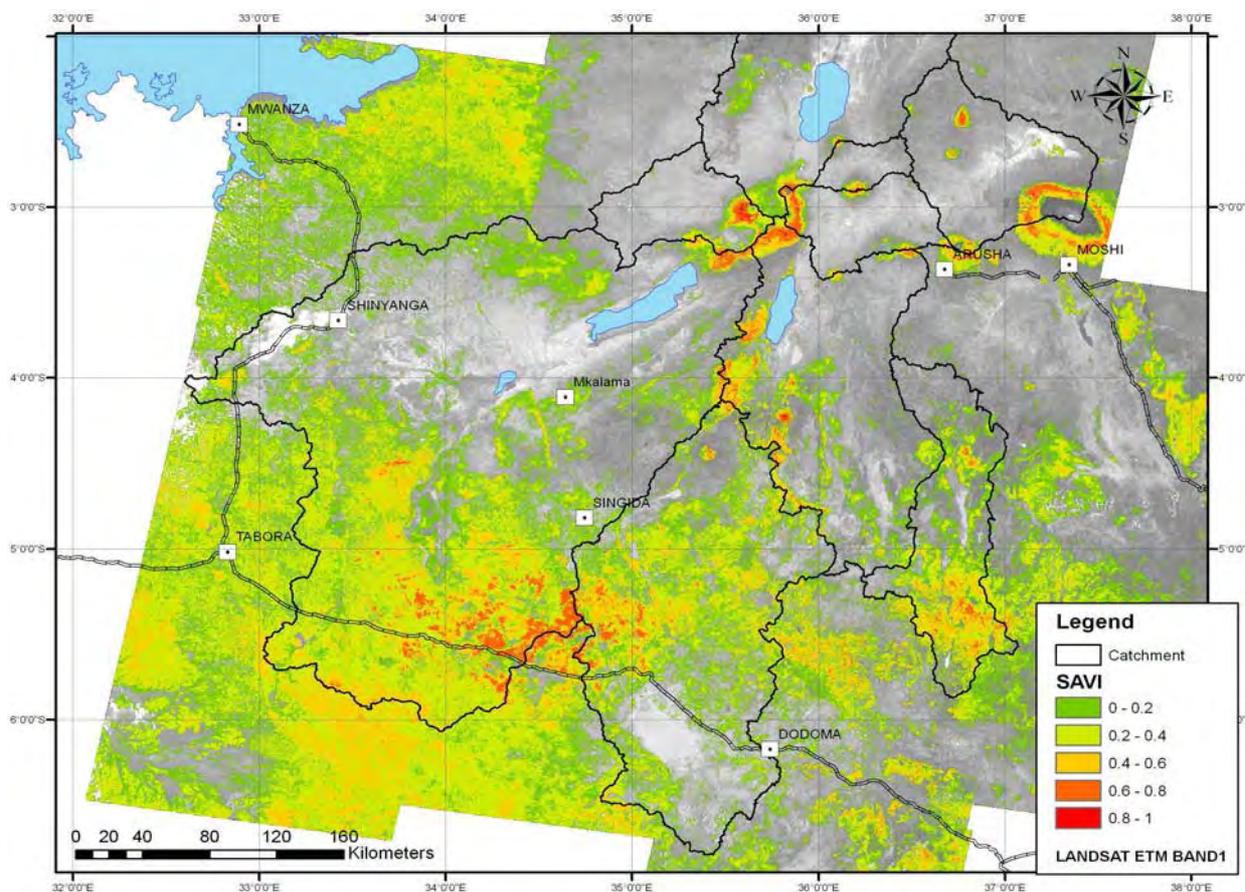
Figure 4-7 SAVI (Soil Adjusted Vegetation Index) Image

SAVI image and VSW image are shown in Figure 4-7 and Figure 4-8 respectively. During January and February when LANDSAT data were acquired, high vegetation index features the two types of areas. One corresponds to high elevation area (above EL1500-2000m) and the other corresponds to the south-western part of IDB along railroad (about EL1000-1400m). The latter also corresponds to smooth topographic characteristic area where is covered by thick weathering zone of granitic rocks. VSW image shows that high soil index distributes in the northern part of IDB, high water index distributes in eastern low elevation area. Almost all of the large lakes and swamps in magenta colour suggest mixed spectra of soil and water because of shallow water depth.

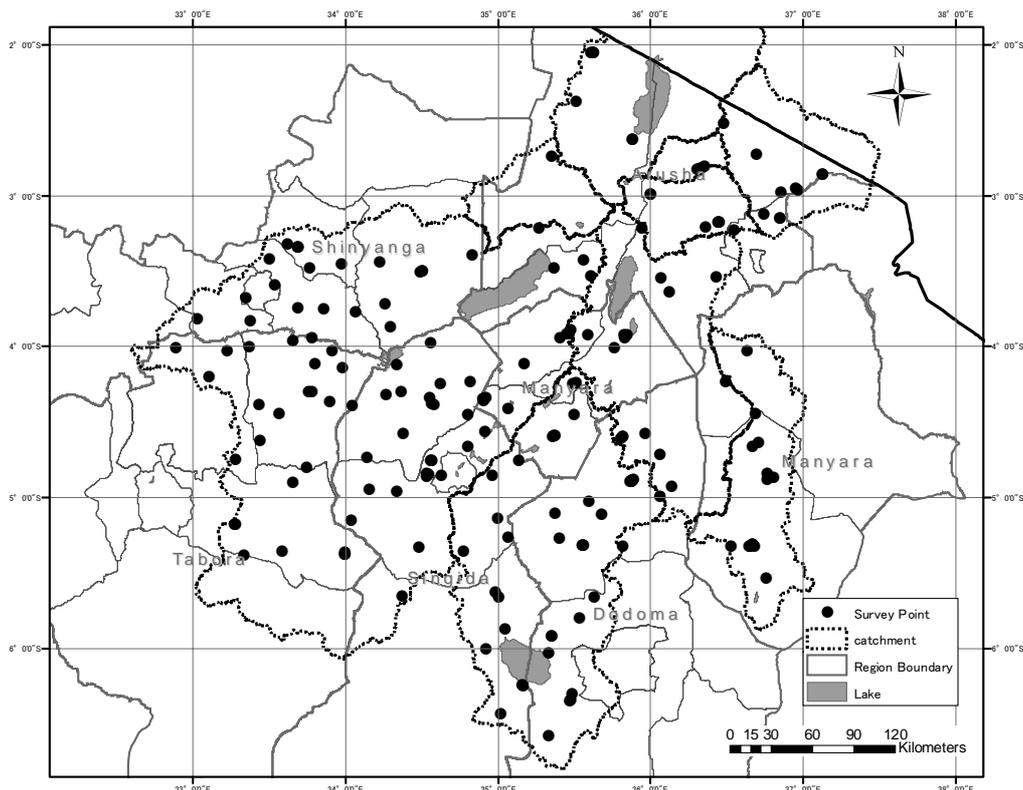
Figure 4-10 Location Map of Survey Points for Vertical Electrical Sounding

The survey points of VES are shown in the Figure 4-10.

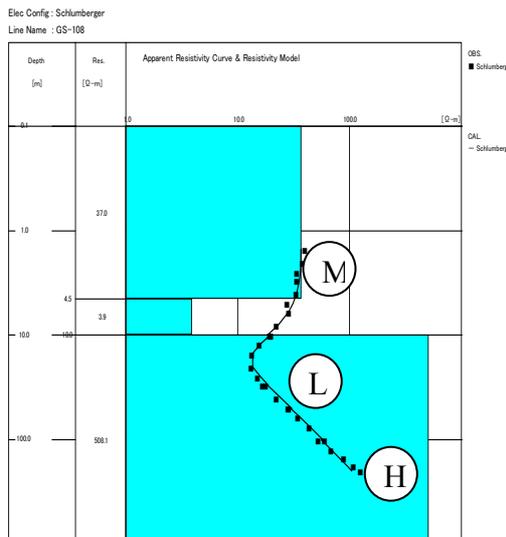
**Figure 4-11 Typical Resistivity Structure -Pattern 1-**

This pattern is typical for igneous rock and metamorphic rock area. Since the survey was conducted in dry season, first layer from the surface had relatively higher resistivity. Low resistivity of the middle layer is estimated as weathered layer or fracture zone, however when the resistivity is less than 10 ohm-m, the layer may be clay or contain salty groundwater. The deepest layer shown high resistivity is presumed to be bedrock. Although the possibility of water struck is low in the bedrock, fissure water can be expected in granite area.

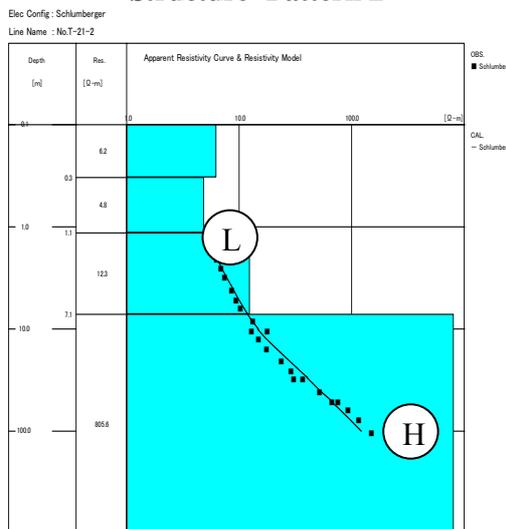
**Figure 4-13 Typical Resistivity Structure -Pattern 3-**

**Pattern 3: Low (Middle) - High**

This pattern is typical for granite area with shallow weathered zone. Weathered layer which shows low resistivity is very thin. And very high resistivity (over 500 Ωm) appears immediately. The high resistivity shows intact rock. Possibility of groundwater is very low.

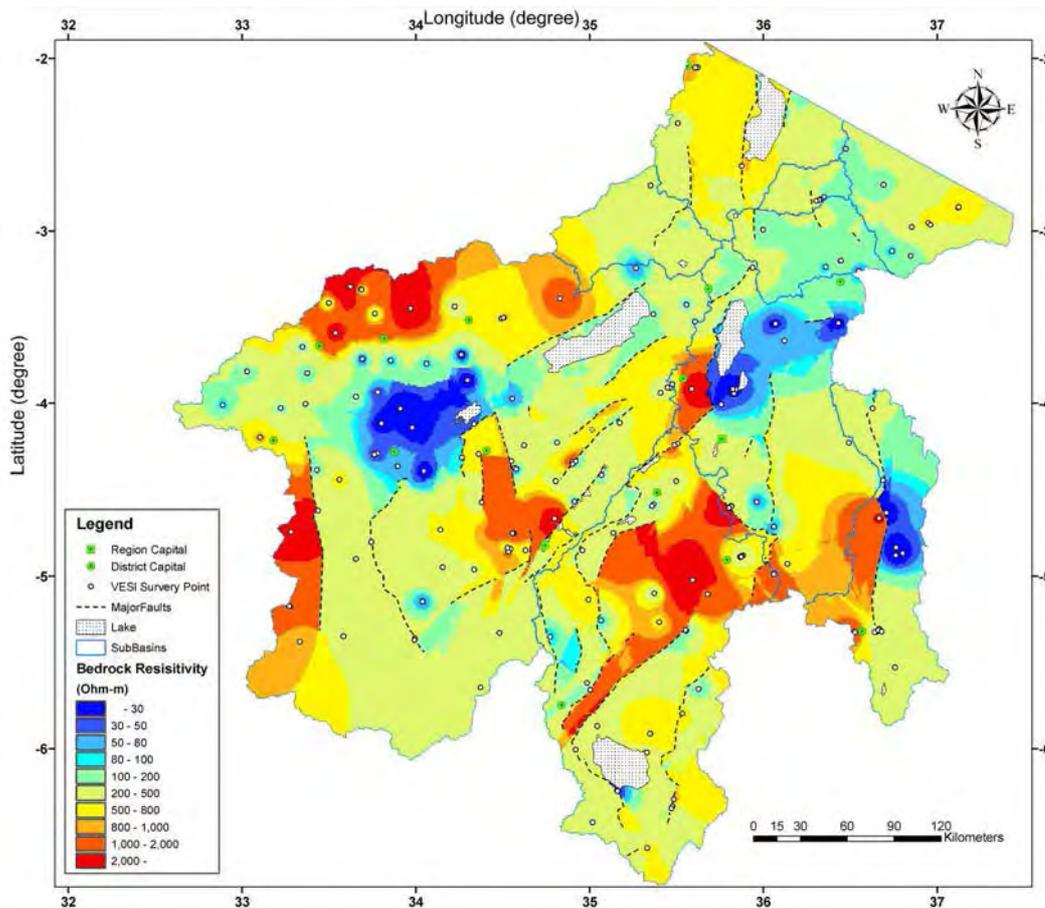
**Figure 4-14 Distribution of Bedrock Resistivity Based on Geophysical Survey**

Based on the geophysical survey, resistivity distribution is illustrated focusing on the bedrock as shown in Figure 4-14. The distribution of resistivity is well-corresponded to geology which has resistivity as shown in Table 4-9.

Resistivity ( $\hat{1}$ m)	Area	Bedrock geology	Remark
Very High (800-2000)	Kondo, Shinyanga, Kishapu Meatu, Maswa	Granitic rock	Few fault and lineament
	South of Babati	Metamorphic rock	-
High (500-800)	Singida, Iramba, Hanang, West of Uyui, Sikonge	Granitic rock	-
	Mbulu, Kiteto, Karatu	Metamorphic rock	-
Middle (200-500)	Bahi, Manyoni, East of Uyui	Granitic rock	-
	Simanjiro	Metamorphic rock	-
Low (100 – 200)	Monduli, Ngorongoro, Arumeru	Volcanic rock	-
Very Low (10 – 100)	South of Shinyanga, South of Kisyapu, Igunga, Nzega	Soft-sediment	Not encountered bedrock until 200m

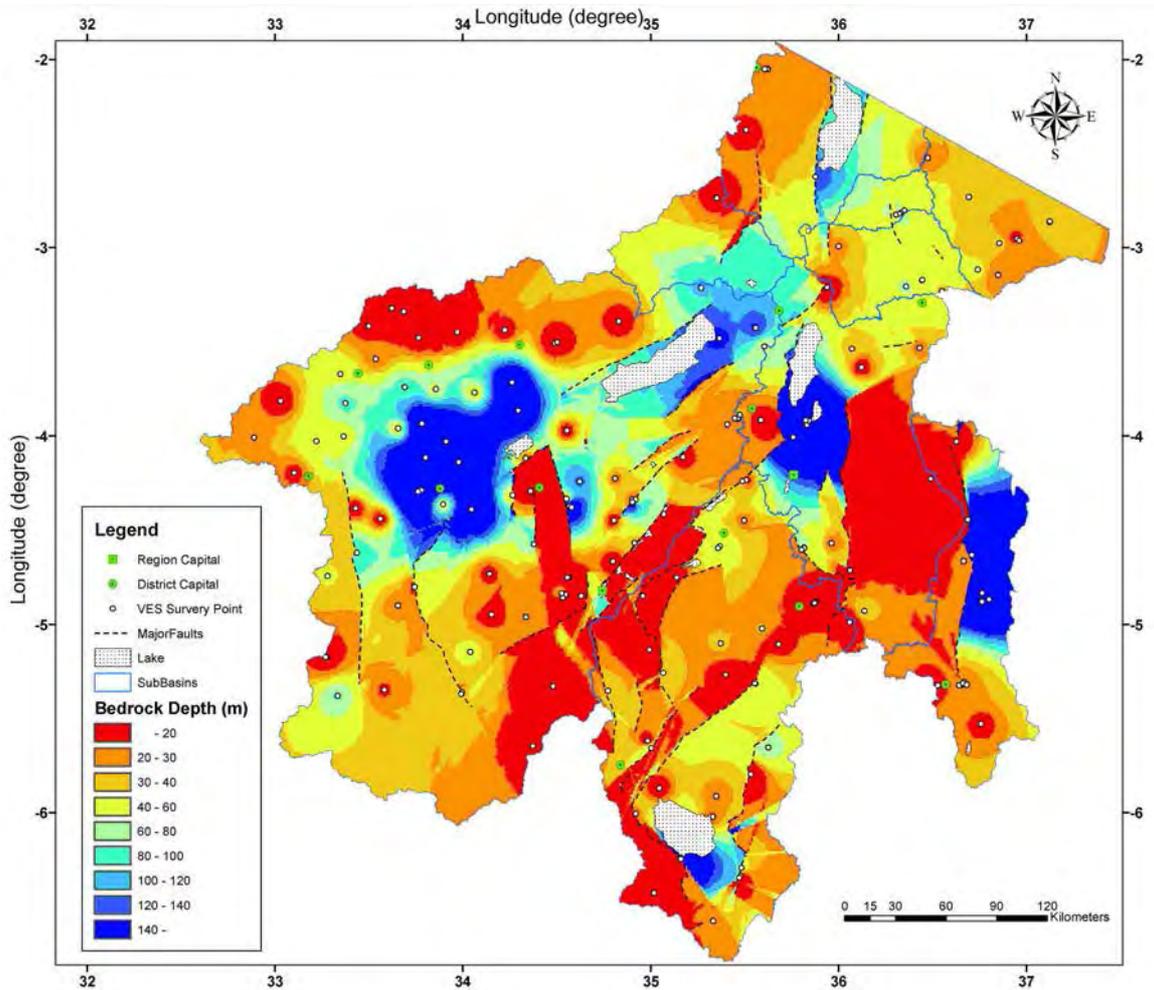
**Figure 4-15 Distribution of Bedrock Depth Based on Geophysical Survey**

On the other hand, a distribution of the bedrock depth based on VES results is shown in Figure 4-15. The feature of the distribution is described in below Table. These are also well-corresponding to the geological distribution.

Very shallow area	Very deep area
Shinyanga, Meatu, Maswa, Uyui, Manyoni, Singida	Manonga river and Wembere river area
Kondoa, Mbulu and Kiteto	Magugu (Babati district)
	Ndedo and Makame (Kiteto district)

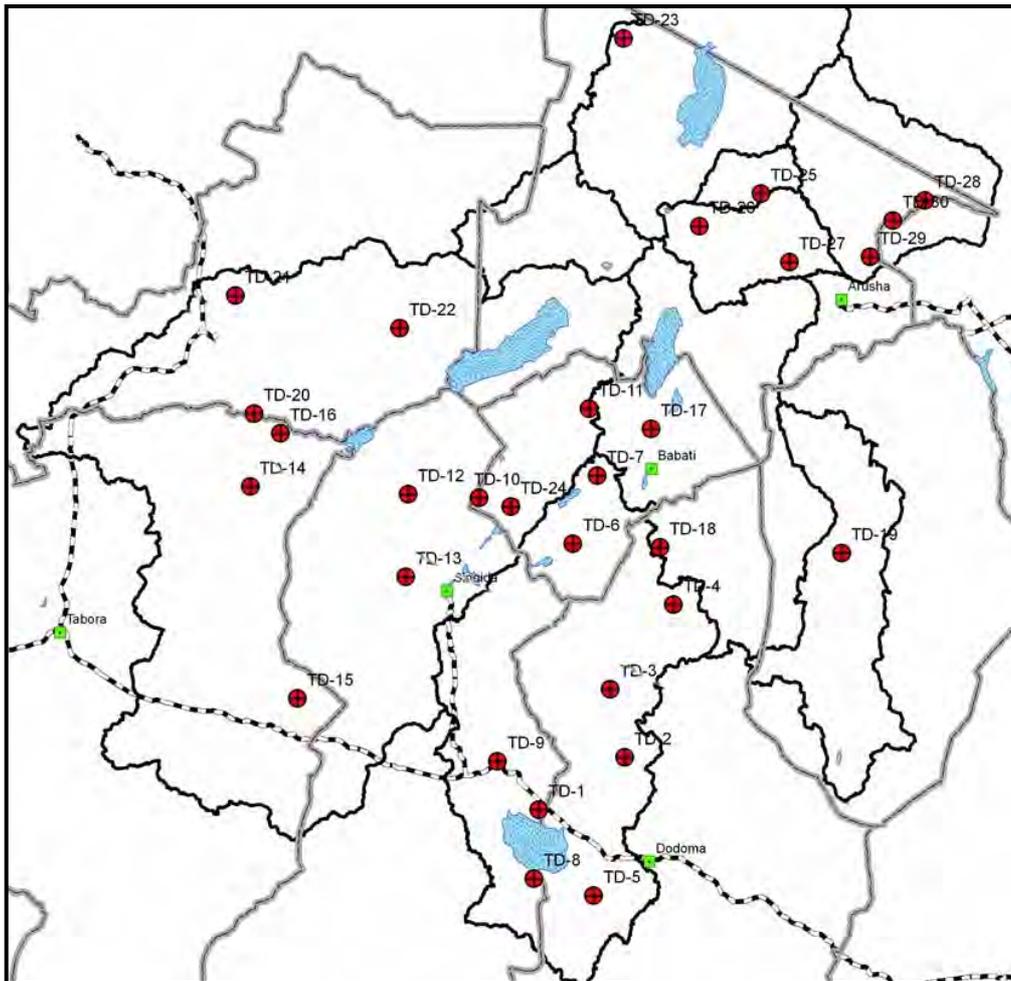
Figure 4-16 Location of Test Borehole Drilling Points

Two methods, three techniques, of geophysical survey were adopted to select test borehole drilling sites. The Vertical Electrical Sounding (VES) was carried out to figure out the outline of geological structure in the candidate areas. When the site wasn't horizontal layered structure, two-dimensional resistivity survey or Magnetic survey was carried out at appropriate line in the candidate areas. Finally, the test drilling sites were determined on the basis of this survey result, including accessibility and topographic feature. The location of the sites are shown in Figure 4-16.

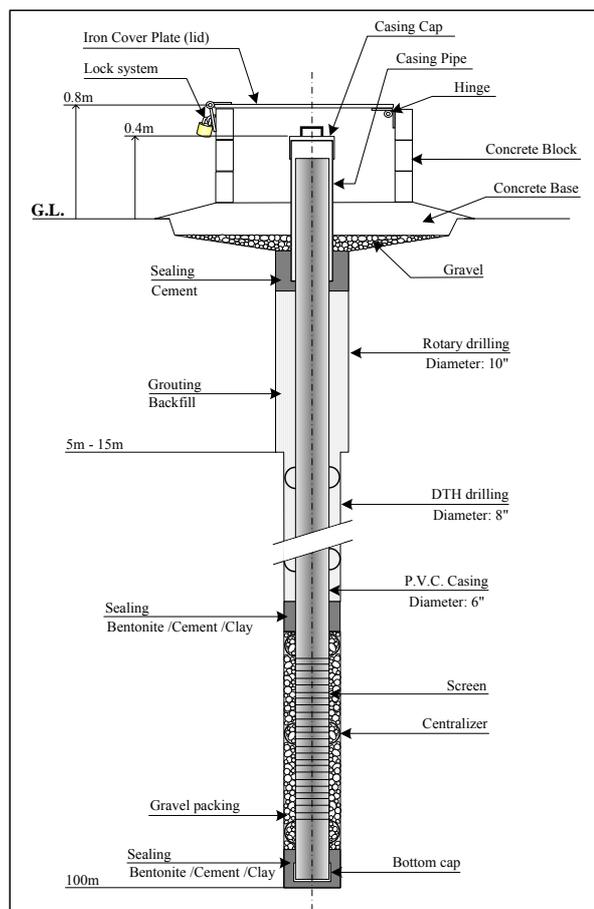
Figure 4-17 Schematic Diagram of Well Structure

Rotary boring method was applied for the soft soil layer and “Down the Hole Hammer” drilling method was applied for the weathered or hard rocks. Casing pipe and suitable drilling fluid were used properly to maintain the borehole wall. The drilled diameter of borehole was 250mm for the rotary drilling and 200mm for the down the hole hammer drilling. Groundwater level and groundwater electric conductivity were measured when the first water strike was found. After completion of the drilling, the geophysical borehole logging was carried out.

The standard well structure is shown in Figure 4-17.

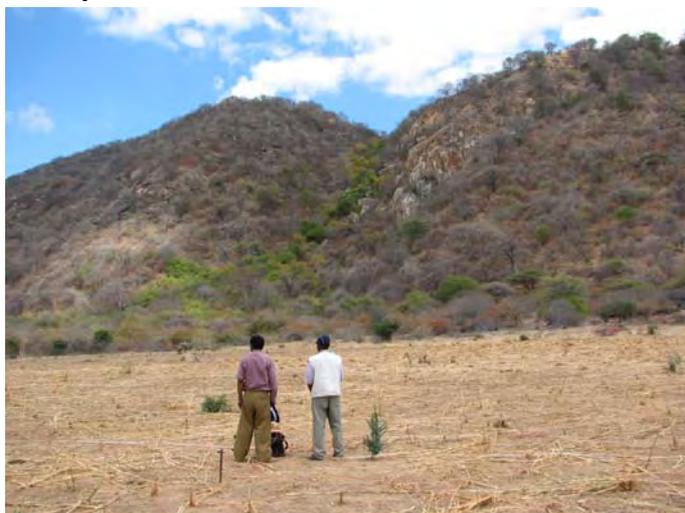
**Resistivity survey in close to fault scarp (Test borehole No. TD-8, Ikasi, Manyoni).**

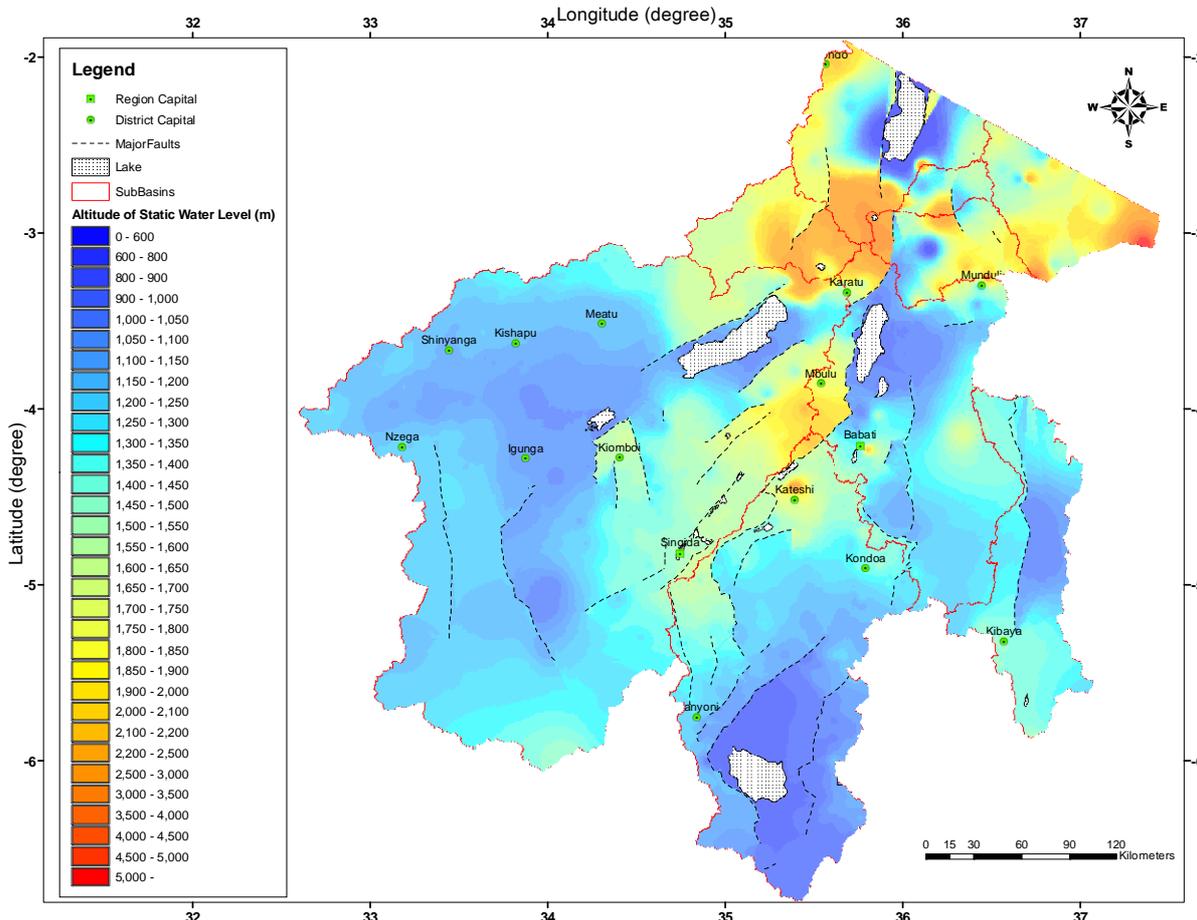
Figure 4-18 Distribution of the Altitude of Static Water Level

The groundwater altitude distribution map was produced by using the existing borehole data, spring data and test borehole drilling data in this study. Groundwater has mainly two kinds of aquifer, confined and unconfined aquifer. The water level of confined aquifer is called piezometric head, and the water level of unconfined aquifer is called natural water table. However, the kinds of aquifers or water levels were not clear in the existing data. Therefore, the difference was neglected in the production of the map. Figure 4-18 shows the distribution map of the altitude of static water level. The altitude of the static water level of each groundwater was calculated from the altitude of wells measured by GPS and their static water levels measured.

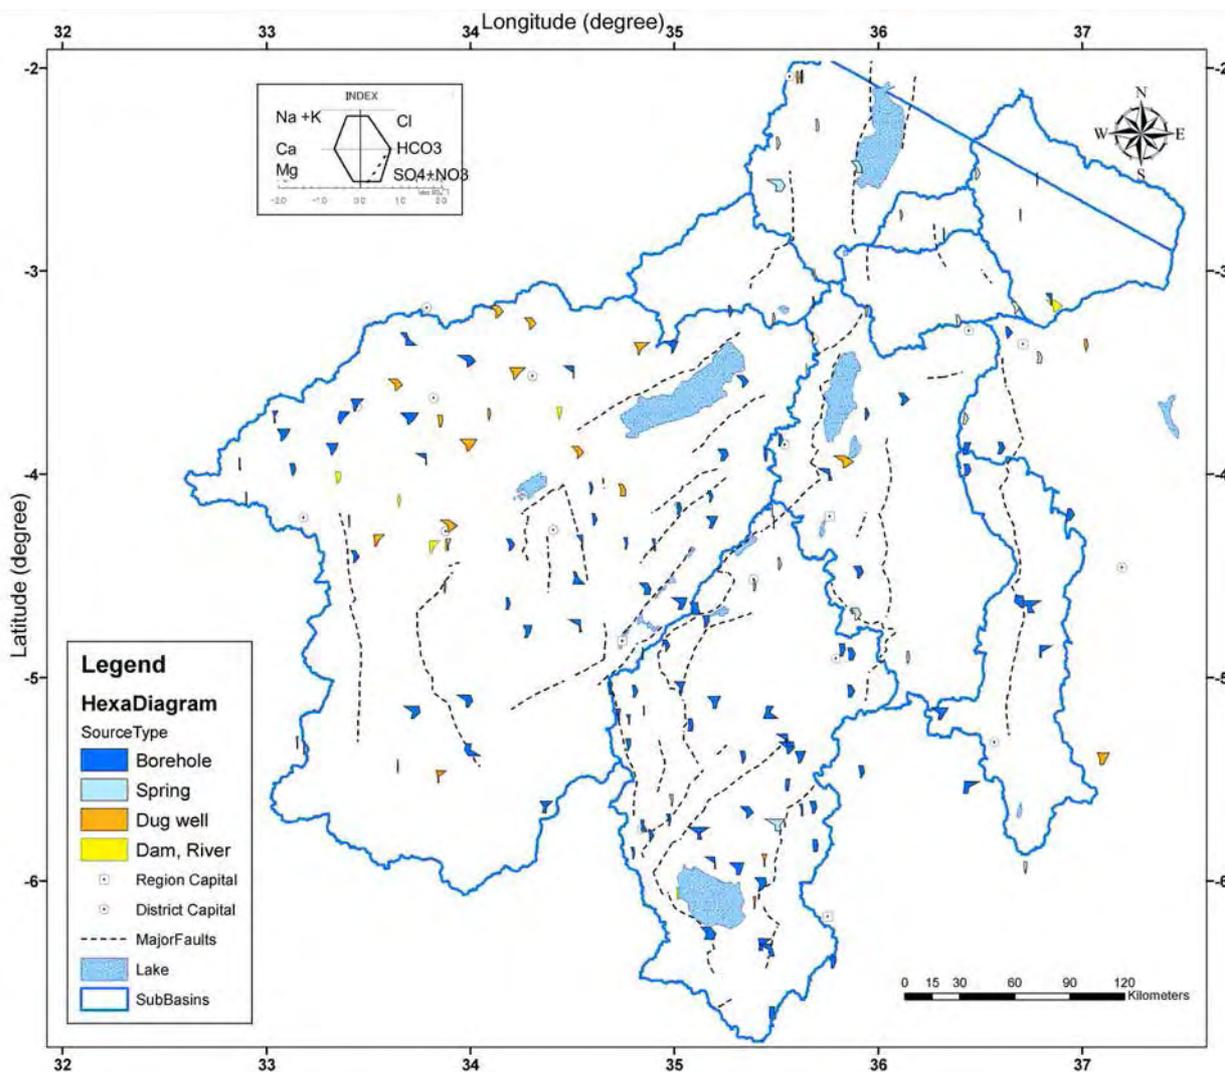
Figure 4-19 Hexa Diagram of Water Quality in IDB

water flow can be analyzed by comparing water quality in upstream and downstream of groundwater. The distribution of water quality hexa-diagram is shown in Figure 4-19. The parameters of water quality are Sodium and Potassium ( $\text{Na}^+ + \text{K}^+$ ), Calcium ( $\text{Ca}^{2+}$ ), Magnesium ( $\text{Mg}^{2+}$ ), Chloride ( $\text{Cl}^-$ ), Bi-carbonate ( $\text{HCO}_3^-$ ), and Sulphate and Nitrate ( $\text{SO}_4^{2-} + \text{NO}_3^-$ ). Additionally, the colour of the diagram shows kinds of sources of the water sample; blue colour shows borehole, light blue shows spring, yellow shows shallow well and orange colour shows surface water.

Generally, surface water forms narrow shape as the diagram because the dissolved mineral is few. Shallow groundwater in shallow well includes relatively much bicarbonate. The downstream of groundwater or the stagnant groundwater tends to have wider width of the diagram because of dissolving larger quantity of various minerals. Especially, the widths of Sodium and Chloride components become wider in the downstream side. The dissolutions of Calcium, Magnesium and Sulphate are depending on the geological condition. For comparison, the hexa-diagram of seawater shows cocktail glass shape because the widths of Sodium and Chloride components are wide and others are narrow.
