**A GUIDE
OF
SLOPE INSPECTION
FOR
MAINTENANCE OF ROADSIDE SLOPE
IN
THE ISLAMIC REPUBLIC OF PAKISTAN**

January 2008

**TECHNICAL ASSISTANCE FOR RECONSTRUCTION OF
BRIDGES DAMAGED BY OCTOBER 8 EARTHQUAKES ON
THE JHELUM VALLY ROAD**

**PAKISTAN TRANSPORT PLAN STUDY IN THE ISLAMIC
REPUBLIC OF PAKISTAN**

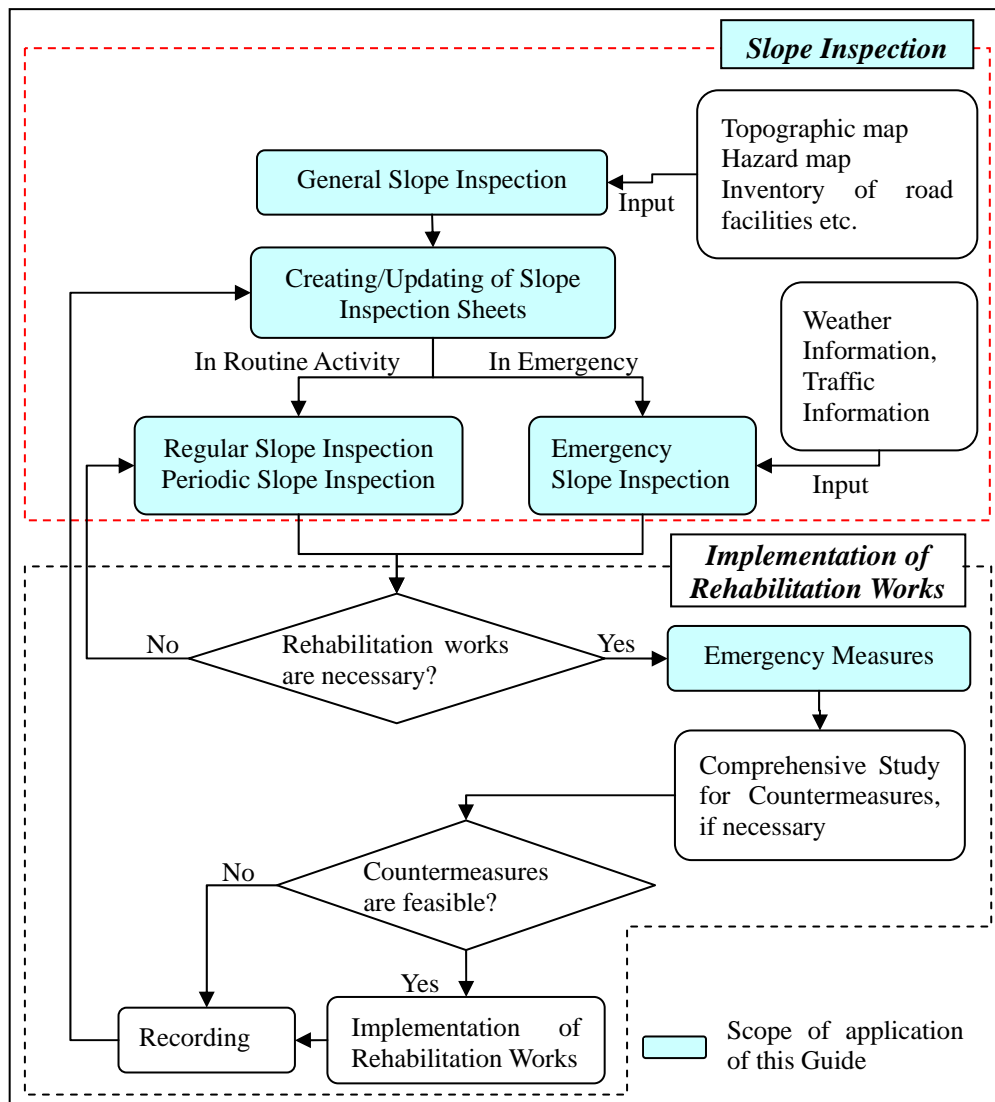
Figure 1.1 A Work Flow for Maintenance of Roadside Slope (Reference: Japan Road Association (1999), partially modified by JICA Study Team)

Basic flow of Maintenance of Roadside Slope is shown in Figure 1.1.

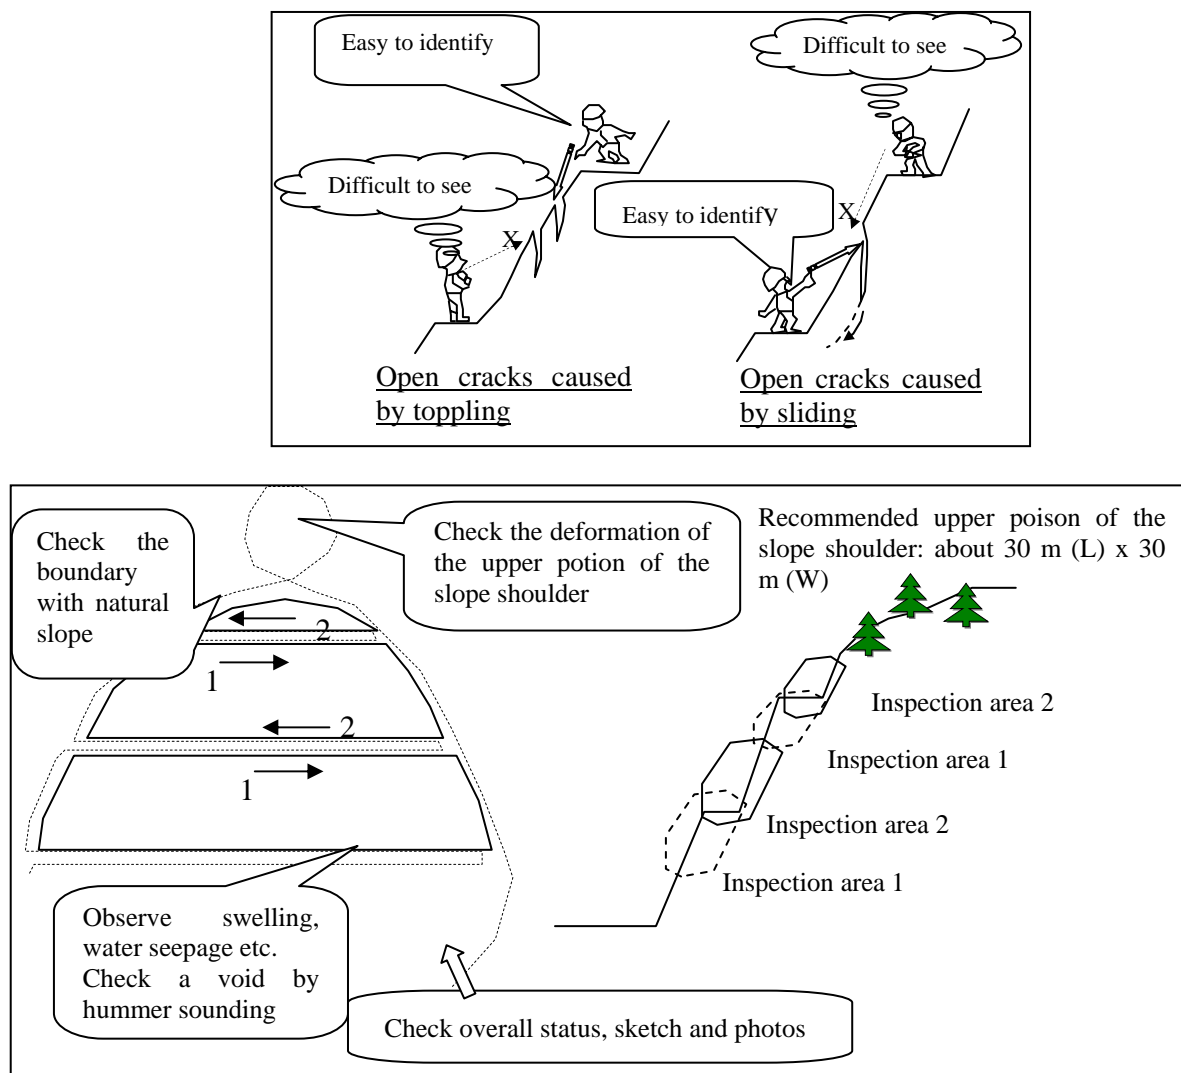
Figure 2.3 Points for Slope Inspection of an Existing Cut Slope (Reference: JH (1982), Slope Inspection Guide 1)

It is necessary to come close to the slope shoulder in the slope inspection, because most of landslides occur at slope shoulders. Some indications of landslides such as open cracks etc. might be found on the slope.

It is advisable to check the same slope twice (from its top and bottom) to avoid the chance of overlooking any symptoms of landslides as shown in Figure 2.3

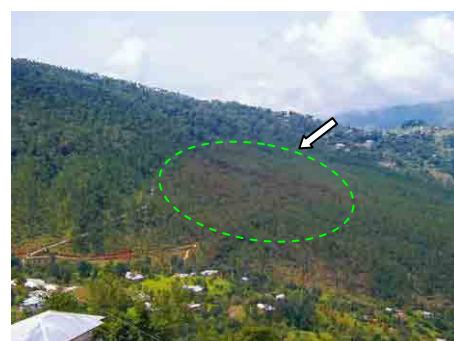
Figure 2.13 Dying Trees Caused by a Landslide beside Murree Road (Source: JICA Study Team)

- Open cracks, Erosion
- Dying trees caused by developed tension cracks (See Figure 2.13).
- Leaning trees caused by the creep of the slope surface.
- Spring, water seepage etc.

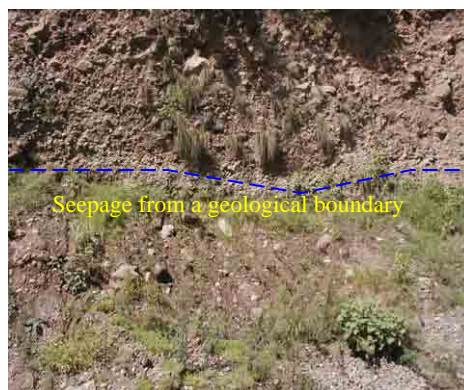
Figure 2.17 Seepage from the Geological Boundary
(Source: JICA Study Team)

The distribution of the vegetation helps to identify seepage from a geological boundary.

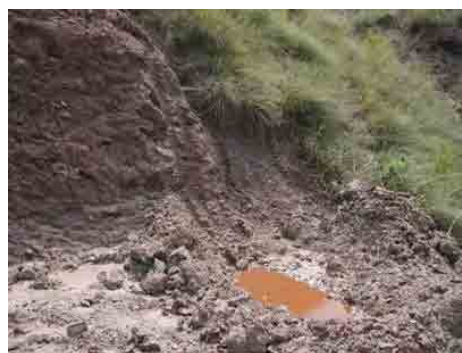
Figure 2.21 Reddish Swelling Soil beside N-75 (Source: JICA Study Team)

Meanwhile, enormous landslides (landcreep) occur on the slope of Jhelum Valley Road and N-75 (Murree-Muzaffarabad) road along the active fault line even if the gradient is less than 1:1.5 as shown in Figure 2.21. Reddish swelling clay is the main factor of recurrent landslides (landcreep) during and after rain falls.

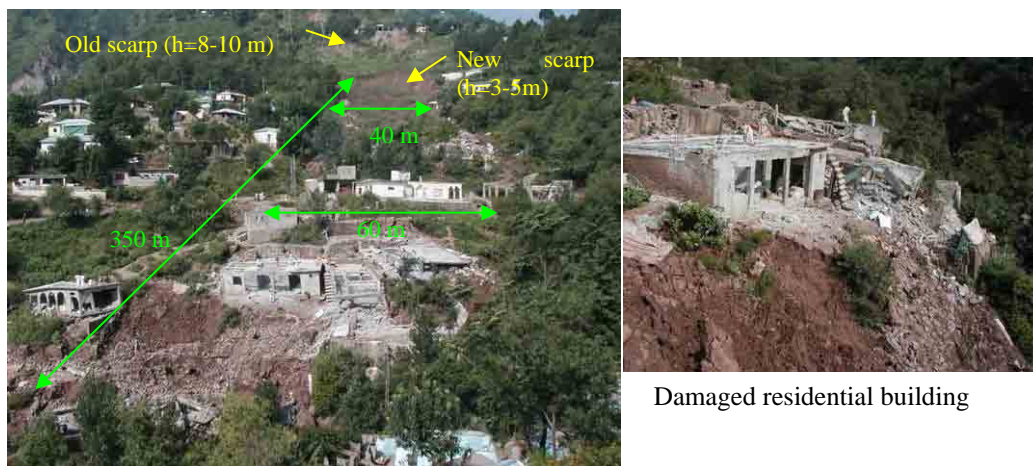
Figure 2.22 Recurrence of An Old Landslide (Landcreep)
(Source: JICA Study Team)

During the 2006 wet season, a landslide (landcreep) moved gradually after the heavy rainfall (more than 100 mm/day of 4th Aug 2006) and had crept for the next one week in spite of the no rain fall. Some houses were seriously damaged from 6th Aug to 8th Aug, 2006 as shown in Figure 2.22.

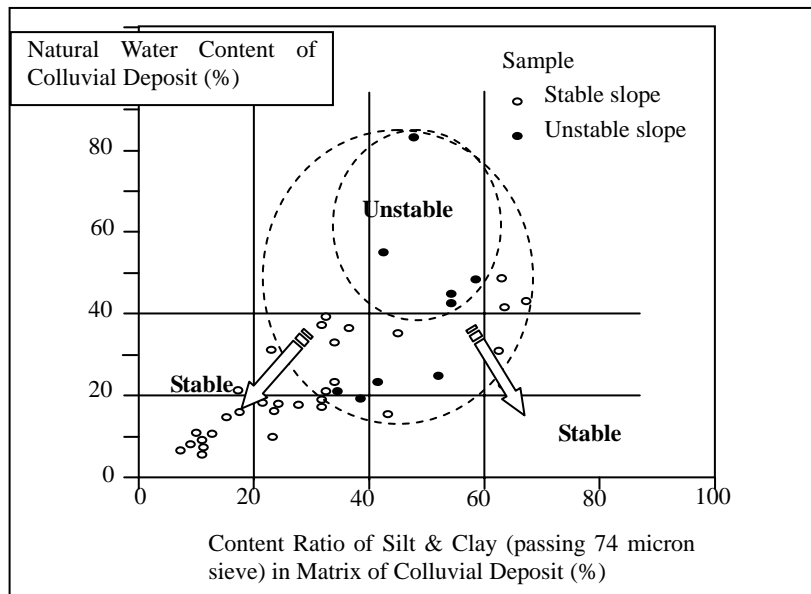
Figure 2.23 Cut Slope Stability of Colluvial Deposit Based on Natural Water Content and Content Ratio of Silt and Clay (References: Okusono, 1979, JH lab report)

In general, cohesive soil (clay) shows low water permeability, high natural water content and poor drainage, and sandy materials show high water permeability, low natural water content, and good drainage. Meanwhile, silt, medium size between sand and clay, shows low water permeability, low plasticity, and poor drainage in spite of relatively high absorption. These characteristics of silt are unsuitable for slope stability.

Medium content ratio area of fine materials (silt & clay) shows slope instability, and increasing or decreasing ratio of fine materials works to stabilize the slope (See Figure 2.23).

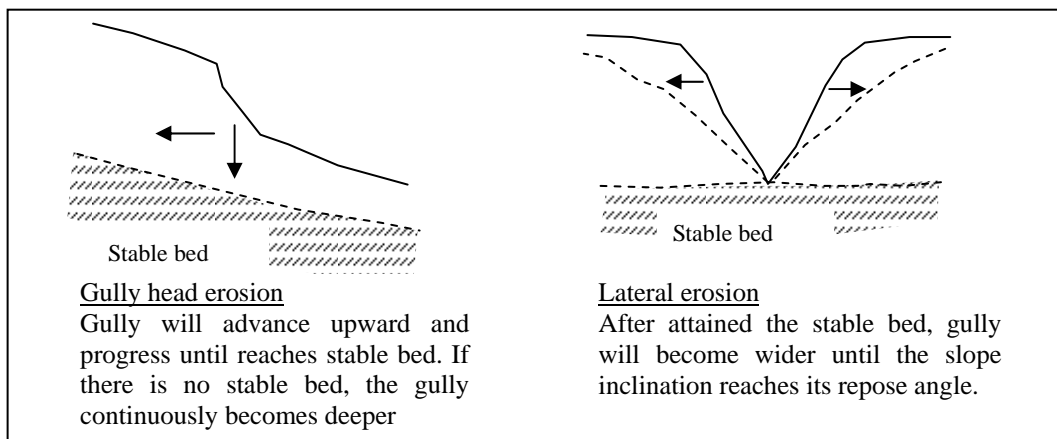
Figure 2.26 Advance of Gully Erosion (Source: JICA Study Team)

Sandy or silty soil slopes are subject to the phenomenon of gully erosions. In general a gully becomes deeper and wider through the under mentioned processes as shown in Figure 26, and consequently leads to landslides.

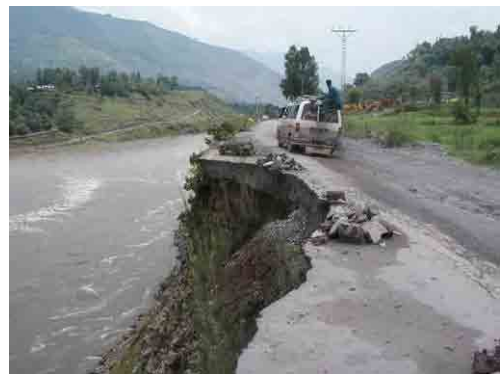
Embankment failures caused by riverbank erosion sometimes results in immense harm to road traffic, since their maintenance works are technically and ecumenically difficult due to its scale as shown in Figure 2.28. An early identification and a quick response are necessary. Hazardous areas of riverbank erosion should be observed carefully in the slope inspections.

Figure 2.28 Embankment Failure caused by River Bank Erosion on Jhelum Valley Road (Source: JICA Study Team)

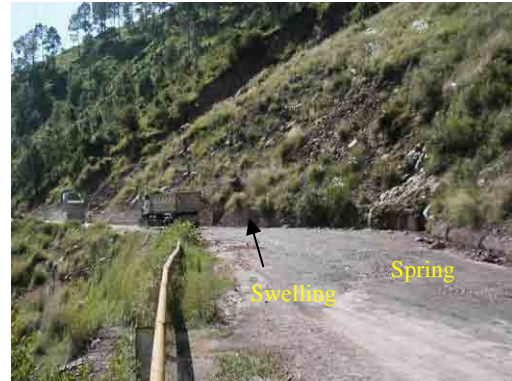
Swelling at the toe of slope indicates the slope creeping (See Figure 2.29). Swelling of slope frequently is associated with water seepage at the toe of the slope and the existence of tension cracks above.

Figure 2.29 Swelling of Toe of slope on Jhelum Valley Road
(Source: JICA Study Team)

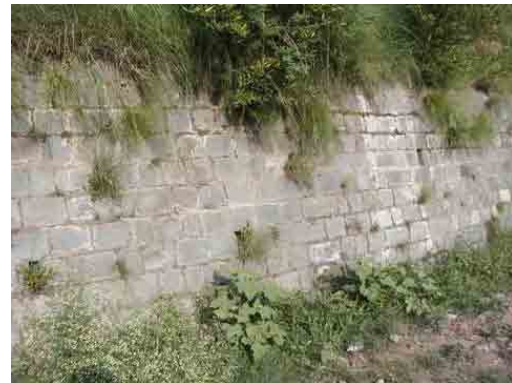
Drained off water sometimes leaves carbonate or red ocher traces on the surface of retaining walls. Bedrocks behind the walls might be loosened and slope stability be deteriorated, because intermittent alternate wetting and drying accelerates the weathering of bedrock. Grass growing in a drain pipe of a retaining wall needs to be removed for slope stability, because the grass obstructs proper water drainage and will lead to water pressure increasing behind the wall (See Figure 2.30).

Figure 2.30 Grass Growing in Drain Pipes of the Retaining Wall (N-75)
(Source: JICA Study Team)

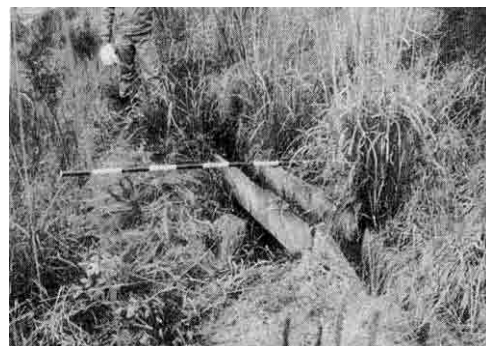
Water leakage often occurs from some joints of a drain as shown in Figure 2.32. Overflow water causes gully erosion.

Figure 2.32 Water Leakages from a Joint of Drain and Erosion (Source: JH (1982), Slope Inspection Guide 1)

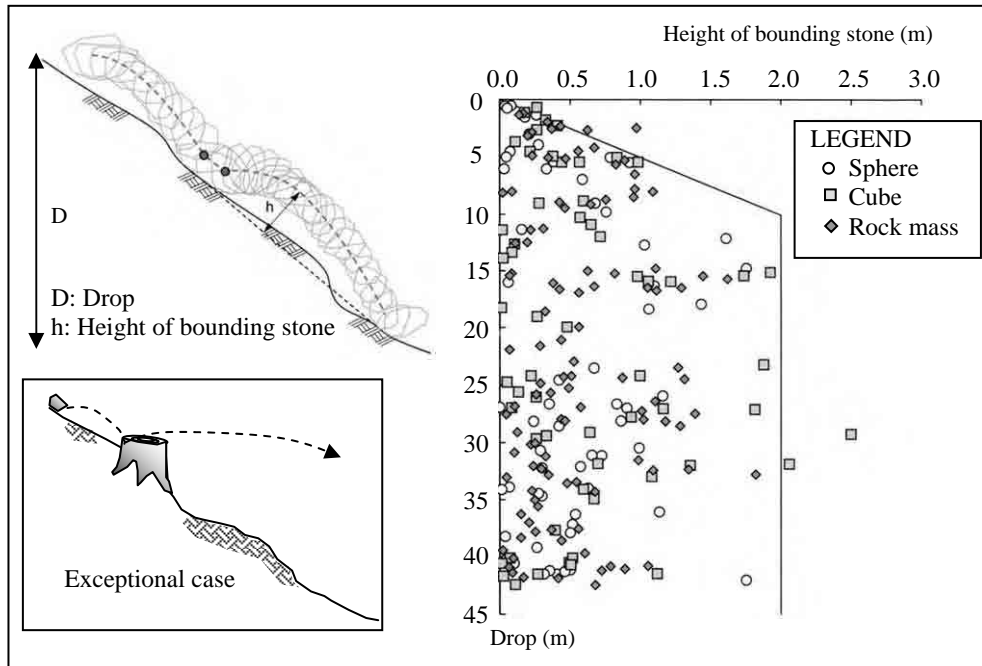
Figure 2.37 Height of Bounding Stone (Source: Nikkei Construction, 2006)

According to Japanese experiences of rock falls, mostly height of the bounding stone is within two meters regardless of the slope length, in case there are no extreme projections (See Figure 2.37).

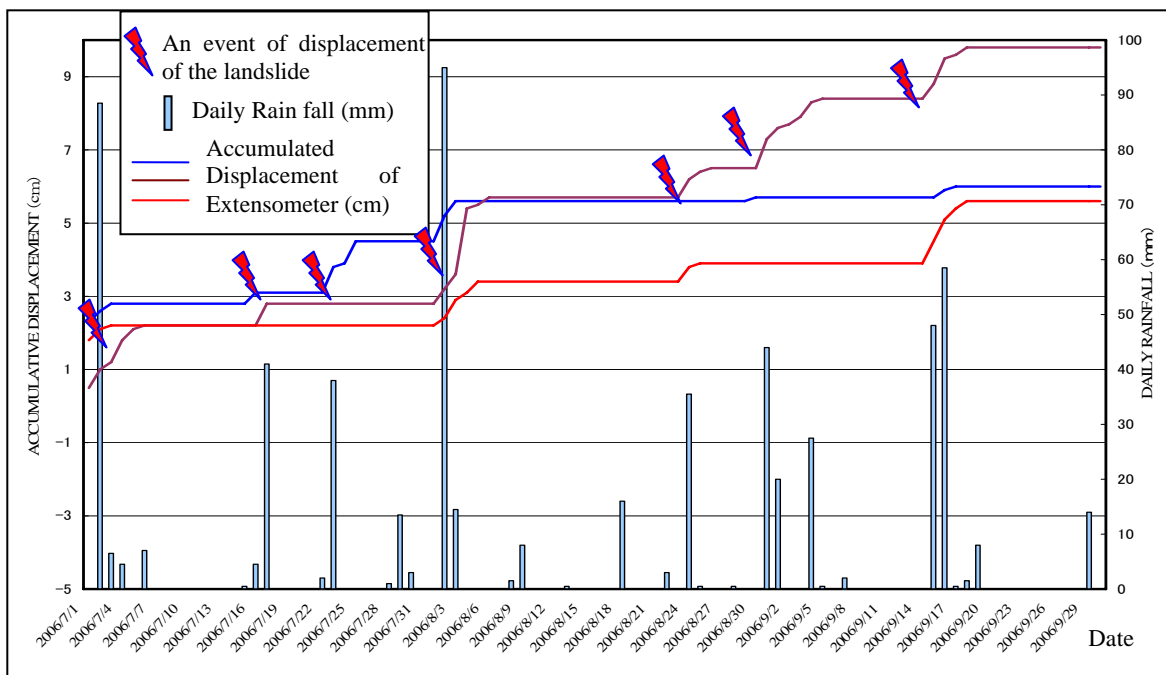
Monitoring data of the subject slope, together with precipitation data, should be analyzed chronologically (See Figure 2.40).

- To determine whether the monitored landslides are stable or unstable from the relationship between time and displacements
 - To determine the effect of rainfall to the movement of a landslide from the relationships between displacement and precipitation
 - To determine the level of warning or whether evacuation is necessary or not by referring to the standard values.
 - To improve the standard values (Rainfalls and Displacements) by analyzing relationship between the displacement velocity and precipitation as well as visual observation results
 - To forecast the time of occurrence of a landslide by measuring the displacement velocity.
- Generally, displacement velocity tends to suddenly increase immediately before the whole slide of a landslide mass so that the time of the landslide can be sometimes forecasted in advance by observing the increased velocity.

Figure 2.40 A Sample of the Stability Analysis of A Monitored Landslide Base on the Displacement Accumulation of Three Extensometers and Precipitation Data, (JICA Study Team)

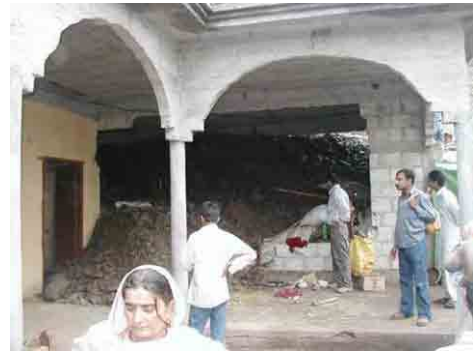
At about 0:30 a.m., July 27, 2006 during a heavy rain, landslide and its associated debris flow occurred near the Minahaji Camp in Muzaffarabad City (See Figure 2.41). The resident heard unusual sound when the debris flow occurred, and could escape immediately before the residential building was destroyed.

Figure 2.41 A Residential Building damaged by a Debris Flow, about 600 m long. Debris Flow deposits are composed mainly of Limestone Gravels of 10 cm-20 cm in diameter, (Source: JICA Study Team)

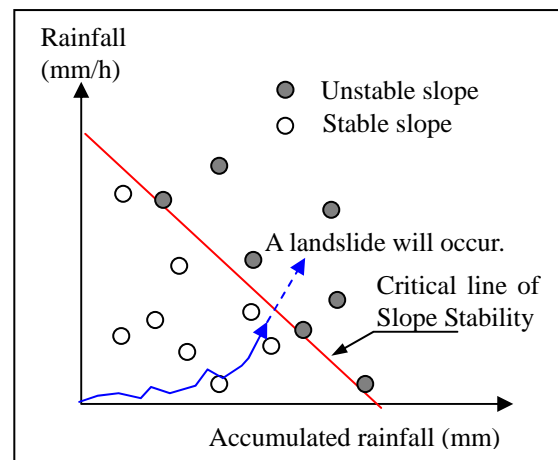
Some large scale landslides often occur after continuous or intermittent heavy rainfalls. Figure 4.42 shows image of assessment of slope stability based on rainfall. Accumulation of precipitation data and results of slope inspection would predict the occurrence of a landslide, although it is difficult right now.

Figure 2.42 Image of Assessment of Slope Stability based on Rainfall (Source: JICA Study Team)
