**THE STUDY ON
MONITORING AND EARLY WARNING SYSTEM
FOR LANDSLIDES AND FLOODS
IN SELECTED AREAS IN THE CAPITAL DISTRICT
OF BOGOTÁ AND SOACHA MUNICIPALITY
IN THE REPUBLIC OF COLOMBIA**

**FINAL REPORT
VOLUME 1 SUMMARY**

JAPAN INTERNATIONAL COOPERATION AGENCY

**PACIFIC CONSULTANTS INTERNATIONAL
OYO INTERNATIONAL CORPORATION**

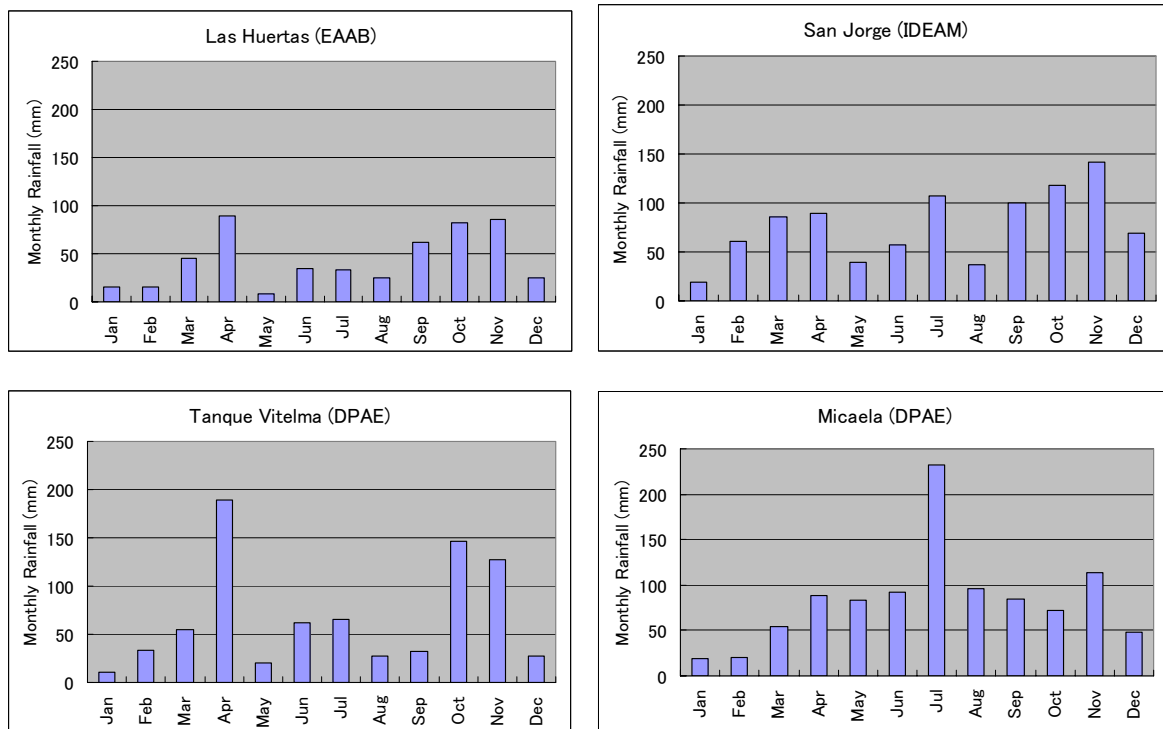
Figure 2-5 Monthly Rainfall Variation in 2003

The monthly rainfall variation in 2003 in the Study Area is shown in Figure 2-5. There are two (2) rainy seasons from March to May and from September to November in the Study Area. As for the characteristic of the Study Area, the rainfall amount is comparatively high in the eastern hilly area in Bogota and southern mountain area in Soacha through the year, and especially the rainfall amount in July is also high in these areas apart from the two (2) rainy seasons as registered by the Micaela station located in eastern and southern hilly area in the Study Area. This trend is also observed in other years such as 2002, 2004 and 2005.

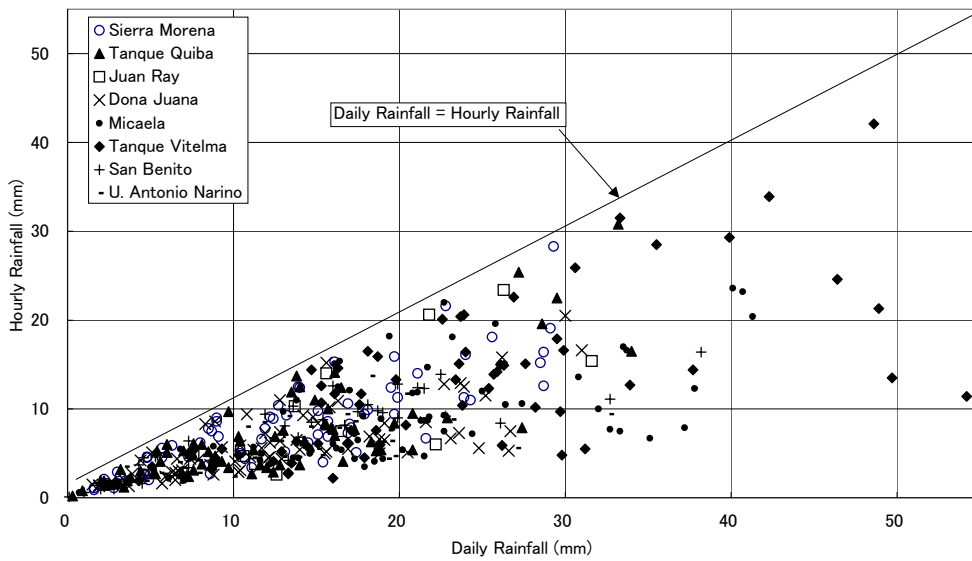
Figure 2-7 Relation between Daily Rainfall and Hourly Rainfall in the DPAE Stations in 2000-2006

Figure 2-7 shows the relation between daily rainfall and hourly rainfall in DPAE stations in 2000-2006. The daily rainfall has a maximum value for each month from 2000 to 2006, and the hourly rainfall has also the maximum value for each month from 2000 to 2006. From the figure, we can see that the percentage of hourly rainfall amount to the daily rainfall amount is about 40-60%, which means the heavy rainfall finishes in short time. Figure 2-8 shows a rainfall distribution in 1 day for Micaela station. These 10 examples in each figure are top 10 of high daily rainfall amount from October 2000

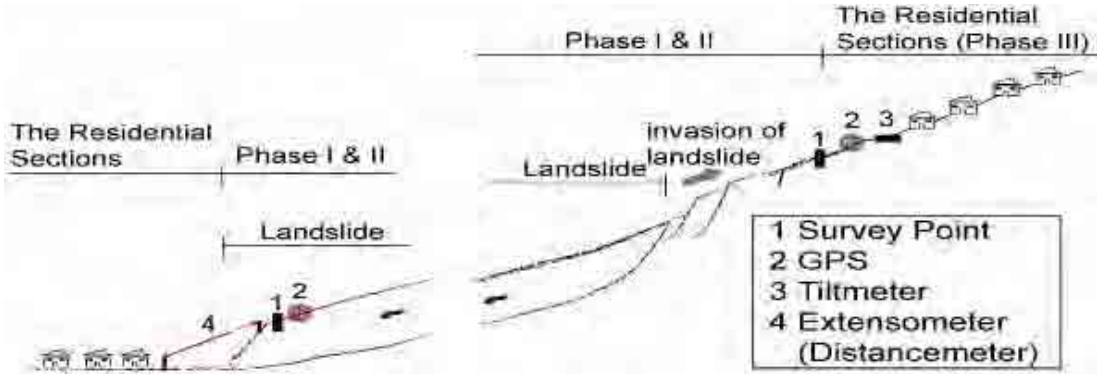
Figure 5-6 Example of Instrumentation along the Landslide and the Residential Areas

Tiltmeter and GPS can be used for the monitoring of the ground movement. By monitoring the ground movement using these instruments along the Landslide and the residential areas as shown in Figure 5-6, we can estimate whether the Landslide is approaching. Tiltmeter and GPS should be installed in secure places such as private sections and premises.

The extensometer is useful at the toe of landslide to monitor the expansion of landslides. Generally, the extensometer requires wire to monitor the distance, therefore it is not recommendable for this area. The laser distance meter should be used for the area since no wire is required between the residential houses and the Landslide.

Figure 5-6 illustrates an example of instrumentation along the Landslide and Residential Areas.

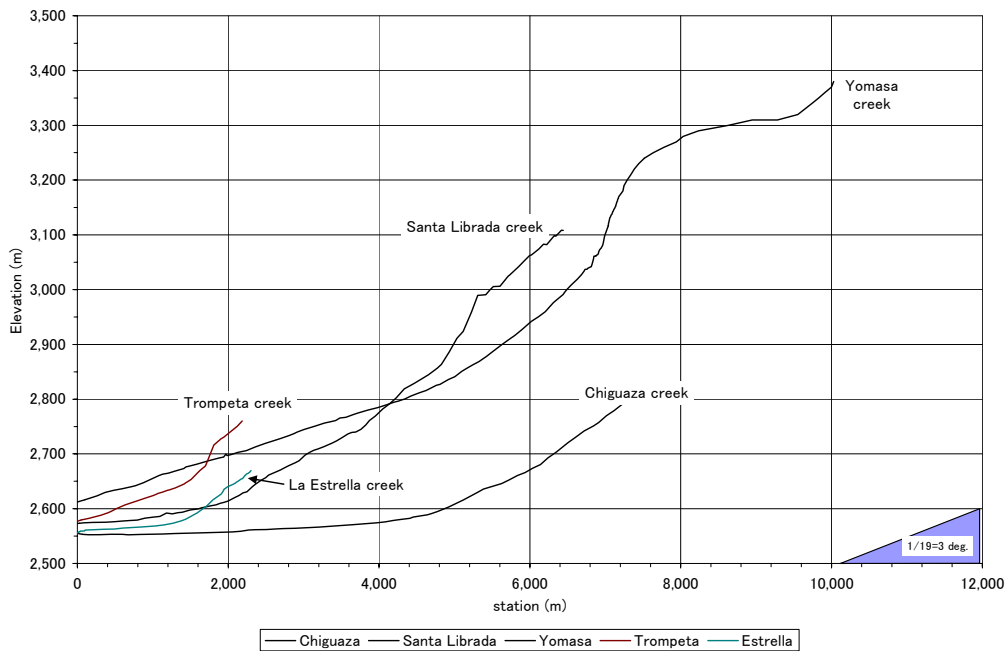
Figure 6-1 Longitudinal Profiles of Target Creeks in Bogota

All target creek catchments of Bogota are located in the Tunjuelo river basin. The Tunjuelo River, which is a tributary of the Bogota River, is located in the southern part of the Metropolitan District of Bogota. The target creeks are Chiguaza creek, Santa Librada creek, Yomasa creek and La Estrella Trompeta creek. (Figure 6-1).

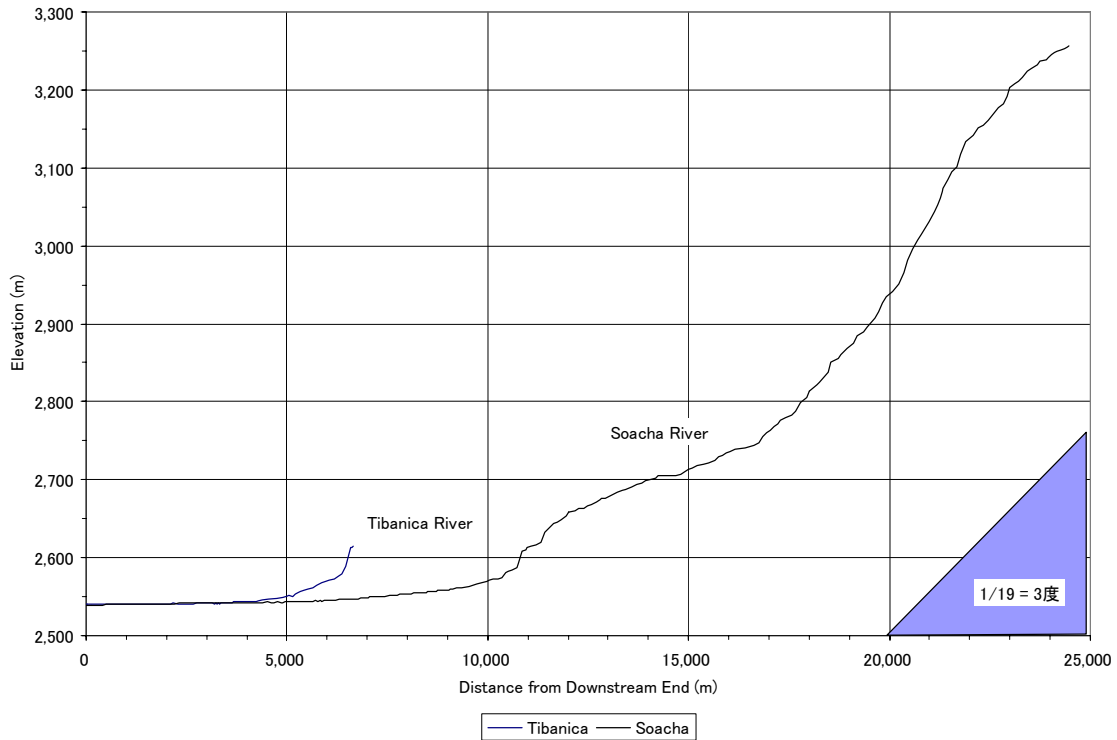
Figure 11-1 Longitudinal Profiles of Target Rivers in Soacha

The Study Area in Soacha Municipality covers the Soacha River and the Tibanica River. The catchment area of the Soacha river and the Tibanica river is 44.3 km² and 19.2 km², respectively. Annual rainfall in San Jorge (IDEAM) which is located in the upper part of the Soacha River is 691 mm as an average value between 1960 and 2002.

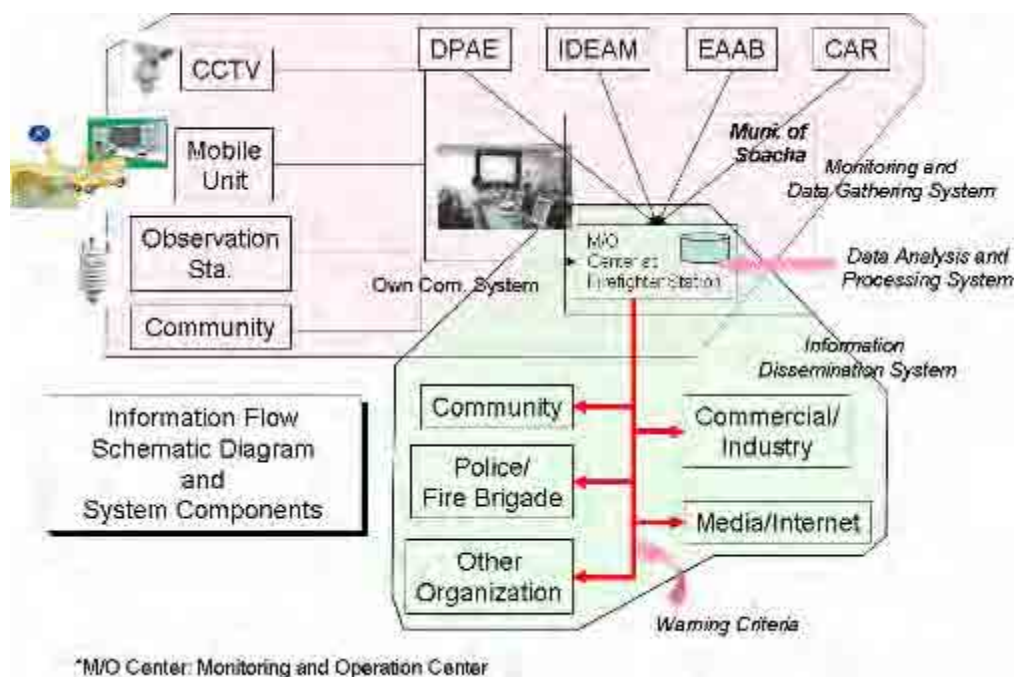
Figure 11-7 Overall System Planning (Future Image)

The overall system planning (schematic diagram of information flow and system components) is shown in Figure 11-7, and brief descriptions of each sub-system are shown in Table 11-2.

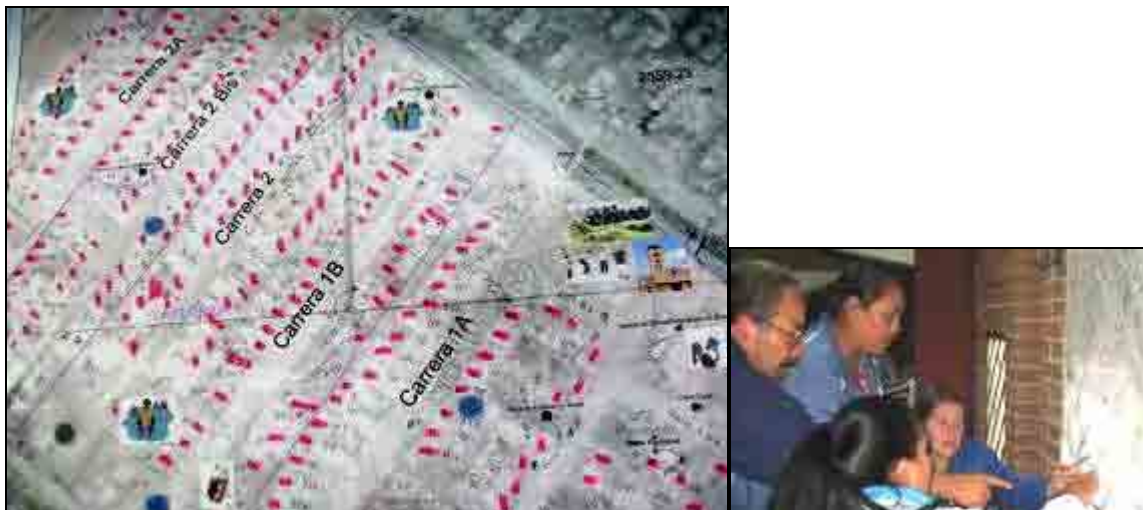
Figure 12-2 Draft Community Disaster Prevention Map

The information (on the hazards that community people are facing and the recourses that they have, the routes and places for evacuation, etc.) which they shared and agreed upon was written into the draft community disaster prevention map (Figure 12-3) and the information on the draft map was corrected during the process until completion of the final map.

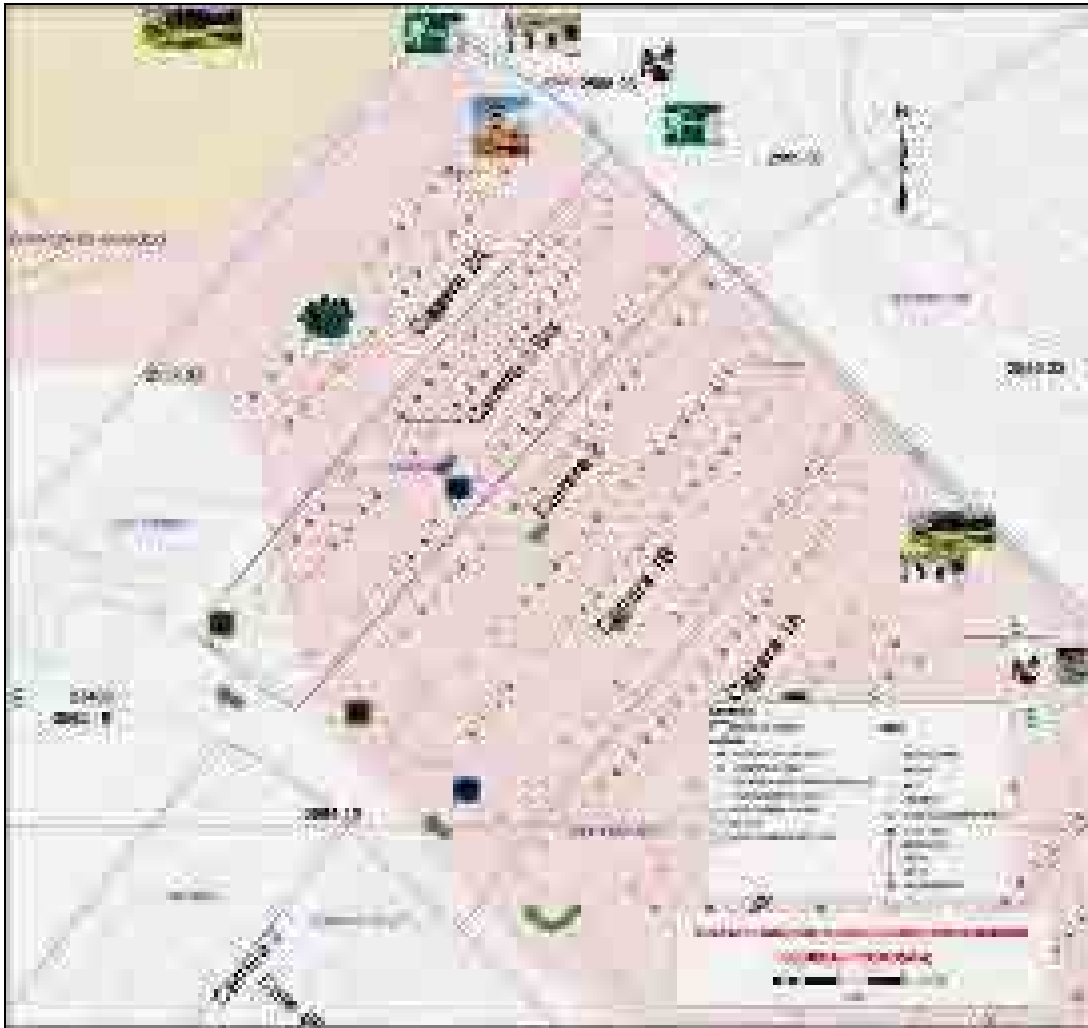
Figure 12-3 Example of Community Disaster Prevention Map

In the Community Disaster Prevention Maps, the evacuation routes are marked with green arrows. The Meeting Points are marked with a circled green “E” letter.

The information visualized on the draft map was transferred into the GIS database and finally produced as the community disaster prevention map as shown below.

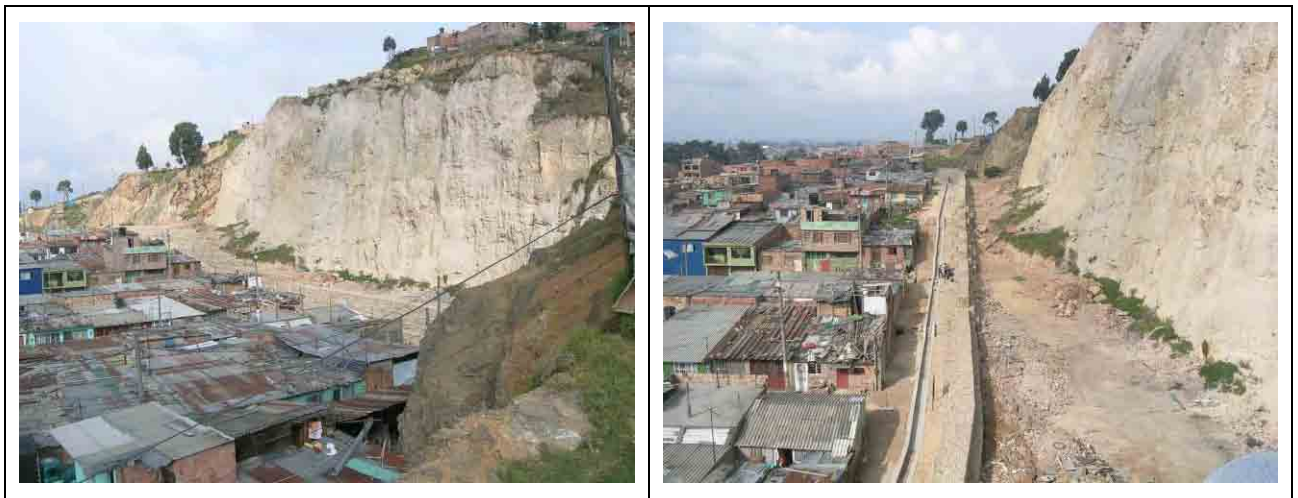
Figure 13-6 General View of Temporary Works

The general view of the Temporary Works is shown as follows.

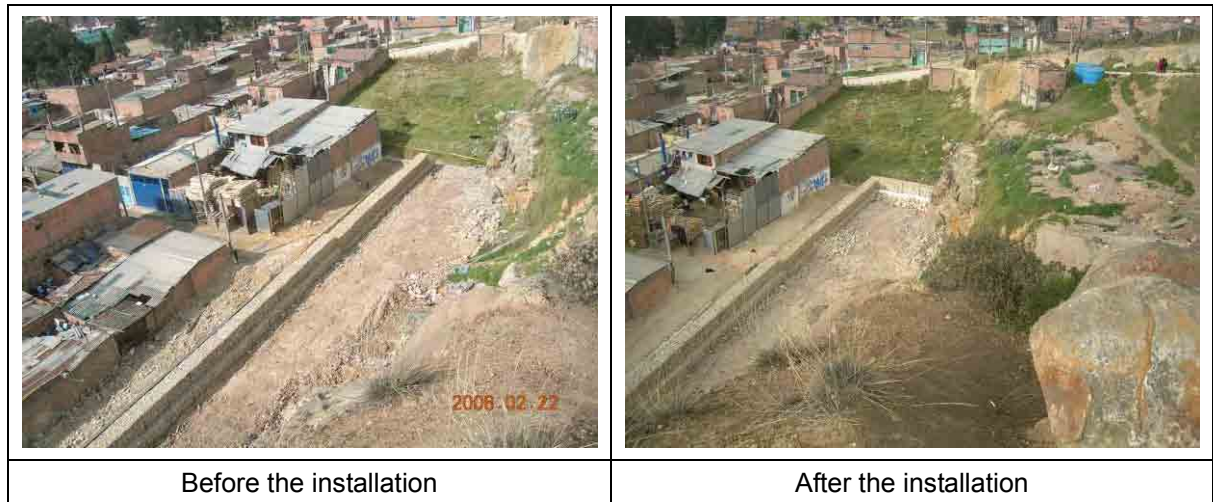
Figure 13-8 Additional Protection Wall

landowner at right angle to the temporary protection wall axis. However, the wall height was lower than the temporary protection wall after the demolition works of houses.

In order to avoid new settlement from this place, the temporary protection wall with a length of 8.0 m was considered in the 2nd Contract.
