SUPPORTING REPORT

S8

COMMUNITY SURVEY

TABLE OF CONTENTS
OF
S8 COMMUNITY SURVEY

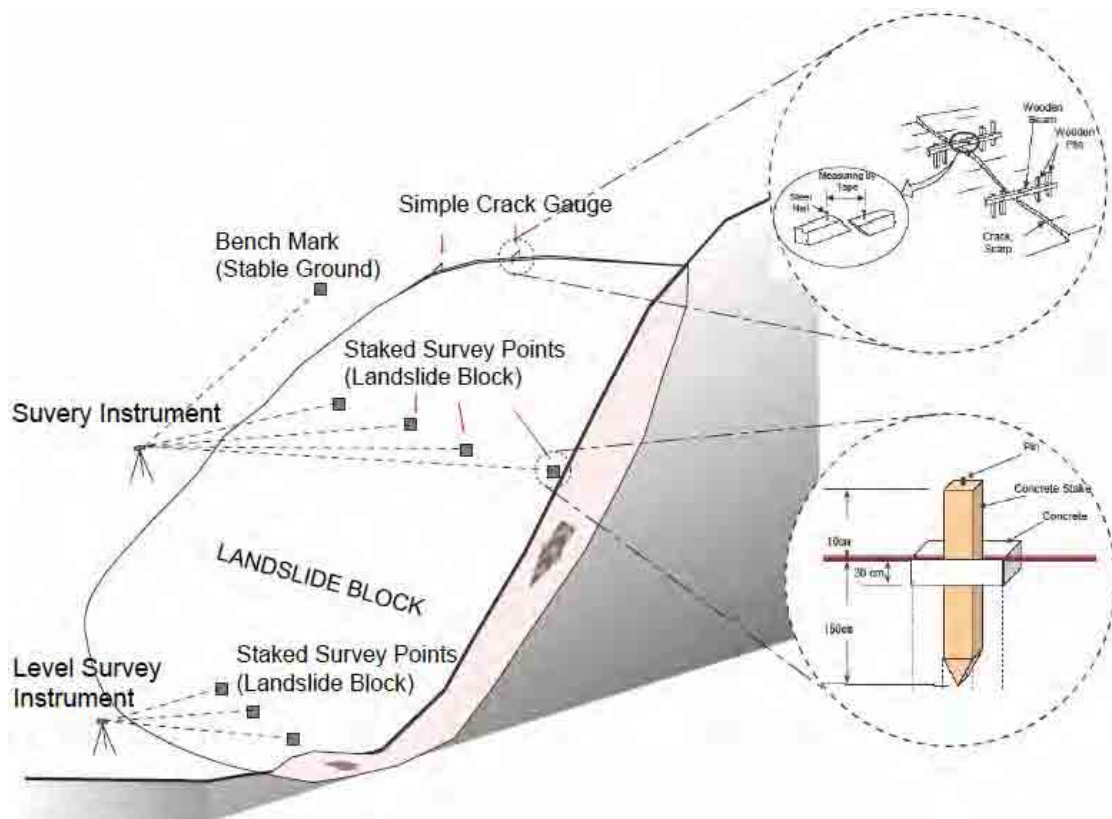
Figure S8-1-1 Conceptual Diagram of Survey Points, Crack Gauges, Level Survey Points

- a. Survey Points
- b. Crack Gauges
- c. Level Survey
- d. Tiltmeter
- e. Laser Distance Meter

Location	Monitoring	Item	Quantity
Boundary between the Landslide and the Residential Area	Survey Point	Survey Points	15
		Fix Points (Bench Marks)	5
Phase II	Crack Gauge	Crack Gauges	3
		Pegs (4 pegs for 1 set)	3 set
Uplift and Deformed House	Level Survey	Survey Points	3
	Tiltmeter	Sensor	1
		Logger	1
	Distance Meter	Laser Distance Meter	1
Target Plate		2

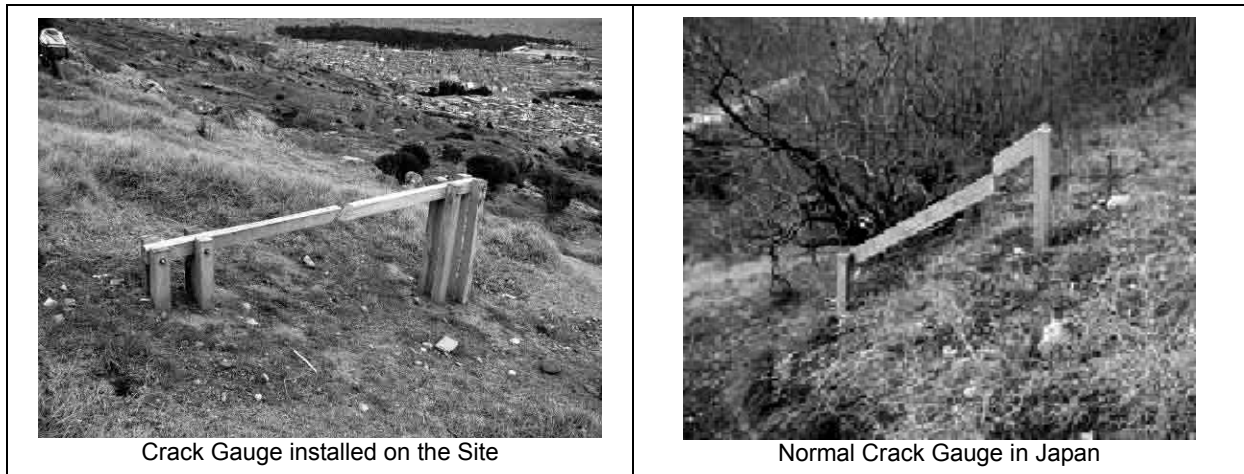
Figure S8-1-4 Crack Gauges

The movement of the cracks monitored by the crack gauges can be summarized in graphs which show relations between time and movement. The graphs can show the movement of the head of landslide block, and then the velocity of the landslide movement may be estimate. Sign board as shown in Figure S8-1-10 are installed at the crack gauges to inform the meaning of the monitoring to the residential people around.

Crack gauges installed on the site are quite bigger and stronger than normal in Japan since they might be destroyed as shown in Figure 6. However the crack gauges were destroyed few times by somebody after installation on the site, then they were changed to stakes as shown in Figure S8-1-5.

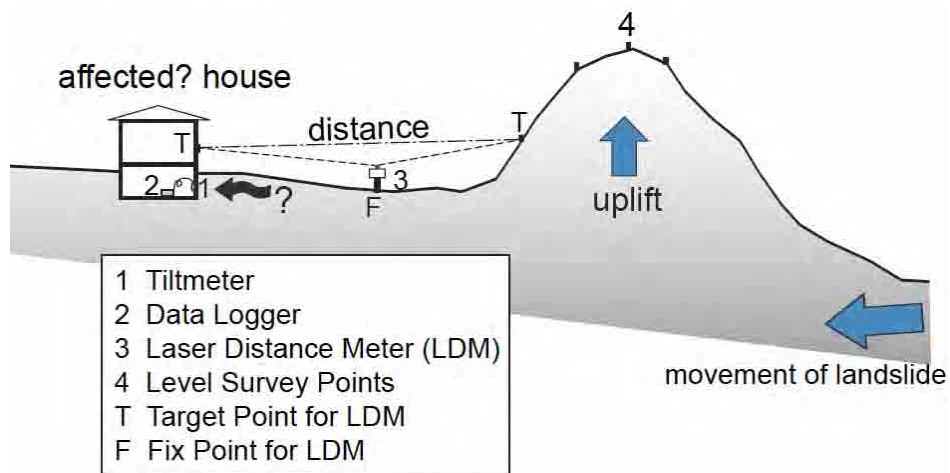
Figure S8-1-6 Monitoring Equipments for the House

The following equipments were installed in and around the house to monitor slow progress of tilting of the house and slow movement of uplift.

- a. Tiltmeters on the basement floor of the house
- b. Laser distance meter to monitor the distance between the house and the uplift
- c. Logger which connected to the tiltmeters in the house
- d. Level survey points to monitor uplifting of the uplift

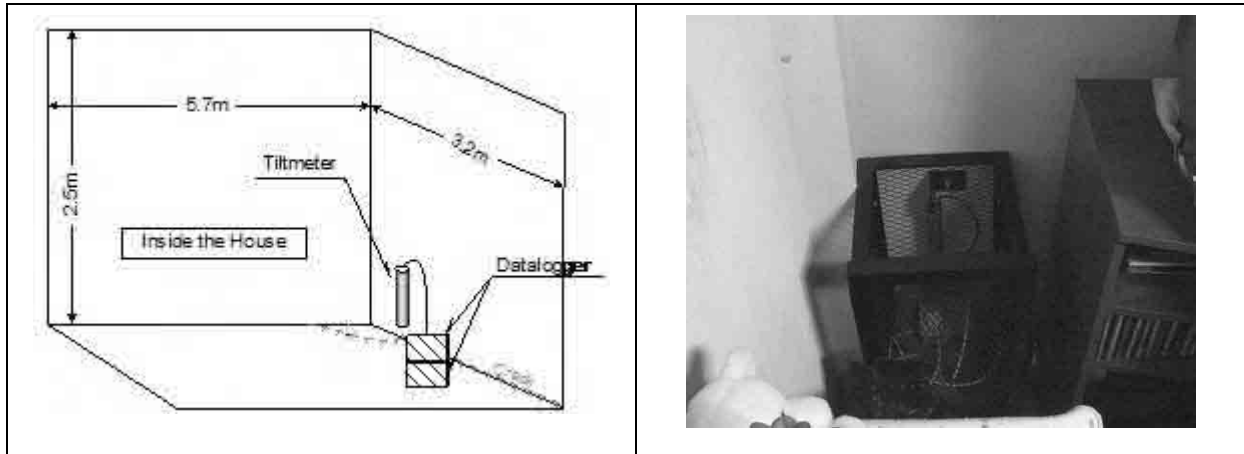
Figure S8-1-8 Schematic Diagram of the Installation of Tiltmeters and Data loggers

To monitor the tilting of the house, one automatic tiltmeter is installed with data logger on the wall of the basement in the house. Specifications of the tiltmeters are as follows;

A single channel type data logger was employed to collect the tiltmeter data. Specifications of the tiltmeters are as follows;

- Available to change any measurement interval (selectable every 1 sec, 1 min, 1 hr, 1 day),
- Data memory: more than 1,000 data

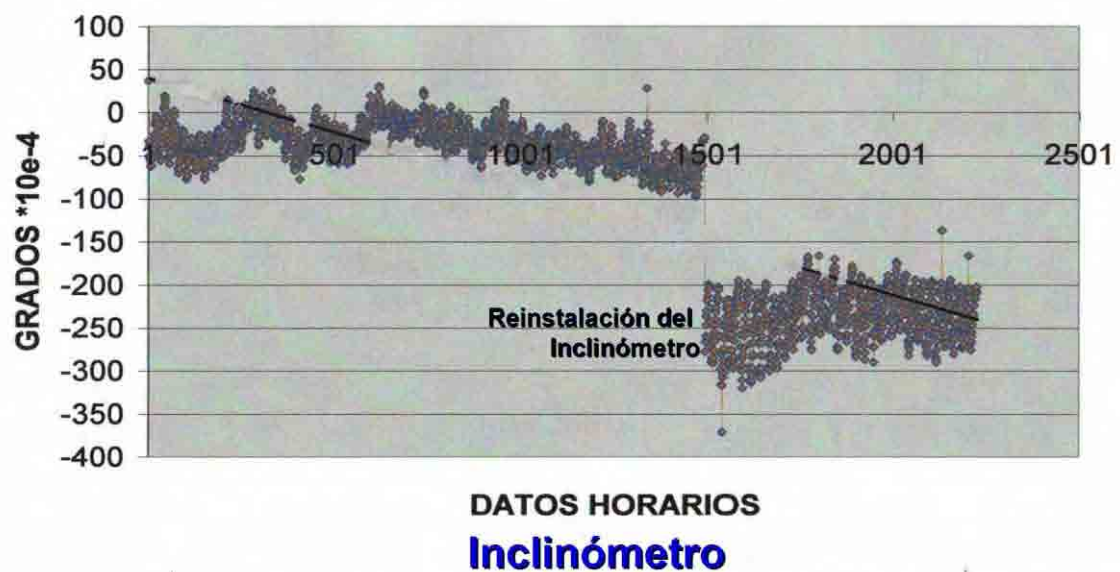
Figure S8-1-9 Inclinometers Movement

Any significant movement has not been seen on all the monitoring at the moment. The results may show that the landslide has not been reached to the safe areas, and the residential areas may be still in safe status. However, the period of the monitoring is too short to judge the safety of the areas, the monitoring should be continued and accumulate the data to confirm the safety of the areas.

(y-axis; 1×10^{-4} degrees, date x-axis; hour from 28 July, gap at day 1660 is because of reinstallation)
 Stolen and Theft

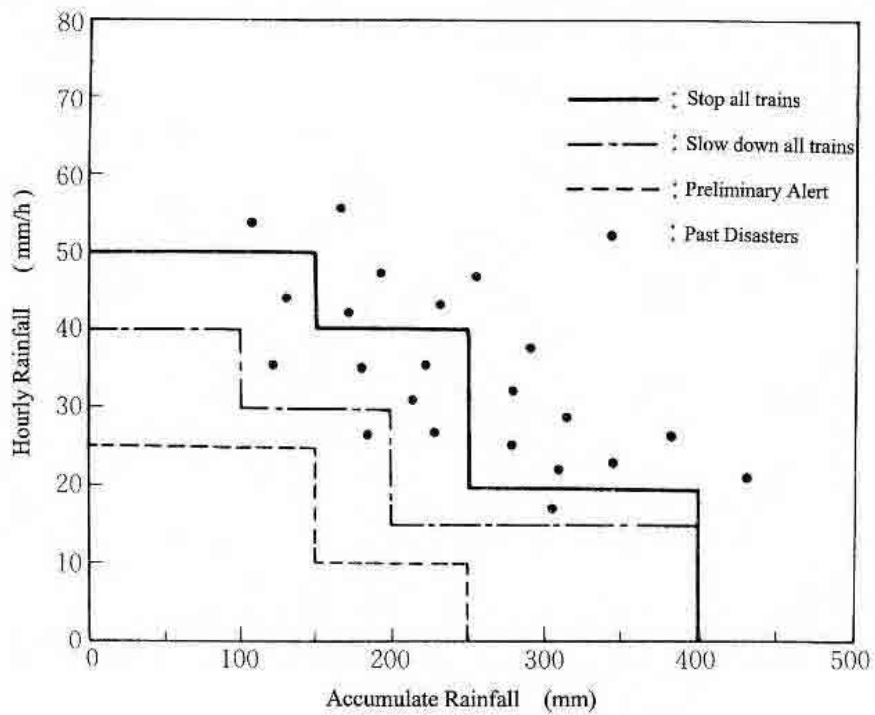
Figure S8-1-12 Train Control Based on Rainfall by Japan Railways

Combined of methods of a) and b) is more reliable than the single application. This method is adopted by Japan Railway (Figure S8-1-12). Japan Railway (JR) is using the following graph to control train system. Figure S8-1-12 shows that the example of train control based on rainfall by JR. It is based on accumulated rainfall and hourly rainfall.

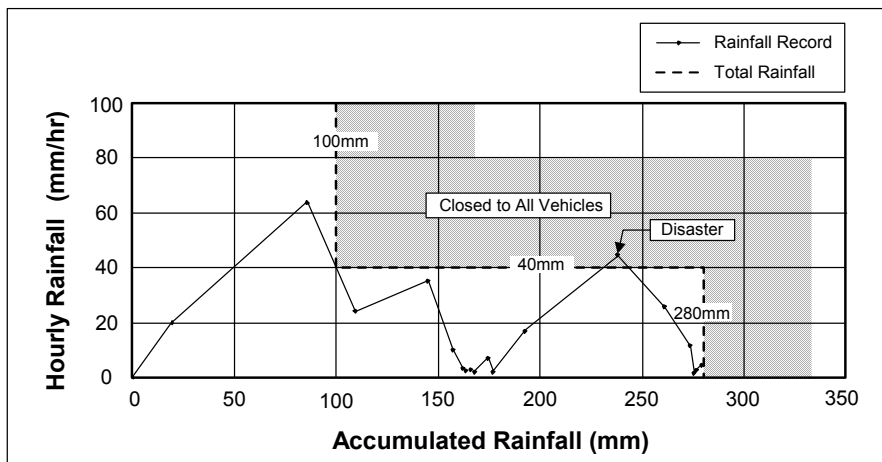
Figure S8-1-13 Train Control Base on Rainfall by Japan Highway Corporation

Figure S8-1-13 shows that the example of traffic control based on rainfall by Japan Highway. It is combination of accumulated rainfall and hourly rainfall. The shadowed area in the graph is to be considered as critical stage for the highways.

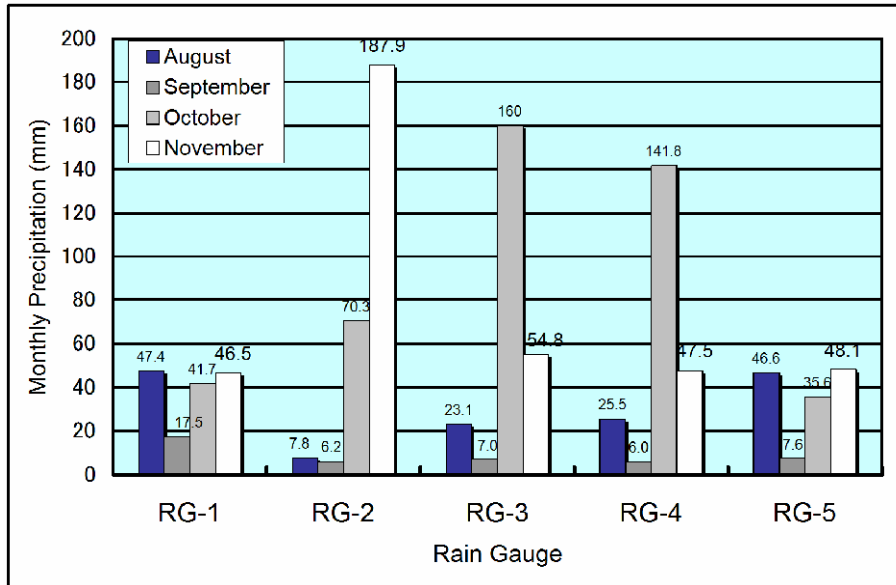
Figure S8-1-21 Monthly Precipitation in September and October

Precipitation monitoring has been carried out for five months, still the precipitation data need to be accumulated for more periods to tell something about rainfall. At the moment, the following things were found in the monitoring.

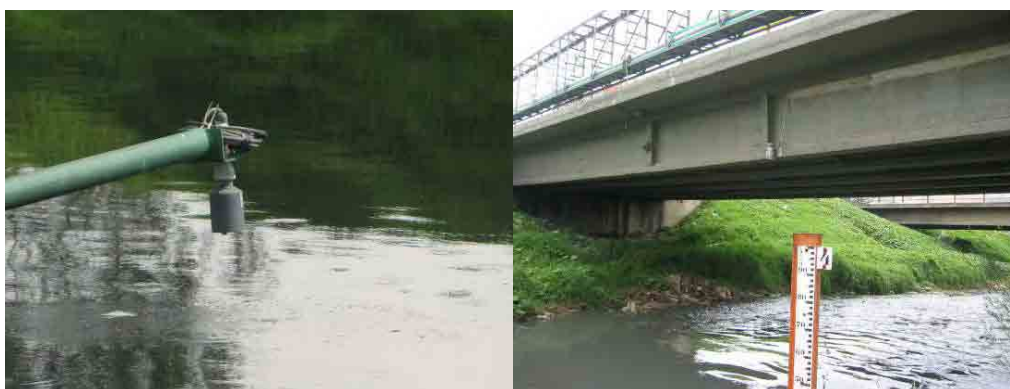
Photo S8-2-2 Non-contact stage measurement sensor
(left: EAAB La Isla Station, Bogota River, right: DPAE San Benito Station, Tunjuelo River)

The advantages of non-contact stage measurement sensor are

- Easy installation to bridge, cantilever
- Cumbersome due to silting, plant growing, garbage can be eliminated.
- Sensor is exposed to public, so it is easy to recognize the change of the sensor such as stolen, damage.

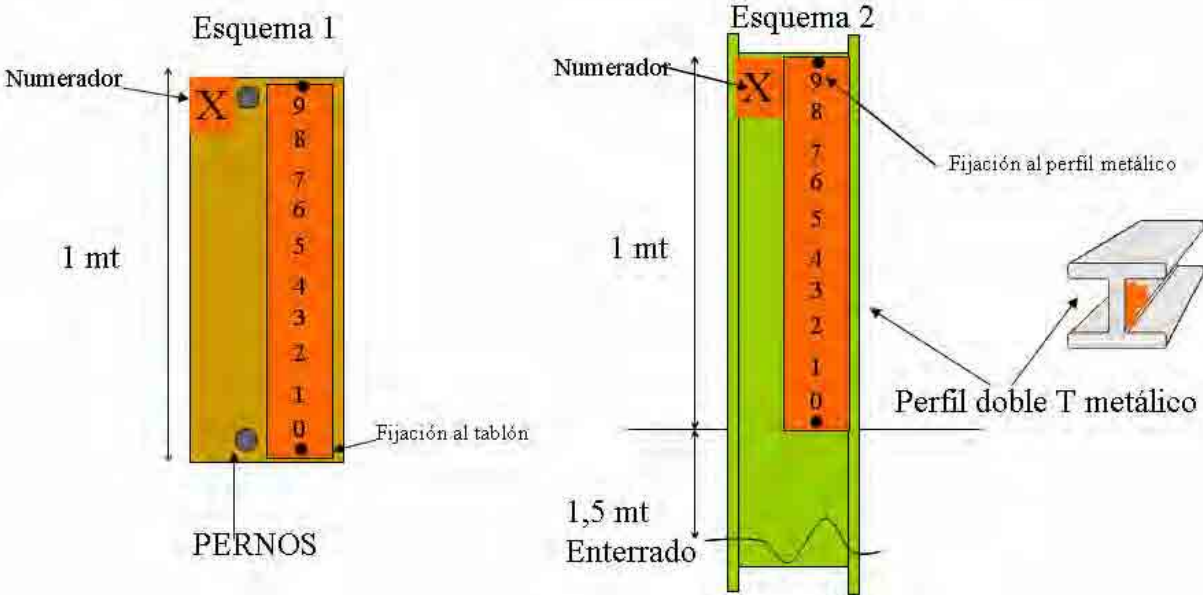
Figure S8-2-1 Standard Staff Gauge in Colombia

The type of staff gauge which was installed in the Study is IDEAM standard type as shown in Figura S8-2-1. DPAE and EAAB have been installing basically similar one to the IDEAM standard. In the Study there are two (2) type of staff gauge installed. The type 1 was used in the case that the installation on wall, in which strong flow hit is not so expected. The type 2 was applied in the case that the installed staff gauge is exposed to flow or steep slope creek such as the Chiguaza upstream.

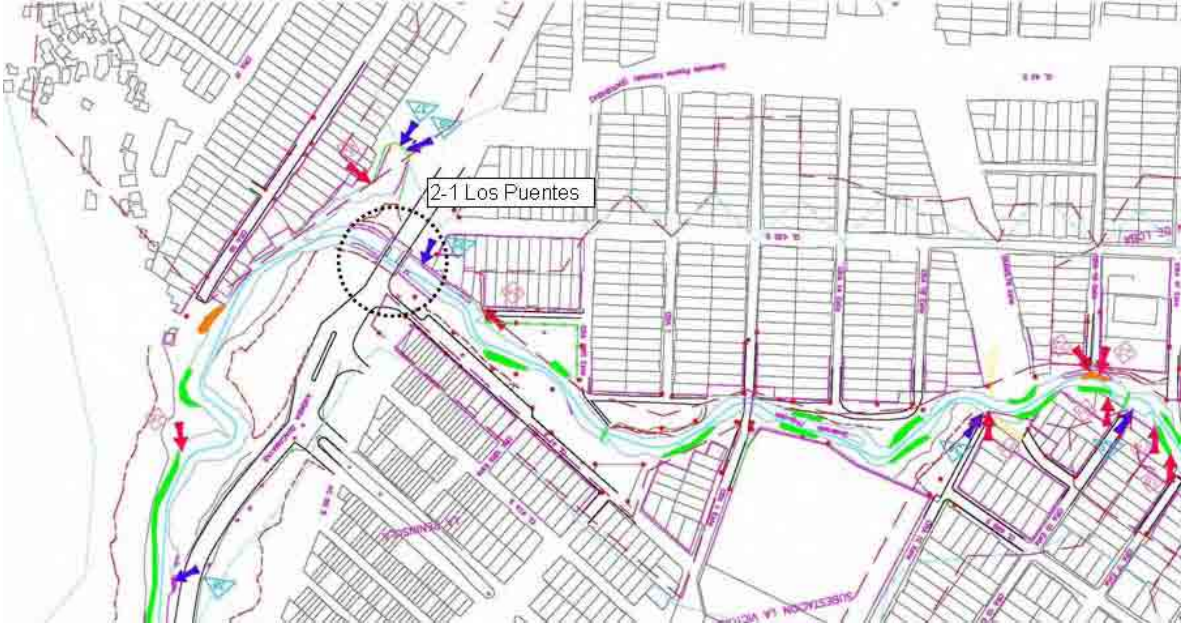
Figure S8-2-4 Candidate Locations for Staff gauge near Chiguaza creek (1)

The following candidate locations were investigated among the affected areas by May 1994 flood. Figure S8-2-4 to Figure S8-2-7 are showing the candidate locations.

No.	Name of Candidate Location	Address (Description on the location)	Advantage	Disadvantage
2-1	Los Puentes	The bridge between TV 1 BIS CL 47 SUR and TV 1 BIS CL 43B SUR (Barrio Peninsula)	Staff gauge can be installed on the sidewall of the section.	It is located on too lower reach of the Chiguaza.
2-2	La Nueva Gloria	The bridge on "CRA 3B Este"	None	The creek is deep and the small box culvert is under the bridge. It is not appropriate for the installation of staff gauge.
2-3	La Gloria	The concrete wall near basketball court " Calle 46 A BIS 6-25E" (Barrio Jacinto)	A resident living in the address has clear memory on May 1994 flood, who can point out the flood mark on the wall of her house. It is appropriate to ask the people read the staff gauge.	none
2-4	Altamira	The bridge on "TV 11B 46-98S"	Staff gauge can be installed on the sidewall of the section.	The affected area is only located 100 m downstream from the bridge. People living near the bridge were not damaged on May 1994.

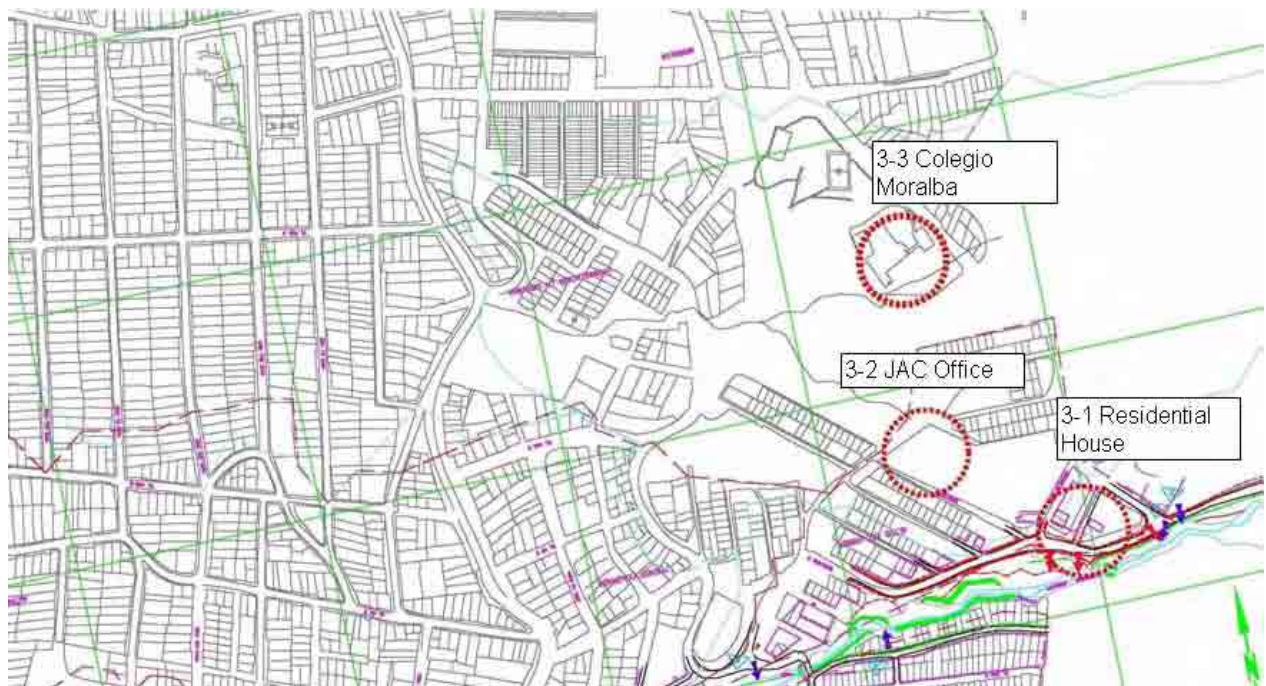
Figure S8-2-8 Candidate Locations for Rainfall gauge near Quindio

Near Quindio, the Study Team selected three (3) locations for the rainfall station as shown in Figure S8-2-8.

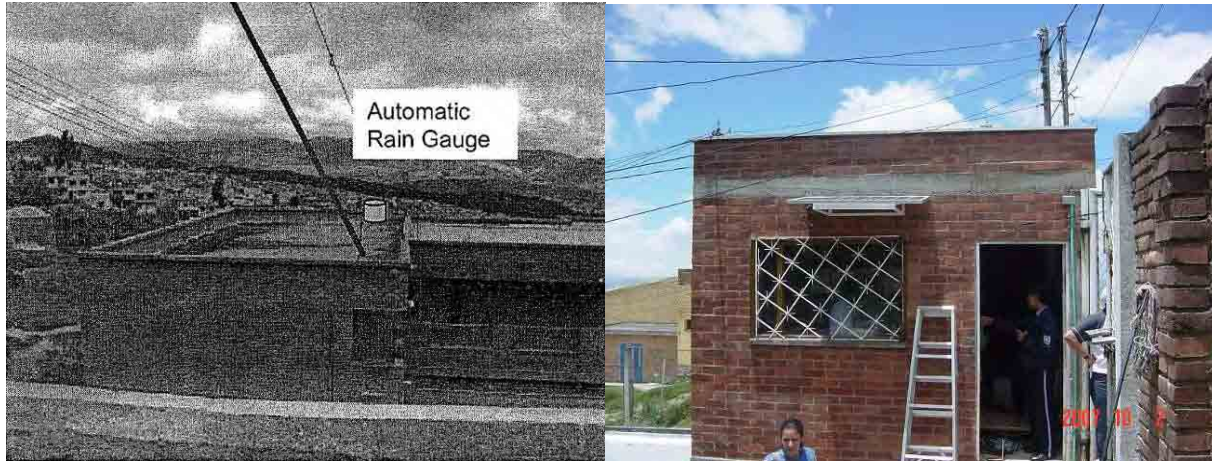
In Moralba, a rain fall gauge was installed. The installation place is the Moralba school. The rain fall gauge is installed on the school house, the data logger and the power supply units are installed in the security guard station of the school.

Photo S8-2-2 Rainfall gauge and Solar Panel in Moralba

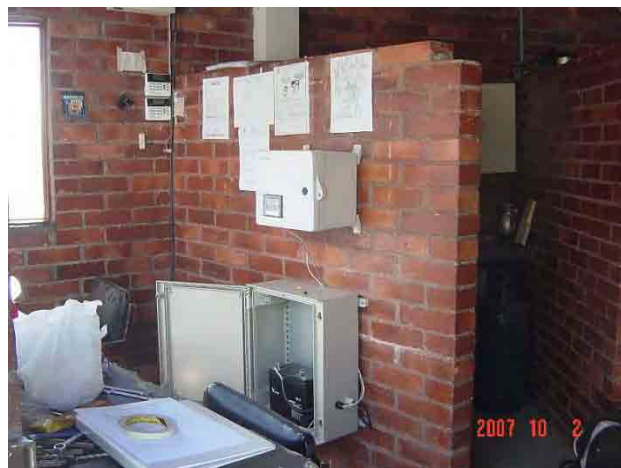
Photo S8-2-3 Data logger and Power supply in Moralba

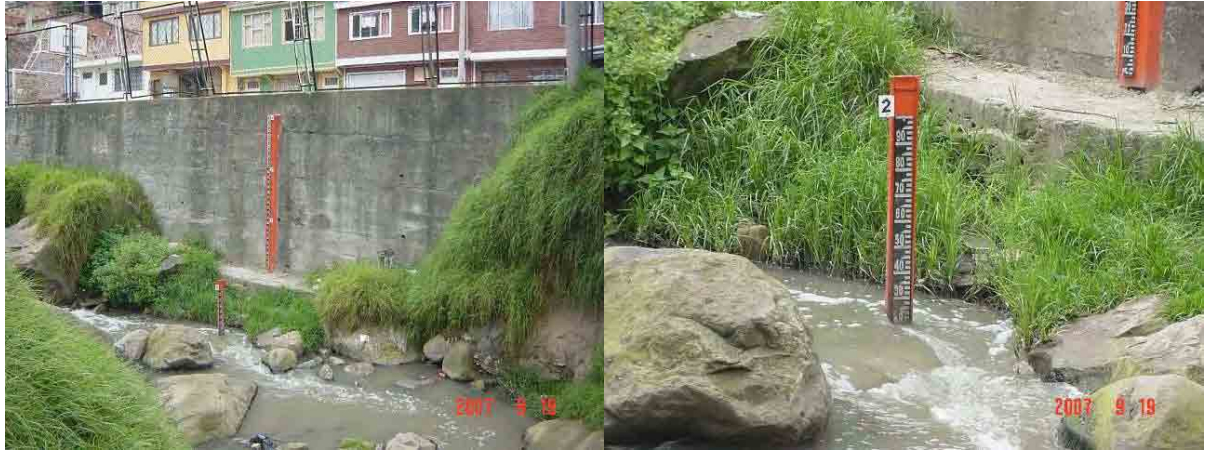
In La Gloria, a staff type water level gauge was installed. The installation place is the mid stream of Chiguaza-river. The staff type water level gauge is installed in the river and on the river wall. Regarding an electrode type simplified water level gauge, it will be installed beside the staff type gauge in wait for the permission to use electric poles.

Photo S8-2-4 Water level gauge at La Gloria

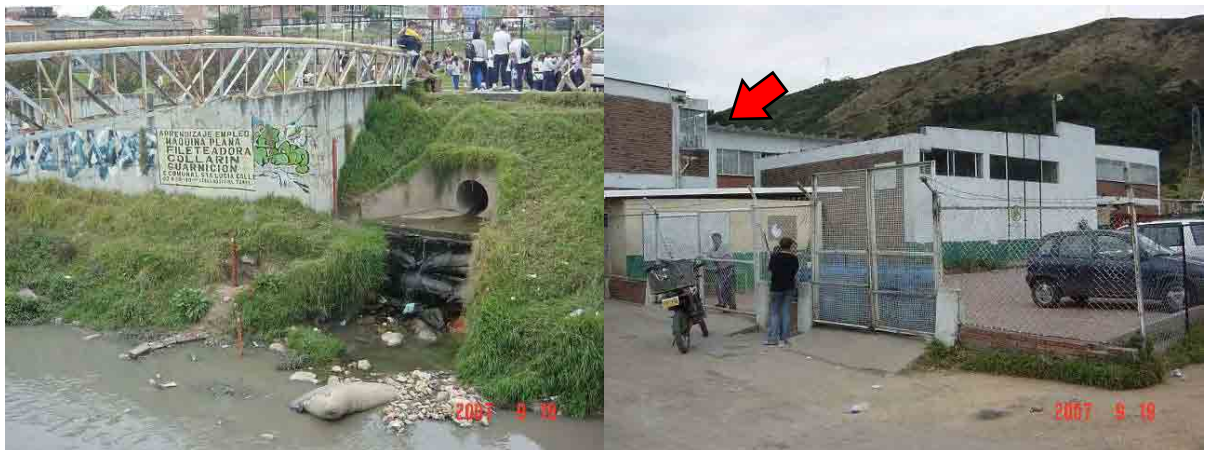
In Los Molinos, a staff type water level gauge was installed. The installation place is the down stream of Chiguaza-river. The staff type water level gauge is installed in the river and on the river wall. Regarding an ultrasonic type water level gauge, the sensor unit will be installed under the foot bridge, the data logger and power supply unit will be installed in the school house.

Photo S8-2-5 Staff Gauge (Left) and School's security guard house for Data Logger

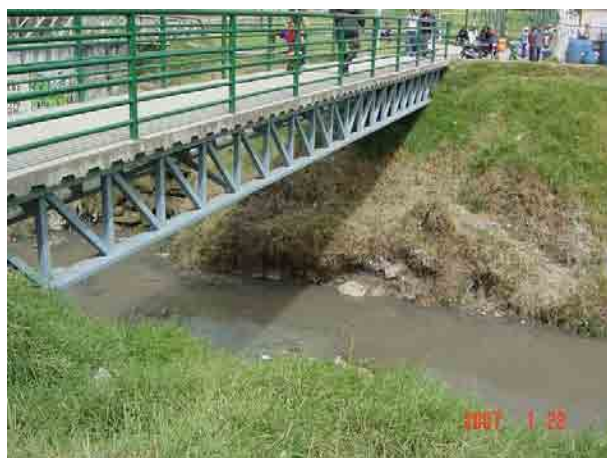
Photo S8-2-6 Footbridge for Ultrasonic Sensor installation

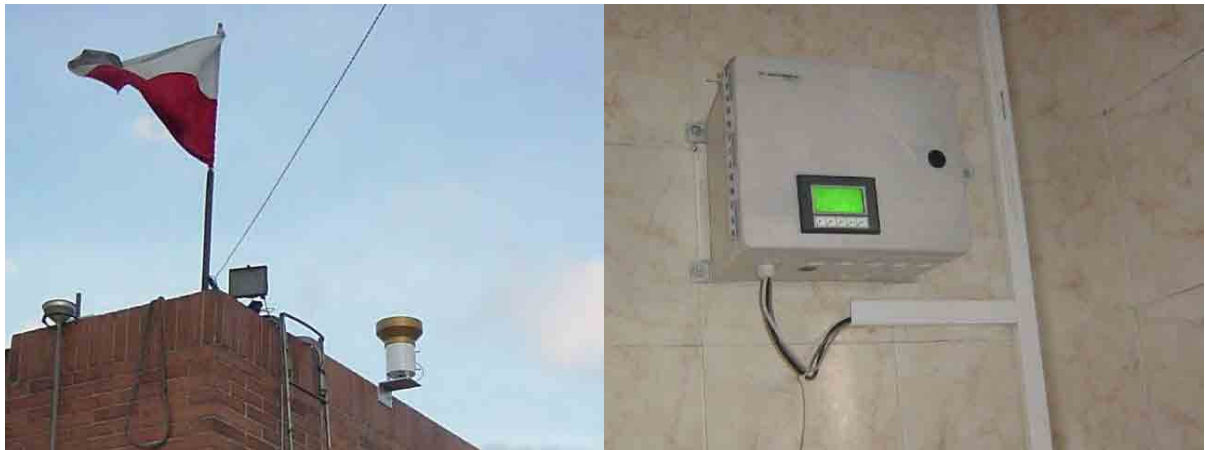
The rain fall gauge is installed on the roof, the data logger and power supply units are installed in the office room.

Photo S8-2-12 Rainfall Gauge and Data logger

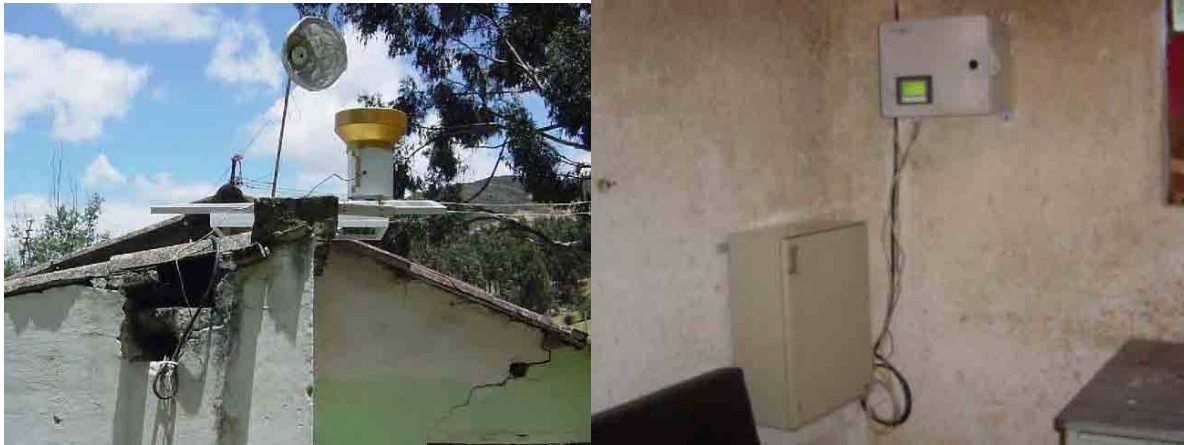
In San Jorge, a rain fall gauge was installed. At first JICA study team planned to install in the IDEAM meteorological field, but the rain fall gauge was installed in the security guard station at the gate of ICA temporarily by various factors.

Photo S8-2-13 Rainfall gauge on the roof and Data logger and power unit

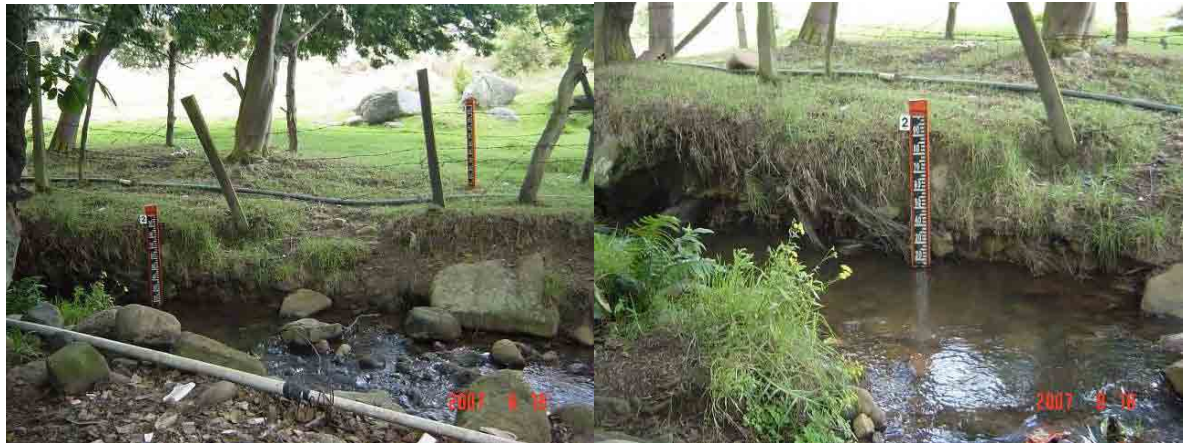
In Fusunga, a staff type water level gauge was installed in and by the river. According to the Fusunga lady, the water level increased at 2.3m in the gauge scale on the occasion of the flood in May 2006.

Photo S8-2-14 Water level gauge at Fusunga

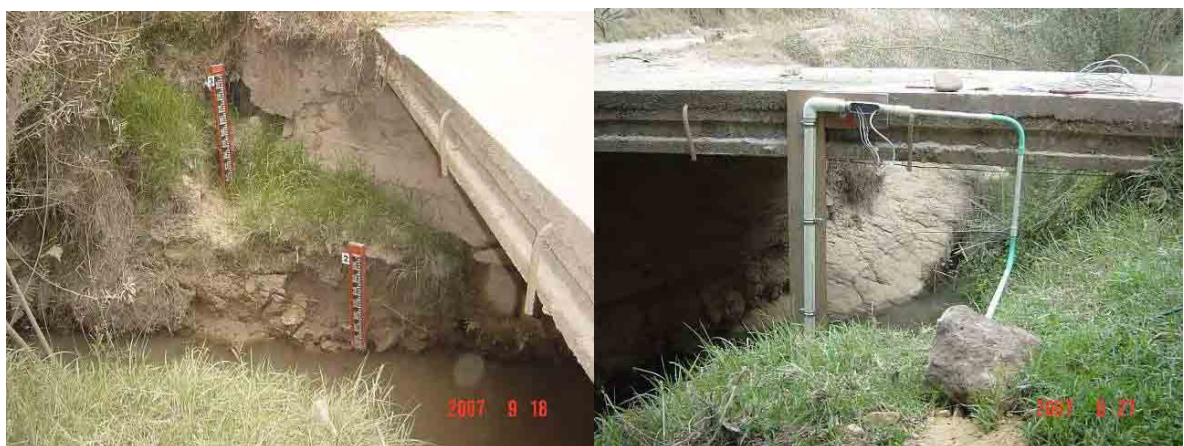
In the prison of Soacha, a staff type water level gauge and an electrode type water level gauge were installed in the river. In the near future a conventional type rain fall gauge, which is installed in the Soacha fire station now, will be moved here.

Photo S8-2-15 Staff gauge and Electrode type gauge

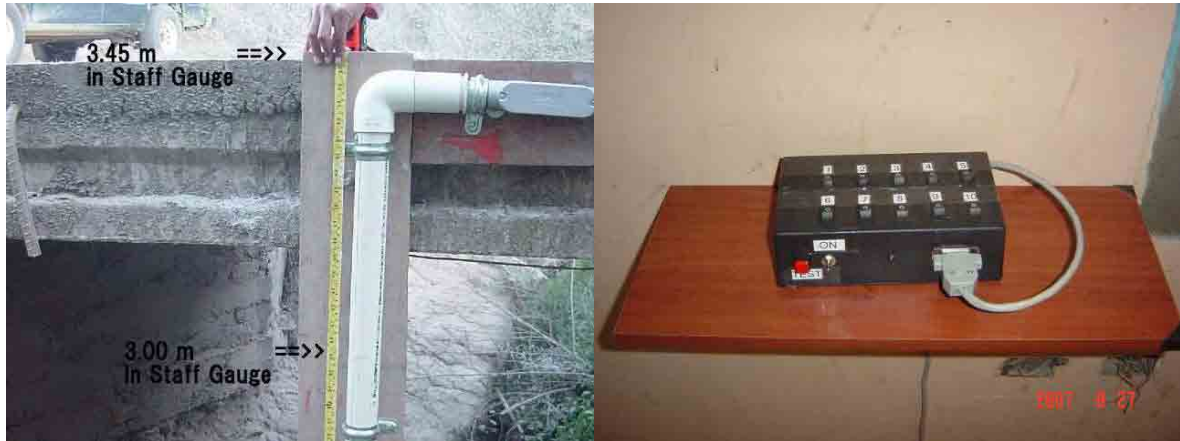
Photo S8-2-16 Comparison of the scale and Alarm box of Electrode type gauge

Switch number on Alarm unit box	Water depth on Staff gauge (m)
10	3.15
9	2.95
8	2.75
1	1.55
1	1.35

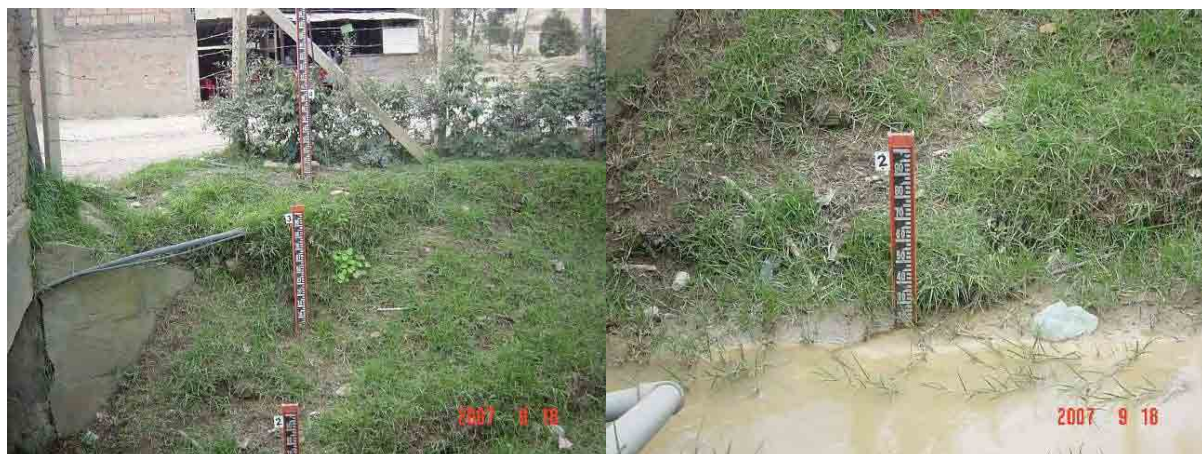
In Ladrillera Santa Fe, a staff type water level gauge was installed in the river. In the near future an ultrasonic type water level gauge will be installed. According to the cooperator in the brick factory, the water level reached at the middle of the handrail of the bridge on the occasion of the flood in May 2006. It means the water level was 3.8m in the gauge scale.

Photo S8-2-17 Water level gauge at Ladrillera Santa Fe

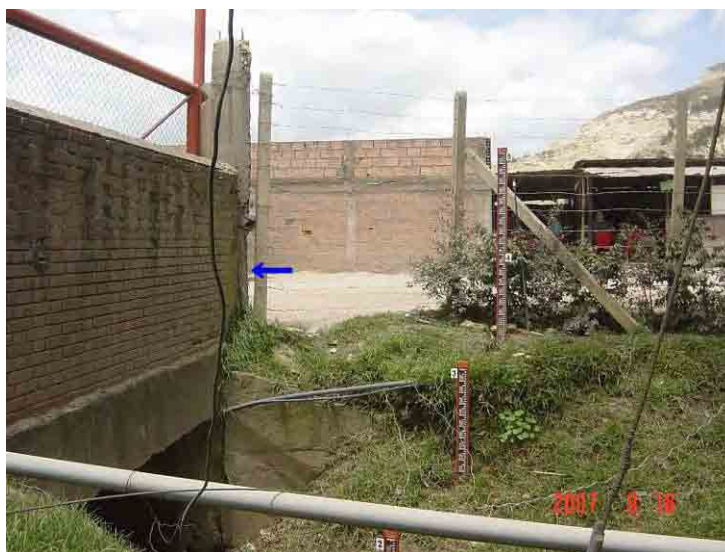
Photo S8-2-18 Water level of the flood in May 2006

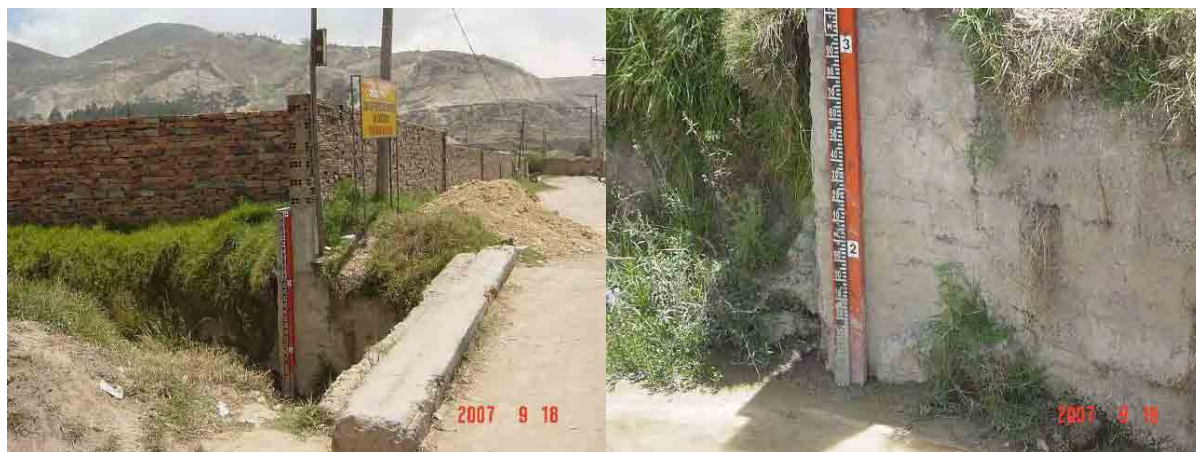
In Llano Grande, a staff type water level gauge was installed in the river. According to the cooperador in the section, the bridge was covered with the river water on the occasion of the flood in May 2006. It means the water level was 3.5m in the gauge scale.

Photo S8-2-19 Water level gauge at Llano Grande

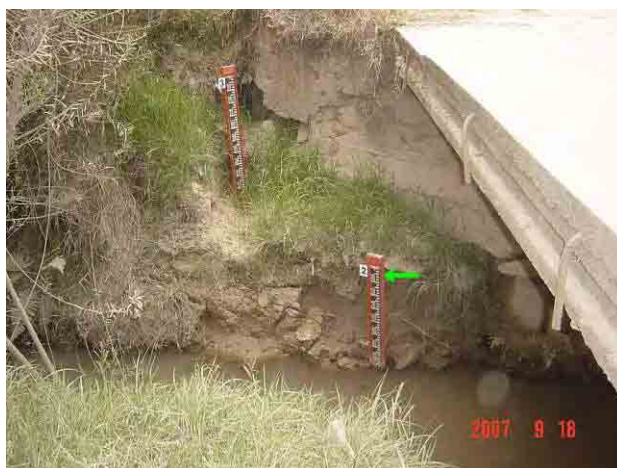
Photo S8-2-23 Setting level of electrode type water level gauge

In the prison of Soacha, a staff type water level gauge was already installed. But the observation by the security guards was not started yet. JICA study team visited the prison and made the training to the cooperators. So the observation and communication was started three times a day. Regarding the electrode water level gauge, it informs the observer with buzzer if the water level reaches the warning level. At this moment, the warning level is set at the switch number 4. It means 1.95m in the staff gauge scale.
