## **G. Structural Measures**

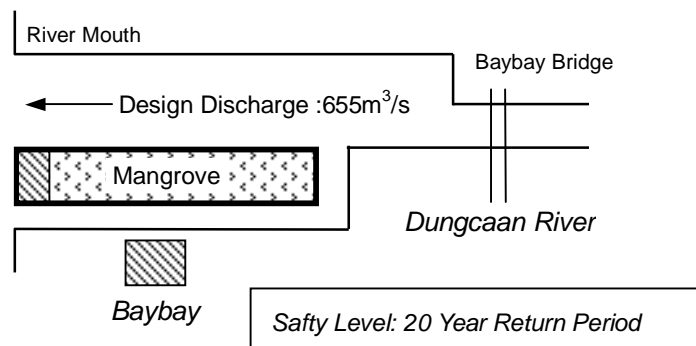
Figure G.3.4 Design Discharge Distribution in the Dungcaan River Basin

Distribution of design discharge for 20-year return period is shown in Figure G.3.4.
